### ORE DRESSING AND METALLURGICAL LABORATORIES.

Investigation No. 1731.

Examination of a Manganese Steel Crusher Toggle Seat.

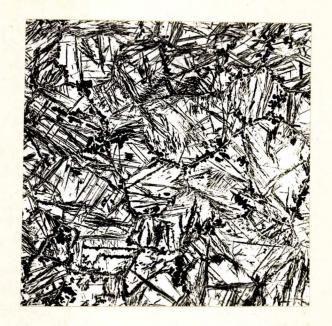
# Figure 1.

Figure 1 is a photomicrograph of the sample as received. The microstructure shows carbides at grain boundaries, needle-like carbides throughout the grains, and the usual background of austenite.

The manganese content is below specification, and is too low for the fairly high carbon content. A sample water-quenched from 1900° F. in these Laboratories still showed some fine free carbides at the grain boundaries. This steel would not be satisfactory even if it had received the proper heat treatment.

The microstructure shows that the steel has not been properly heat-treated. The fact that attempts to duplicate this structure were unsuccessful suggests the possibility that the sample is still in the as-cast condition.

- 1. The casting failed because it had not received the proper heat treatment. It is possible that it received no heat treatment.
- 2. Even if it had received the correct heat treatment the casting would not have given satisfactory service, as the manganese content is too low.

K100, mital etch.
MICROSTRUCTURE AS RECEIVED.

Needle-like inclusions and dark masses are carbides. Background of austenite.
