Investigation No. 1732.

Metallurgical Examination of Track Link Connectors.

Abstract

The early failure of the track link couplings was found to be caused by quenching cracks. Recommendations as to changes in material and heat treatment are made.

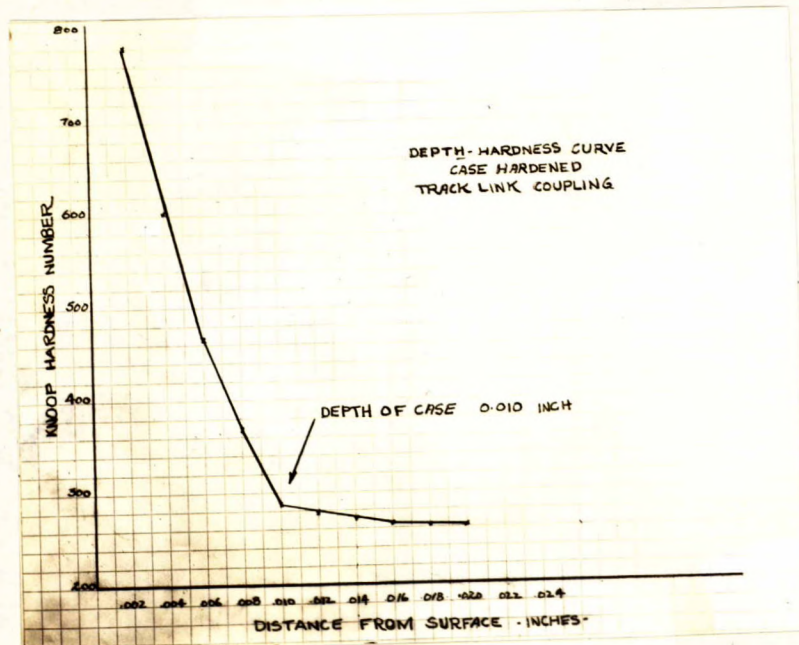
Figure 1.

To determine the depth of carbon case, a Tukon hardness tester was used. The curve in Figure 1 shows the hardness of the metal in relation to the distance from the surface. The case depth is 0.010 inch.

The "Knoop" hardness values of 780 at the surface and 256 in the core correspond, respectively, to approximately 750 and 230 Vickers.

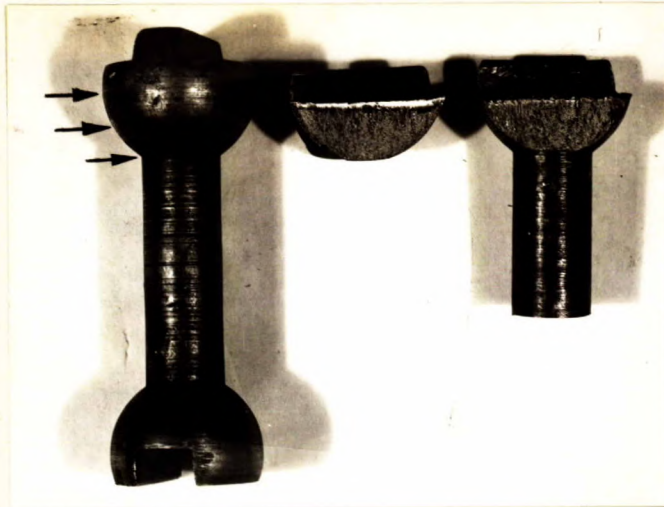
Figure 2.

At the change of section and shoulder (see arrows, Figure 2), small surface cracks were observed in both the failed and the unused connectors. In the unused parts the cracks are small (see Figure 3). In the part that failed, the cracks have widened considerably (see Figure 4).

PHOTOGRAPH OF TRACK LINK COUPLINGS,
SHOWING NATURE OF FRACTURE.

Microscopic cracks located as shown in Figure 2 are the obvious cause of failure. When the track link connectors are subjected to alternating stresses in service these cracks increase in size and the result is early failure.

- (1) Increasing the radius of the fillet at the shoulder.
- (2) Using an oil rather than a water quench. (It should be noted that a milder quenching medium will lower the surface hardness somewhat.)
- (3) A stress-relieving draw at about 300° F. immediately after quenching.

- (a) Increasing the radius of the fillet at the head.
- (b) Using a less severe quenching medium.
- (c) Giving them a stress-relieving draw at 300° F.

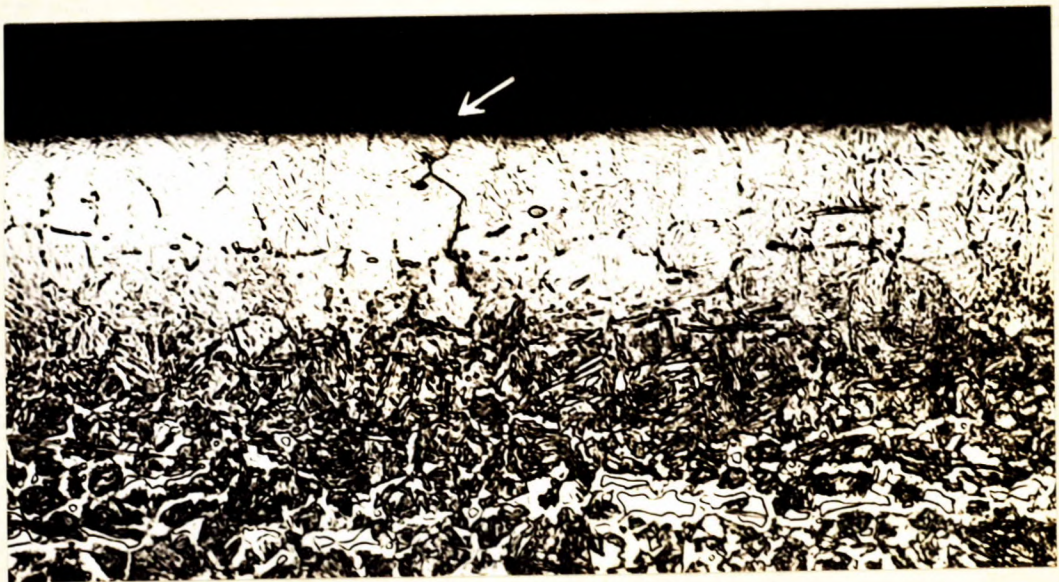
Figure 3.

X500, etched in 2 per cent nital.

TRACK LINK CONNECTOR WHICH
HAS NOT BEEN IN SERVICE.

White arrow points to quenching crack.

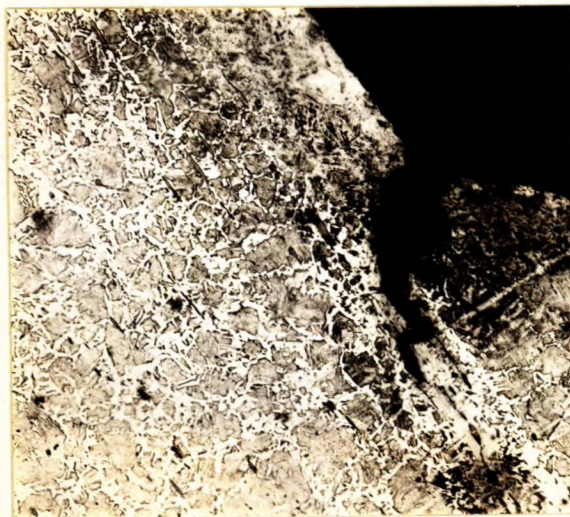
Figure 4.

X100, etched in 2 per cent nital.

TRACK LINK CONNECTOR WHICH
FAILED IN SERVICE.

Note crack in fillet (sharp change of section).
