November 10th, 1944.

ORE DRESSING AND METALLURGICAL LABORATORIES.

Investigation No. 1736.

Investigation of Defective Boiler Tubes
from S.S. "Kitsilano Park".

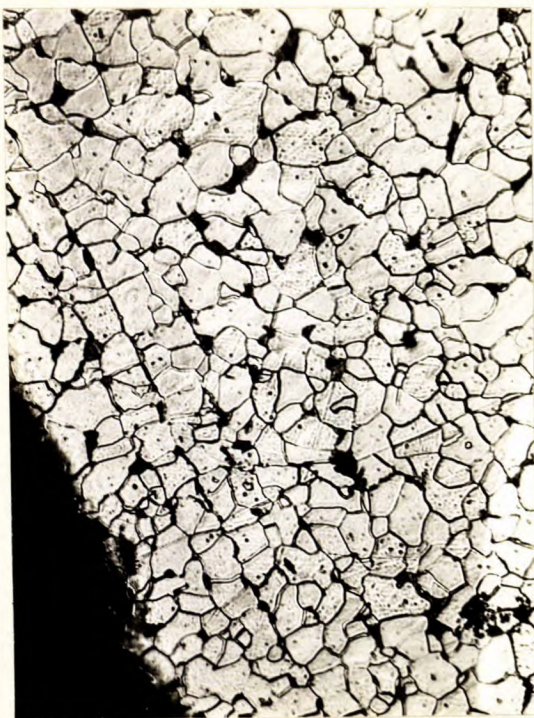
Figure 1.

Examination of metal from the unbulged part of the tube showed a normal grain structure with a small amount of pearlite present. Figure 1 is typical of the metal near the inside surface of the tube and Figure 2 is typical of the metal near the outside surface. Examination of metal from the bulged part of the tube showed a normal grain structure with a somewhat greater amount of pearlite. It still would be considered to have a low carbon content. Figure 3 is typical of the metal near the inside surface and Figure 4 is typical of the metal near the outside surface. There was no indication of defects, such as cracks or an excessive amount of inclusions, in the metal from the bulged part.

X250, nital etch.
TYPICAL OF METAL
NEAR INSIDE SURFACE.

UNBULGED PART OF TUBE.

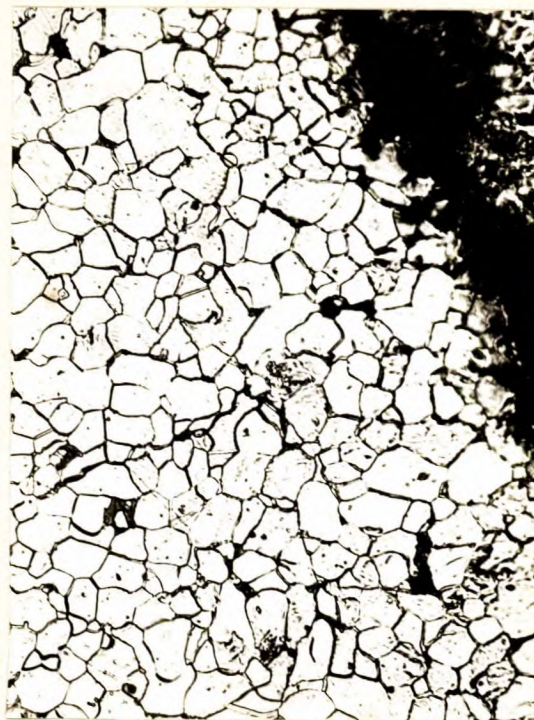
Figure 2.

X250, nital etch.
TYPICAL OF METAL
NEAR OUTSIDE SURFACE.

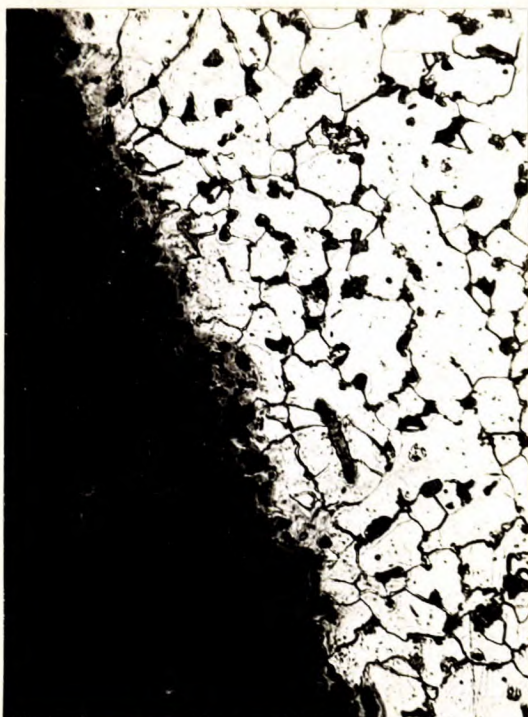
Figure 3.

X250, nital etch.
TYPICAL OF METAL
NEAR INSIDE SURFACE.

BULGED PART OF TUBE.

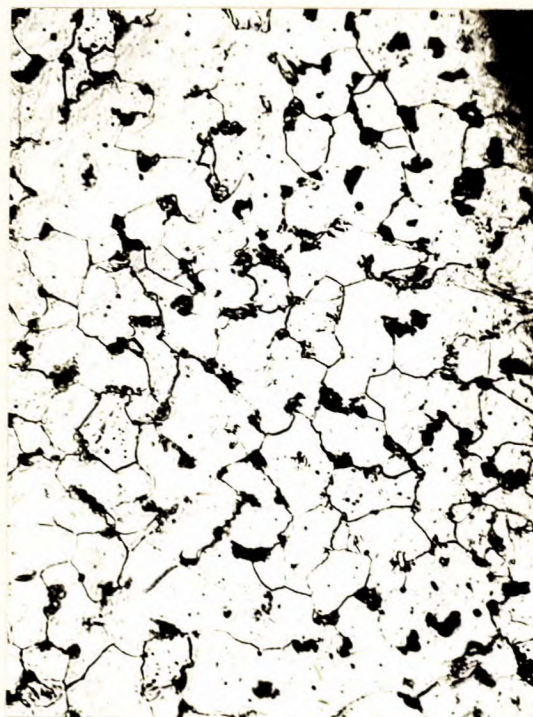
Figure 4.

X250, nital etch.
TYPICAL OF METAL
NEAR OUTSIDE SURFACE.
