November 11th, 1944.

ORE DRESSING AND METALLURGICAL LABORATORIES.

Investigation No. 1739.

Examination of Three Manganese Steel Castings.

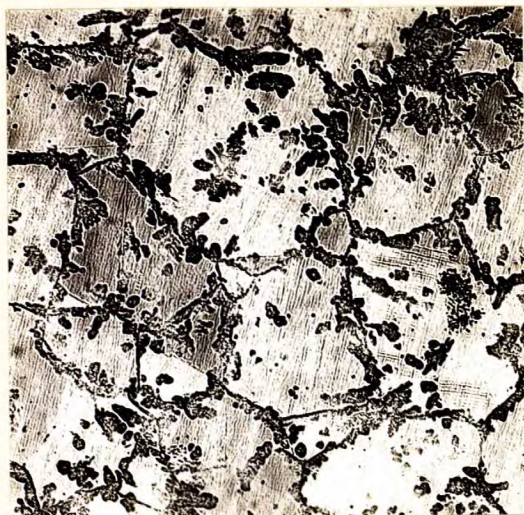
Figure 1.

The microstructures of the three samples are shown in Figures 1 to 3. Figure 4 is a photomicrograph of the structure obtained on quenching a sample of manganese steel from 1700° F. The four specimens had similar microstructures. They all contain coarse carbides at the grain boundaries, with the usual background of austenite.

The fact that a similar microstructure was obtained by quenching a sample from 1700° F. indicates that the steel had been underheated, as suggested in Mr. Critchley's letter. The as-cast structure has not been removed.

X100, nital etch.

MICROSTRUCTURE OF SAMPLE
FROM BUCKET.

All samples consist of coarse carbides at grain boundaries, in a background of austenite. As-cast structure has not been removed.

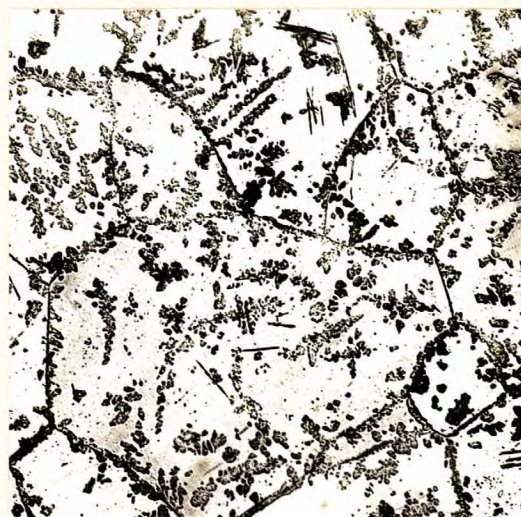
Figure 2.

X100, nital etch.

MICROSTRUCTURE OF SAMPLE
FROM DIPPER TOOTH.

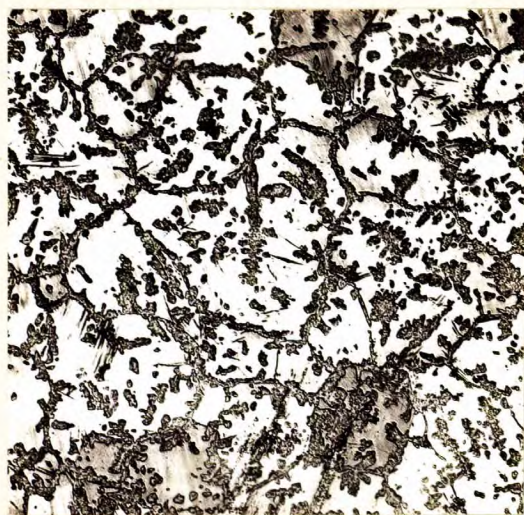
Figure 3.

X100, nital etch.

MICROSTRUCTURE OF SAMPLE
FROM GRIZZLY BAR.

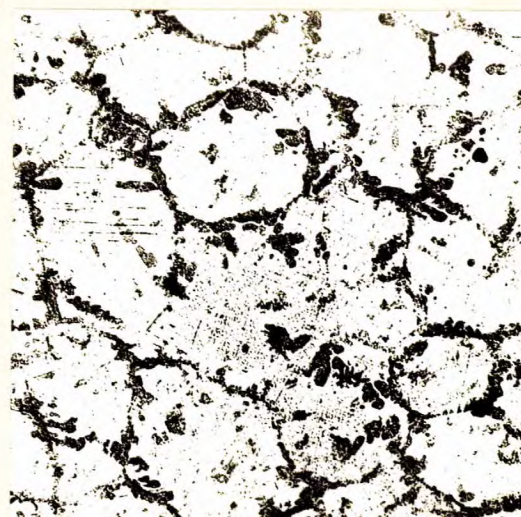
Figure 4.

X100, nital etch.

MICROSTRUCTURE OF SAMPLE
QUENCHED FROM 1700° F.

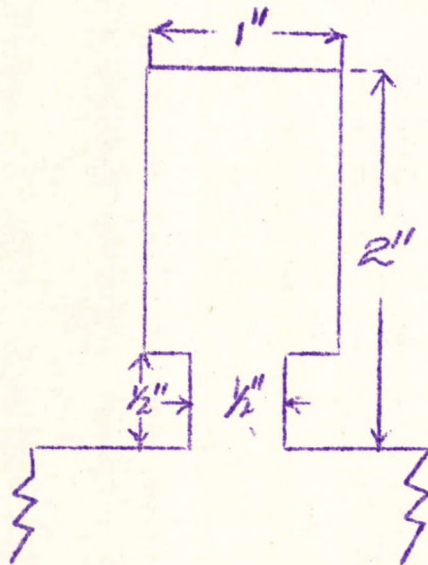
SUGGESTED KNOCK-OFF PLUG.

The use of a knock-off plug is offered as a suggestion which might insure against the delivery of any poorly heat-treated steel. The plug could be attached to the pattern, and knocked off just before the casting is shipped. If the steel was improperly heat-treated the plug would be brittle.
