Investigation No. 1740.

Examination of a Broken Steel Shaft
from a Briquetting Press.

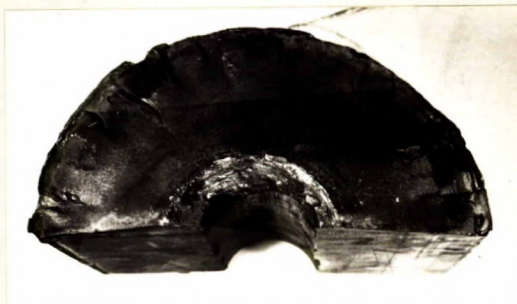
Figure 1.

Figure 1 is a photograph showing the half-section of the fractured surface of the shaft. The fracture has the appearance of a fatigue failure produced by alternating torsional stresses.

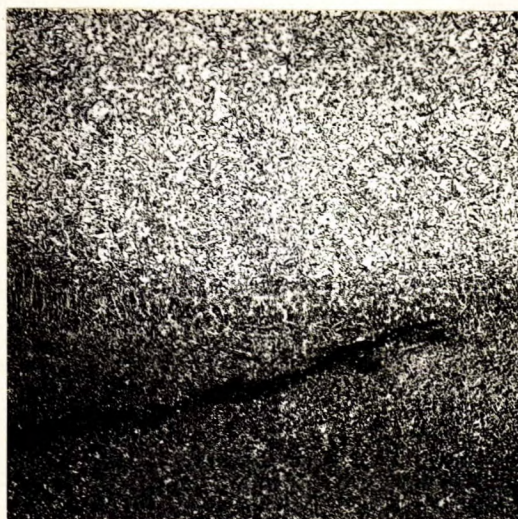
Figure 2.

A specimen of the metal adjacent to the fracture was polished and examined under the microscope in the unetched condition. The steel was found to be fairly clean. After etching in a solution of 2 per cent nitric acid in alcohol the steel was re-examined. Three different structures were observed, (1) the low-carbon weld metal on the outer surface of the shaft, (2) the heat-affected zone next to the weld metal, and (3) the original structure of the parent metal. Figure 2 is a photomicrograph, at X100 magnification, showing the transition zone between the weld and the parent metal. A crack extending longitudinally nearly to the edge of the fracture can be seen in this photomicrograph.

(Vickers hardness number of weld metal, 164-198.

(Vickers hardness number of parent metal in heat-affected zone, 334 to 418

SHOWING TRANSITION ZONE OF
WELD AND PARENT METAL.

The chemical composition of the steel is within the range specified for SAE 4140 steel, except for the manganese content which is several points above the upper limit--this is of no significance. This type of steel is widely used for the manufacture of heavy-duty shafting. The mechanical properties of the shafting are satisfactory and indicate that the steel was properly quenched in oil from 1550° F. and drawn at around 1200° F. The hard intermediate zone near the weld would be brittle, as this steel has an impact value of less than 10 foot-pounds in the 400 Brinell range. This hard material would also be notch sensitive and therefore subject to fatigue failure. The microscopic examination showed cracks in this brittle zone.

per cent carbon, special precautions should be taken to prevent the formation of brittle zones such as were found in the shaft. Preheating temperatures of 300 to 500° F. have been found effective in eliminating or reducing the formation of hard and brittle areas. By heating to 1100° F. to 1200° F., it is possible to restore the desired properties in the areas affected by the welding heat. The use of a low-carbon welding rod for this repair is considered good practice in so far as build-up is concerned. However, for the heavy abrasive conditions likely to be encountered it would not wear well, and it is recommended that the layer of low-carbon weld metal be covered with a hard facing metal. If only a small amount of metal is removed by wear hard facing metal could be used alone, but if much build-up is required the two-rod technique is best, as the weldment would be less brittle and cheaper to install. The most highly stressed part of the shaft would be at the fillet between the journal and the drum. Any discontinuities of section, such as the cracks observed in this area, would further induce stress concentration. It is most probable that the crack which caused this fatigue failure found its nucleus at this point.

In future repair work of this kind it is recommended that the part be preheated and held at 300 to 500° F. during the welding operation. Care should also be taken to prevent the shaft from cooling too rapidly. The shaft should be tempered after welding. If no furnace is available this can be done with an oxy-acetylene torch, using "Temp 11" sticks to indicate temperature.

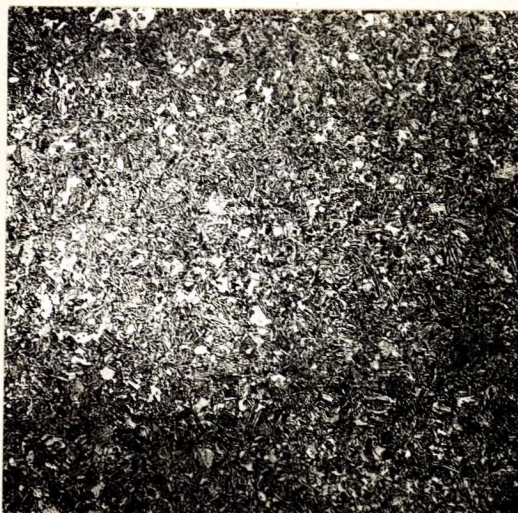
Figure 3.

Figure 3 is a photomicrograph showing the sorbitic structure of the parent metal in the unaffected zone.

SHOWING ORIGINAL STRUCTURE
OF PARENT METAL.
