R E P O R T
of the
ORE DRESSING AND METALLURGICAL LABORATORIES.

Investigation No. 1741.

Metallurgical Examination of Failed
Carrier Idler Wheel.

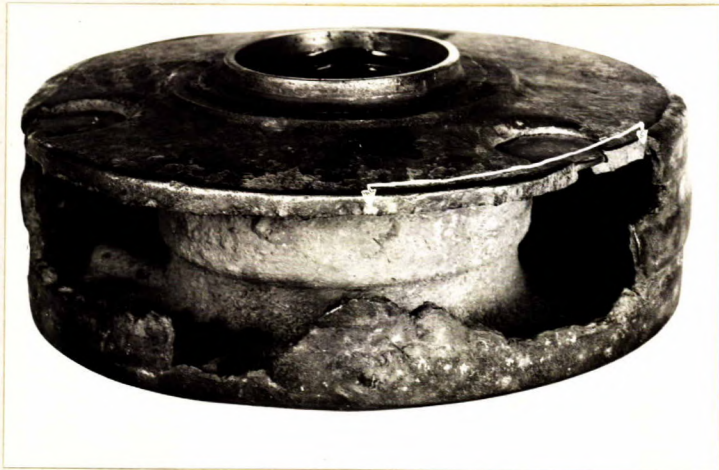
The rim had completely disappeared in some places, although, from the accompanying drawing (CTL 13452-B), it was supposedly a minimum of 0.55 inch thick at the centre. See Figure 1.

NOTE FRACTURE IN SIDEWALL,
AS SHOWN WITH ARROWS.

The sidewall had fractured along a line just below the rim (marked by arrows in Figure 1). Figure 2 shows a general view of the idler wheel.

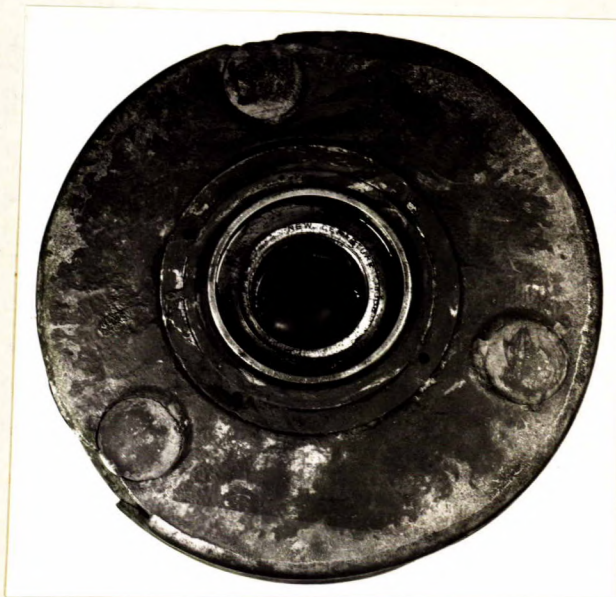
Figure 2.

GENERAL VIEW OF IDLER WHEEL.
(Approximately 1/3 full size).

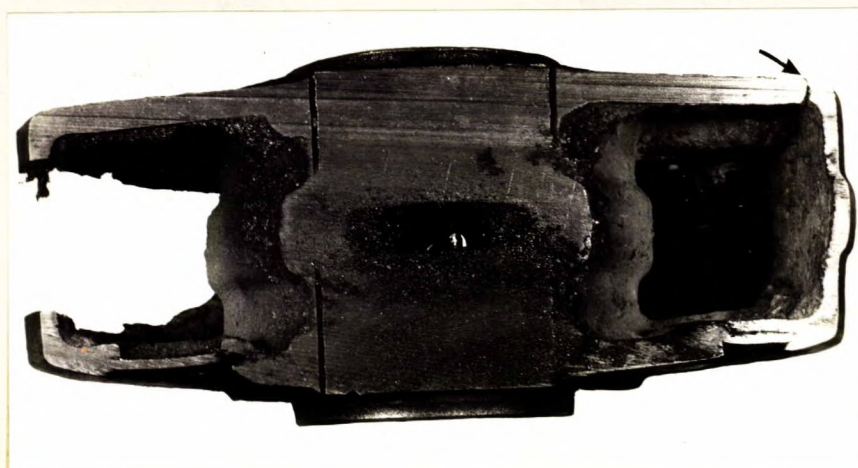
Figure 3.

A decarburized zone approximately 0.05 inch thick was seen around the edge of the samples examined. No pearlite was seen, and the interior of the samples had the appearance of good malleable iron--ferrite with nodules of temper carbon. A crack was observed at the juncture of the rim and sidewall (see Figure 3). This was the only fault discernible in the wheel.

NOTE CRACK AT JUNCTURE OF
RIM AND SIDEWALL.

1. The core used in casting might have been too hard. In solidifying and cooling, the metal rather than the core would be forced to yield and a "hot tear" would result. The position of the fracture on the idler wheel is a natural place for "hot tears".
2. Excessive loads may have been applied to the wheel. The location of the crack, however, does not appear to substantiate this supposition.

It would appear, then, that the crack occurred during casting and that possibly further cracking occurred in service. With no support on one side the rim of the wheel would then collapse.

1. The metal is a malleable iron of good quality.
2. Failure was due to the presence of "hot tears", and further cracking probably occurred in service.
