O T T A W A November 13th, 1944.

R E P O R T
of the
ORE DRESSING AND METALLURGICAL LABORATORIES.

Investigation No. 1742.

Metallurgical Examination of Fractured
Steel Aircraft Bolt.

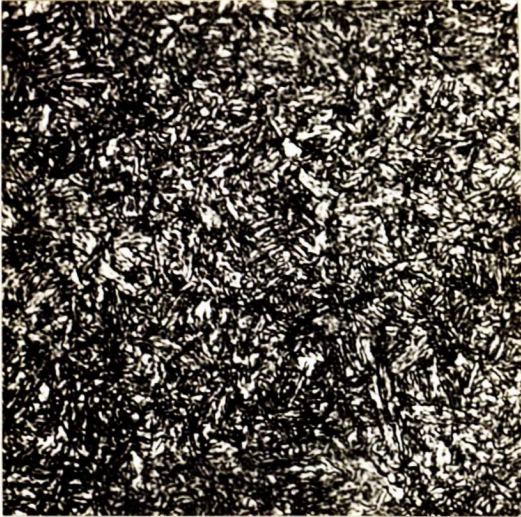
Figure 2.

Samples were cut and examined in the etched as well as in the unetched condition. Figure 2 shows, at X750 magnification, the microstructure obtained by etching in 2 per cent nital. The structure is typical tempered martensite.

X750, nital etch.

MICROSTRUCTURE, CONSISTING
OF TEMPERED MARTENSITE.

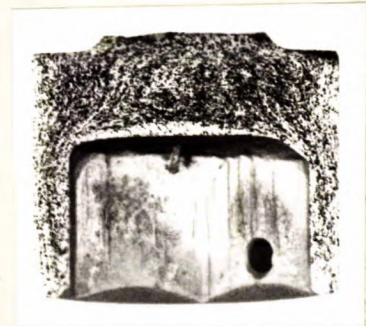
Figure 3.

Figure 3 is a macro photograph of a section through the fractured head of the bolt which had been etched in 50 per cent HCl. The flow lines indicate that the head was made by the "upsetting" method.

FLOW LINES PRODUCED BY
"UPSETTING" METHOD
OF FORGING.

(Approximately $2\frac{1}{2}$ times
normal size).

1. The head of the bolt was produced by the "upset" method of forging.
