ORE DRESSING AND METALLURGICAL LABORATORIES.

Investigation No. 1745.

Investigation of Chassis Frame Side
Rails of Armoured Truck.

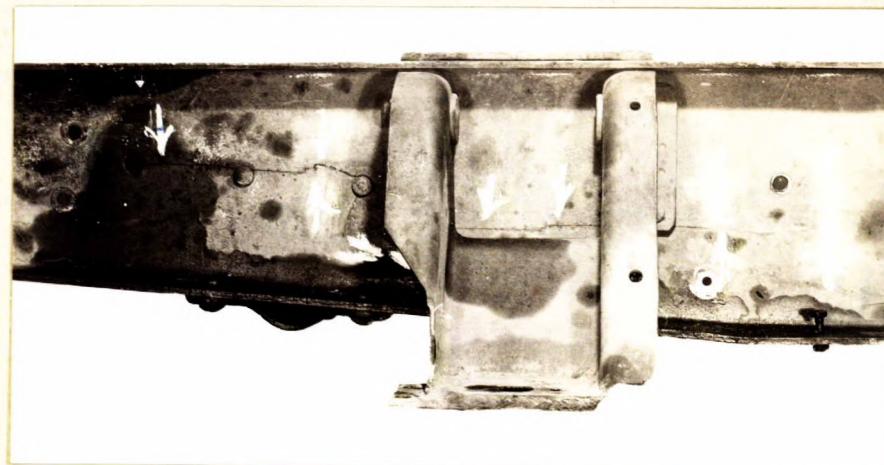
Figure 1.

As shown in Figures 1 and 2, failure occurred specifically in the web of the chassis, with cracks originating at the rivet holes.

RIGHT FRAME SECTION OF CHASSIS.

Arrows indicate crack.

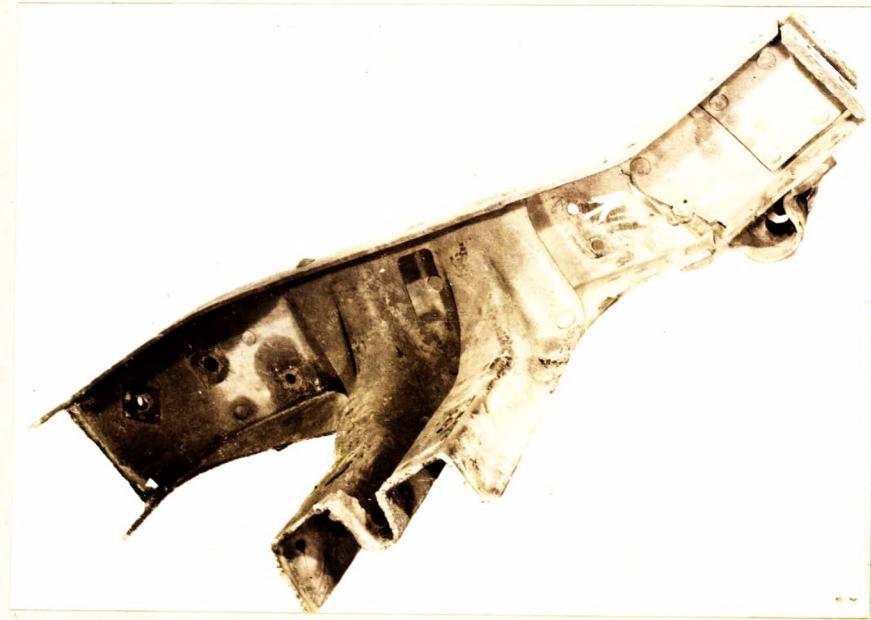
Figure 2.

LEFT FRONT SECTION OF CHASSIS.

Arrows indicate point of failure.

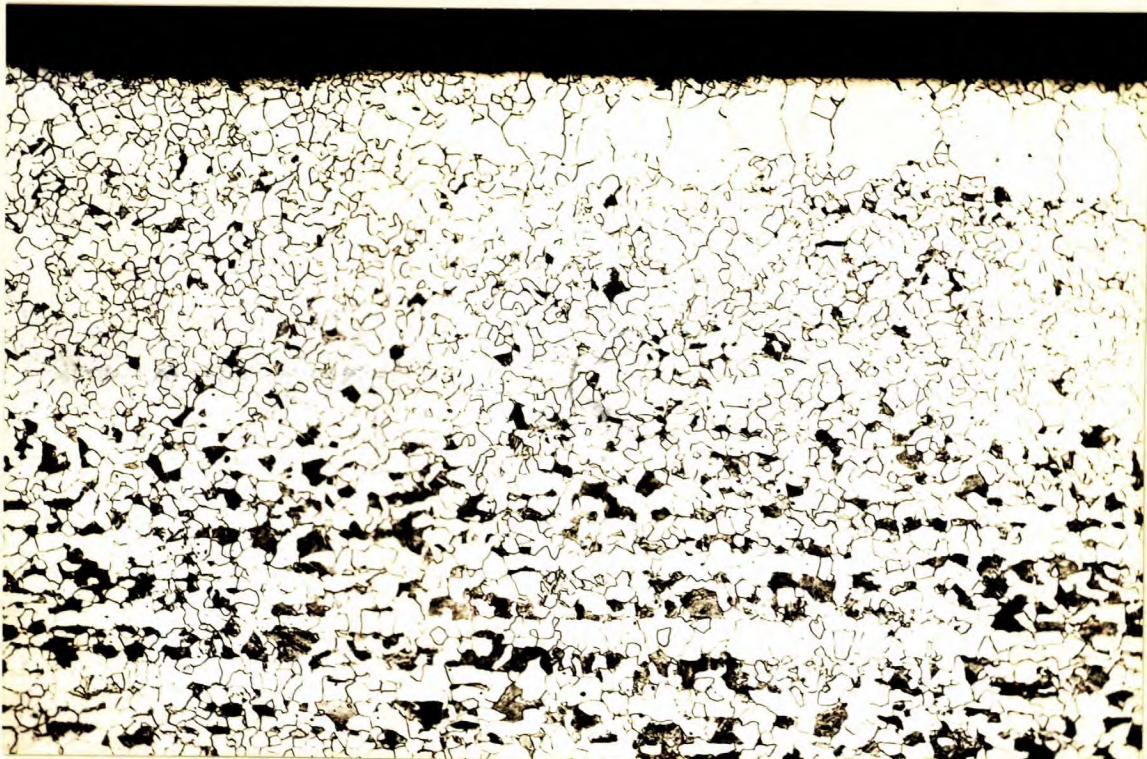
Figure 3.

CHASSIS FRAME NO. 1.

Note decarburized surface, and core
microstructure of pearlite and ferrite.

Of considerable significance is the fact that the less satisfactory frame (No. 1) is decarburized to a depth of 0.013-0.019 inch. It is a well known fact that surface decarburization lowers the endurance limit and consequently impairs the resistance to fatigue-type stress.

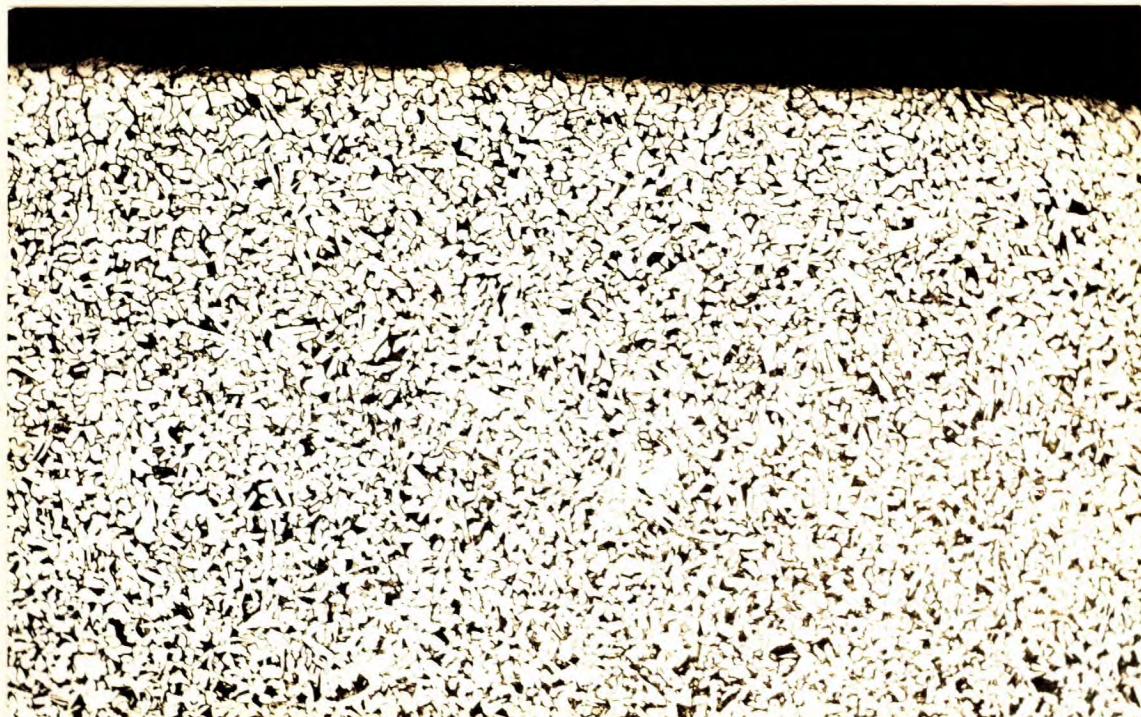
Figure 4.

CHASSIS FRAME NO. 2.

Note freedom from decarburization. Finer
dispersion of pearlite indicated faster
cooling rate, which explains higher hardness.

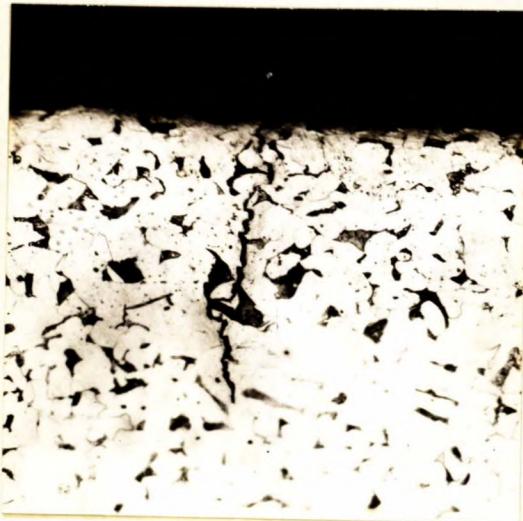
Figure 5.

FATIGUE CRACK AT SURFACE OF RIVET HOLE.

Numerous cracks originating at the rivet holes, and microscopic fatigue cracks at the same location, indicate clearly that both chassis frames failed in fatigue, i.e., they have been subjected to alternating stresses which are greater than the endurance limit of the steel.
