Investigation No. 1746.

Metallurgical Examination of a 3.7 Steel Shell Forging.

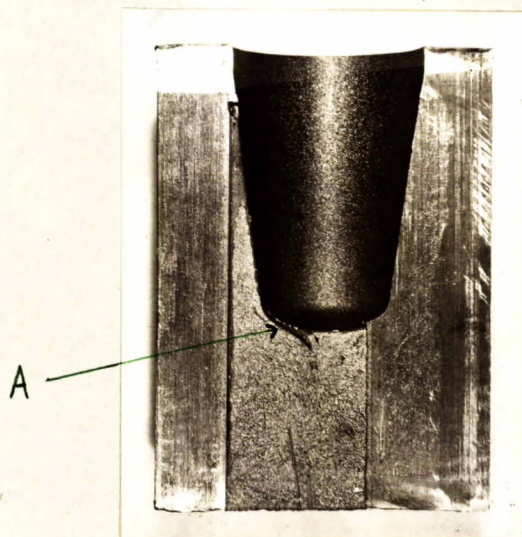
Figure 1.

Figure 1 is a photograph showing a section of a 3.7-inch steel shell with a small blister at the base of the forged cavity, at "A". The steel had a coarse-grained fracture.

3.7-INCH STEEL SHELL FORGING.
(Approximately 1/3 size).

The chemical composition was within the range specified for shell steel. The steel also had the specified mechanical properties. The areas of unsound metal at the base of the forged cavity are due to the presence of possibly trapped gases or a small amount of secondary pipe. Forging apparently was not enough to close these cavities. The defects indicate either faulty cropping practice or deoxidation. In view of the silicon in the steel the former is almost certainly the cause of the trouble. Steel containing such cavities should not be used in shells, for while such cavities do not greatly weaken the shell there is no guarantee that more serious defects are not present. Moreover, the surface of the shell cavity may

No significance could be attached to the lines in the coarse-grained fracture of the shell.

1. The steel was properly made and heat treated to the specified mechanical properties.
2. The porous condition observed either was caused by entrapped gases in the ingot or resulted from a secondary pipe which was not closed in the forging operation, with the latter being the more probable explanation.
3. Steel showing such defects should not be used in shells.
4. The manufacturer of the ingots should be informed of these defects and steps taken by him to eliminate this condition.

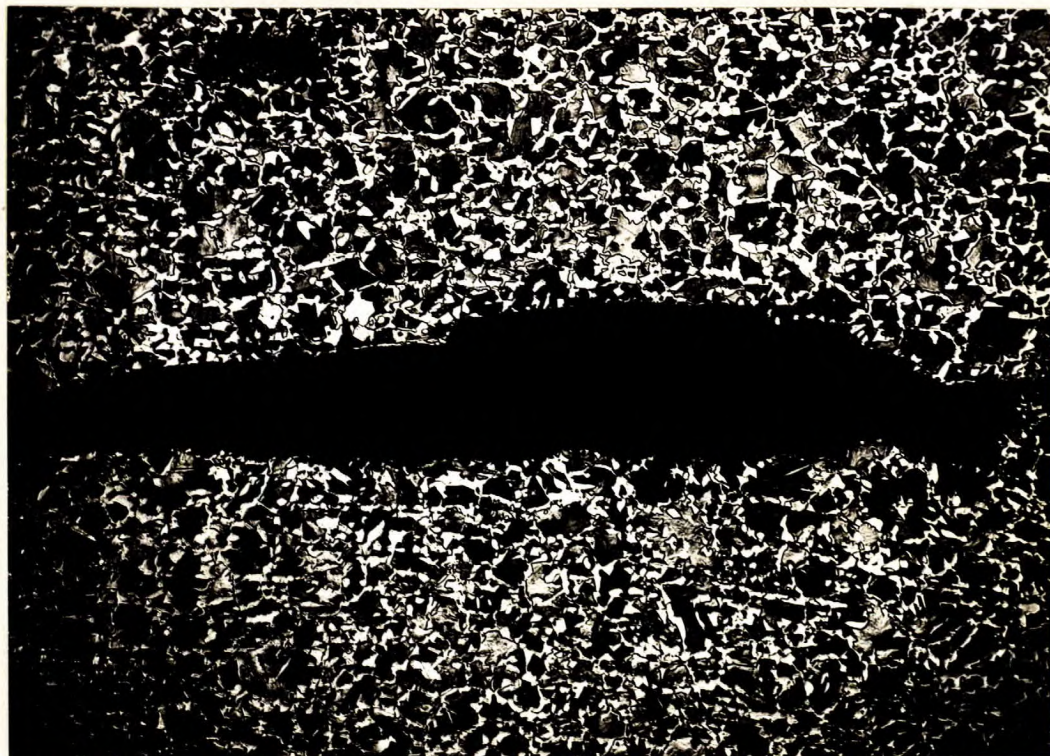
Figure 3.

The steel was then etched in a solution of 2 per cent nitric acid in alcohol and re-examined. Figures 3 and 4 show the nital-etched structure of the material, at 60 and 100 magnifications respectively. In Figure 3 is also shown a cavity which was not quite closed in the forging operation. The structure is typical of that of normalized medium-carbon steel and consists of pearlite (the iron-iron-carbide constituent, the dark etching material) and ferrite (the iron constituent, the white etching material).

X60.

SHOWING NITAL-ETCHED STRUCTURE AND
ELONGATED POROUS CAVITY.

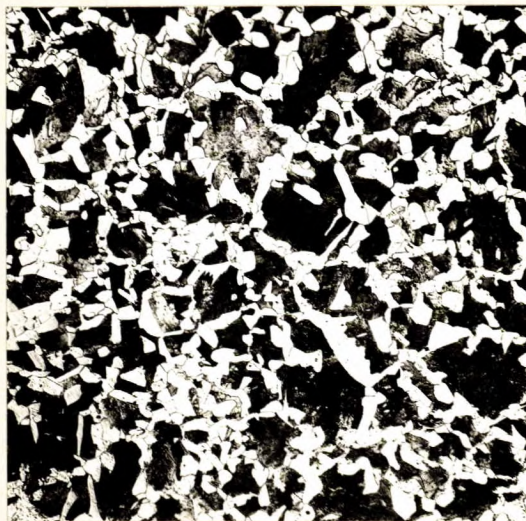
Figure 4.

X100, etched in
2 per cent nital.

SHOWING PEARLITE (DARK AREAS)
AND FERRITE (WHITE AREAS).

The steel is in the normalized condition.
