ORE DRESSING AND METALLURGICAL LABORATORIES.

Investigation No. 1748.

Metallurgical Examination of Welded Inconel
Exhaust Stub for Mosquito Aircraft.

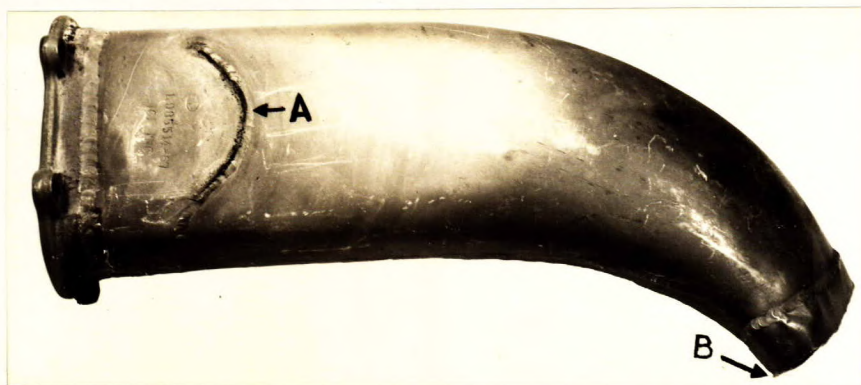
Visual examination revealed two defective welds in the areas marked A and B in Figure 1. At A, a crack extended along the weld for a distance of 4 or 5 inches. At B, a small crack was observed extending inward for a distance of approximately one inch from the end of the stub.

GENERAL VIEW OF INCONEL EXHAUST STUB, SHOWING
CRACKS ALONG WELDS AT A AND B.

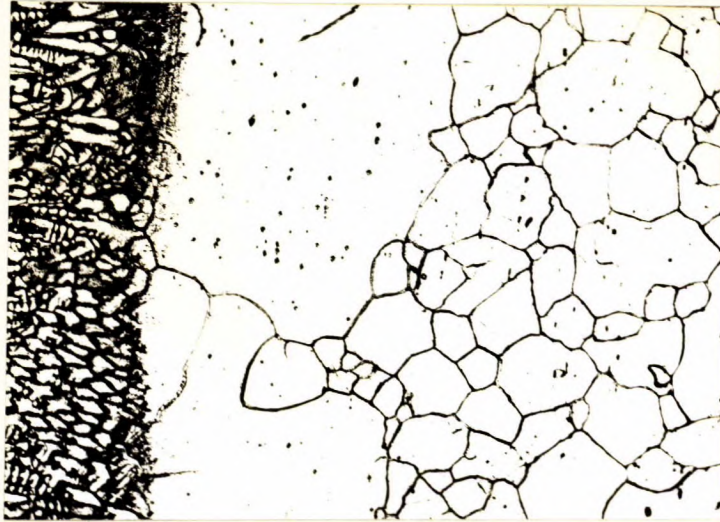
Figure 2.

Figure 2 is a photomicrograph, at X100 magnification, showing the normal structure obtained when there is proper fusion between the weld metal and the original metal. Note large grains adjoining the weld metal, caused by the high temperature.

NORMAL STRUCTURE OBTAINED BY PROPER FUSION OF
WELD METAL ONTO ORIGINAL METAL.

Note large grain size adjoining weld metal.

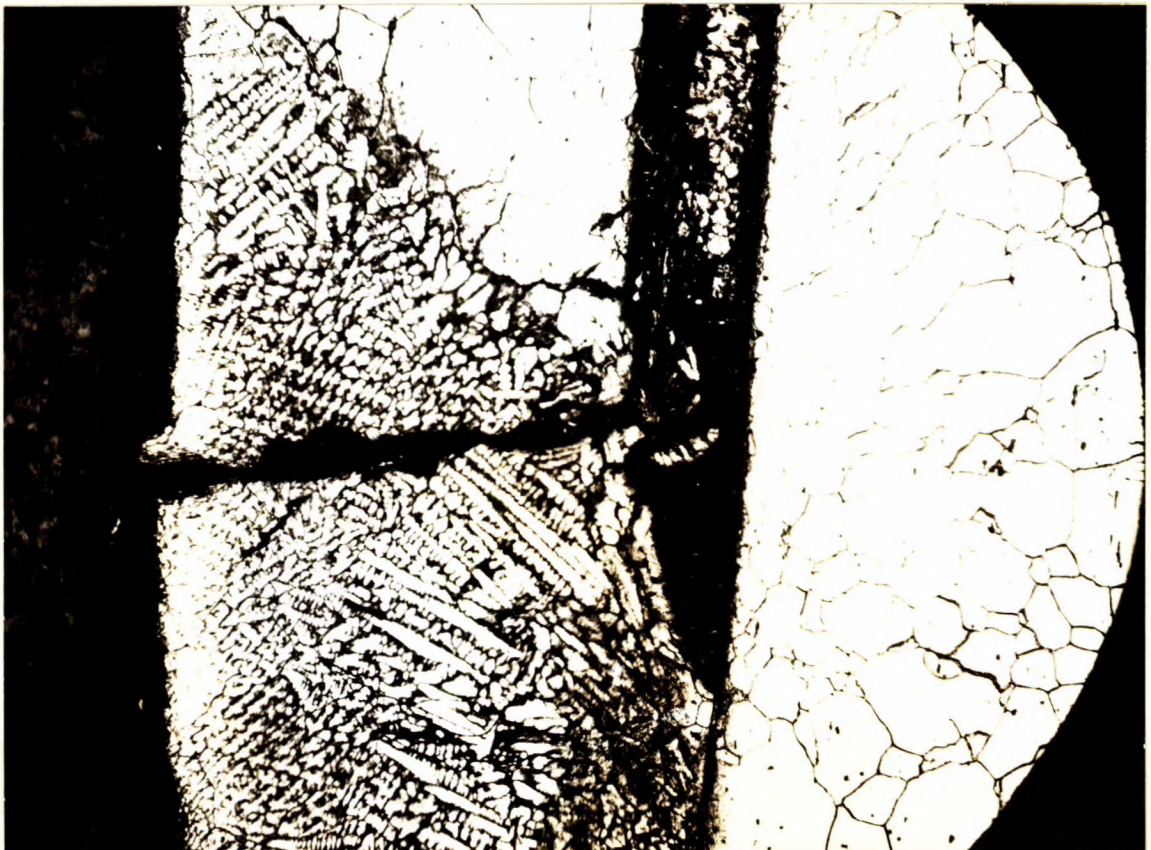
Figure 3.

Figure 3, taken at X50 magnification, shows the crack through the weld in area A. This crack was formed, due

to the "bridge effect" created by the welding of the two sheets not in contact with each other, as a result of improper jiggling. Note the absence of enlarged grains at the adjoining edge of the Inconel sheet, because of the space between the sheets which acts as an insulator, resulting in lack of fusion.

Examination of the photomicrograph (Figure 3) clearly indicates the reason for the crack in the weld at area A (Figure 1). Since there is a gap between the two sheets that were welded, the resultant "bridge effect" set up would lead to excessive stresses in the weld material. It should be realized that in the primary stages of solidification the molten weld metal has very little mechanical strength, and the gap results in complete lack of mechanical support of the molten metal forming the weld. This condition can be eliminated by

CRACK IN WELD AT SECTION A.

Due to space between sheets, resulting
in weak "bridge" effect. Caused by
improper jiggling.

closer contact between the sheets to be welded, by means of proper jiggling.

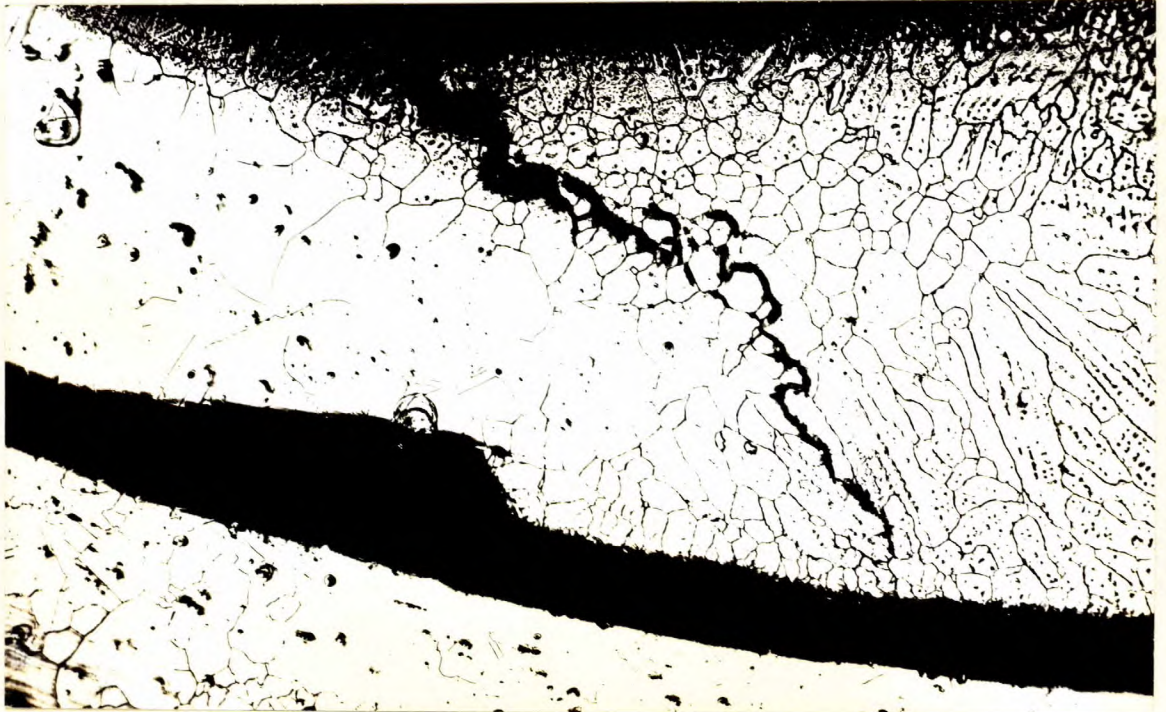
Figure 4.

Figures 4 and 5, taken at X50 magnification, show cracks occurring at either end of the same weld. It should be noted that the cracks occur at the toe of the weld in both cases, resulting from excessive stresses set up because of porosity and lack of fusion between the weld metal and the sheet material (see Figure 5). This sample was cut from area B.

The cracks at the toe of the weld, shown in Figures 4 and 5, are caused by lack of fusion between the weld metal and the sheet metal, producing areas which are too weak to withstand the contraction stresses of the cooling weld metal. Lack of fusion may result from the incomplete removal of tightly adhering oxide film from the surfaces to be welded. The porosity shown in Figure 5, which is caused by excessive welding heat, would also result in a serious weakening of the weld metal.

CRACK OCCURRING AT TOE OF WELD, DUE
TO IMPROPER FUSION.

(Section taken from area B).

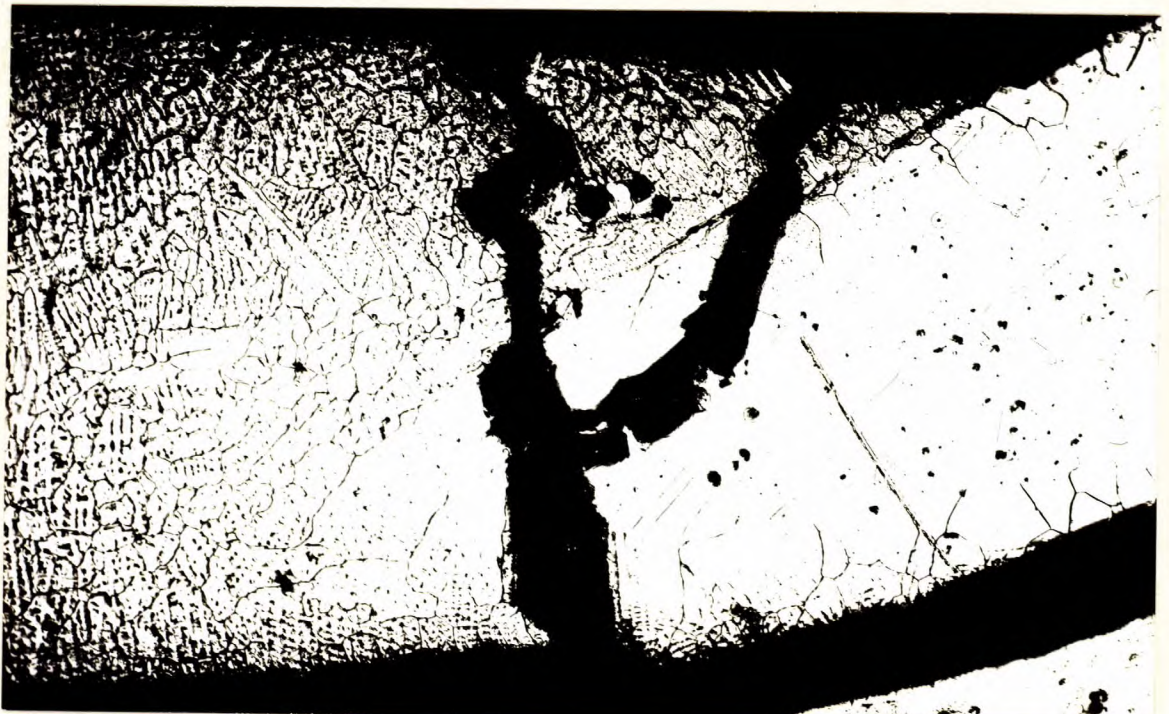
Figure 5.

CRACK OCCURRING AT OTHER EDGE OF WELD, CAUSED
BY LACK OF FUSION AND POROSITY.

(Section taken from area B).

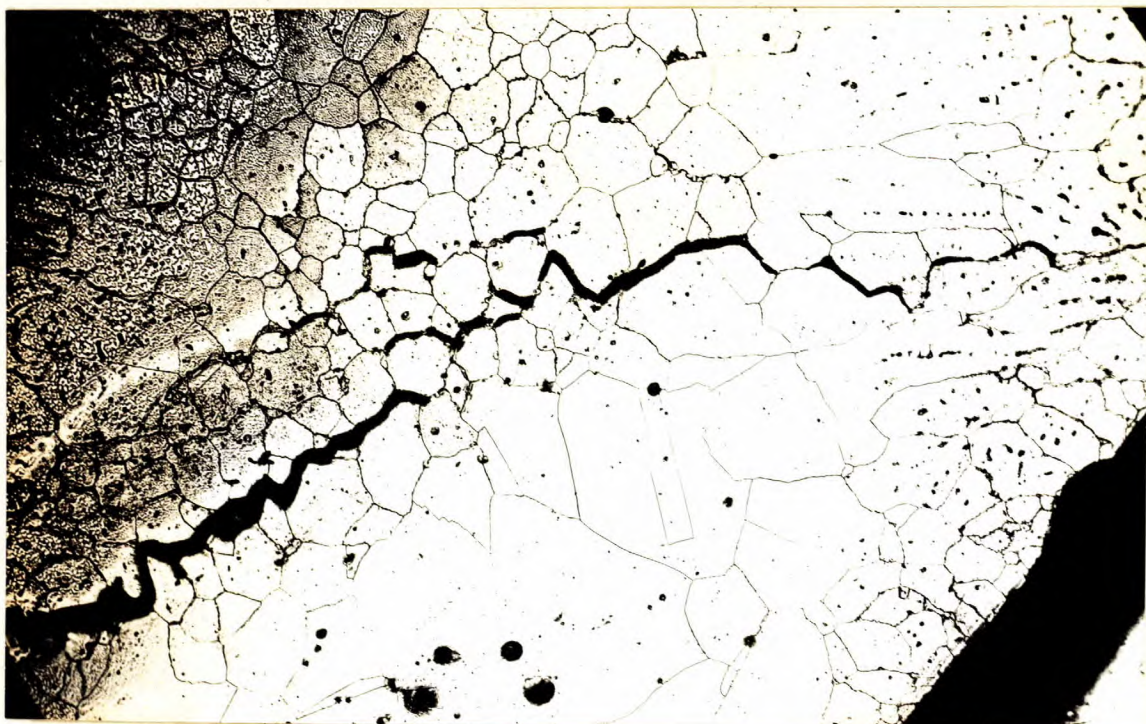
Figure 6.

Figure 6, taken at X100 magnification, is an enlarged photograph of the crack shown in Figure 4, illustrating the intergranular path followed by the crack. Figure 7 further illustrates intercrystalline cracking found in a sample taken adjacent to that shown in Figures 4 and 6. Figure 8 shows large gaps caused by the lack of fusion between ends of sheet. Figure 9 is a photograph showing inconsistent penetration of the weld metal.

Severe intercrystalline attack, as shown in Figure 6, will result when the atmosphere is permitted to become excessively oxidizing during the welding operation. These cracks may possibly have originated at the welding surface as a result of severe oxidation along grain boundaries. A crack thus initiated follows an intercrystalline path. This type of embrittlement can be prevented by maintaining a constant slight excess of a reducing gaseous atmosphere (acetylene) during welding.

SHOWING INTERGRANULAR PATH OF CRACK AT TOE OF
OF WELD, CAUSED BY LACK OF FUSION.

(Area B).

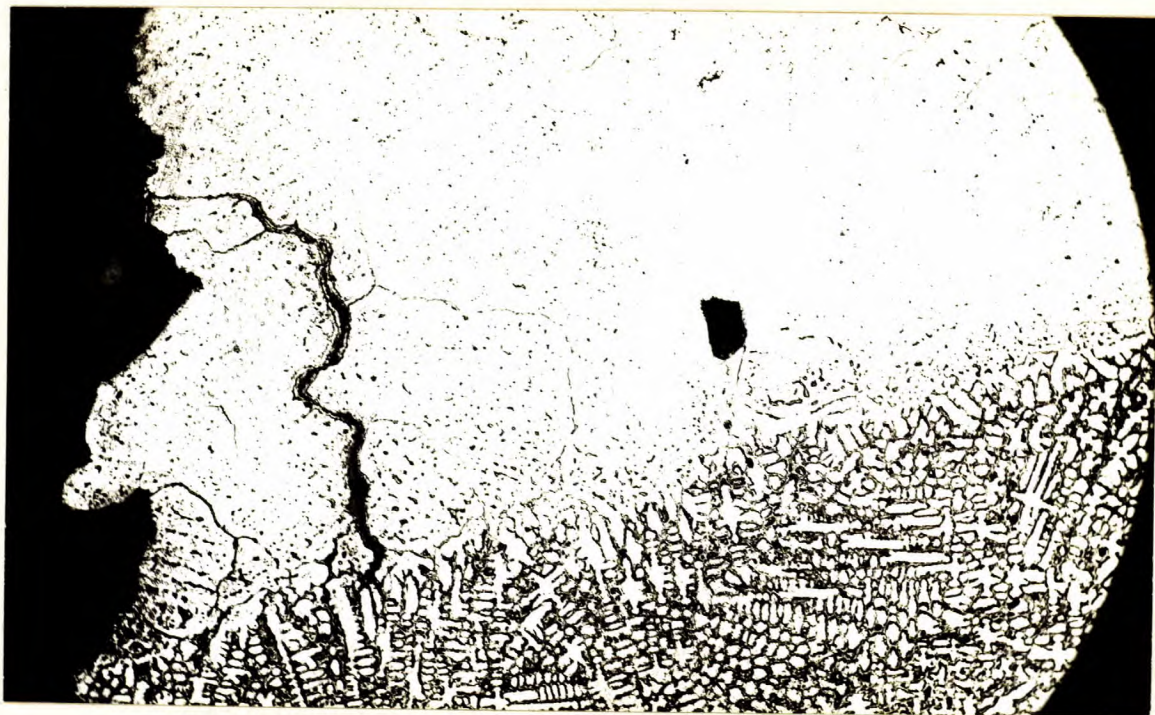
Figure 7.

INTERGRANULAR CRACKS ADJACENT TO FRACTURE.

Note also large blow hole.

(Area B).

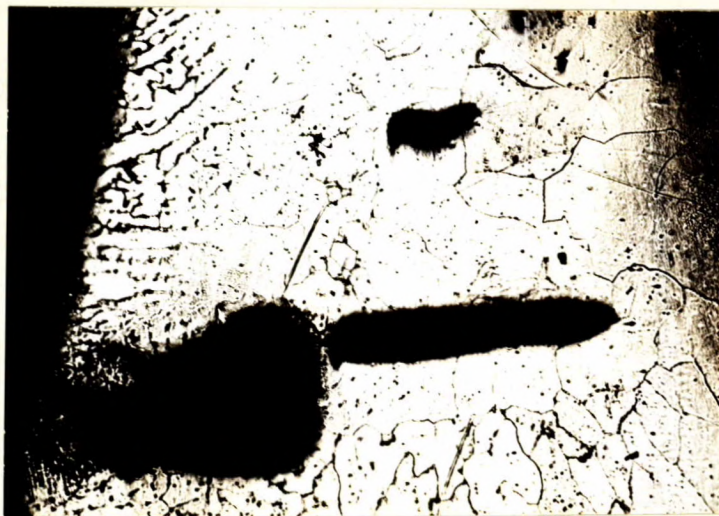
Figure 8.

Lack of fusion between ends of sheets, as shown in Figure 8, is probably caused by improper alignment between the edges to be welded, as indicated by the width of the gap. Another possible cause is improper torch manipulation, which has resulted in the metal not being brought to the fusion temperature along the joint.

X50, aqua regia and glycerine etch.
LACK OF FUSION BETWEEN ENDS OF SHEET.
(Area B).

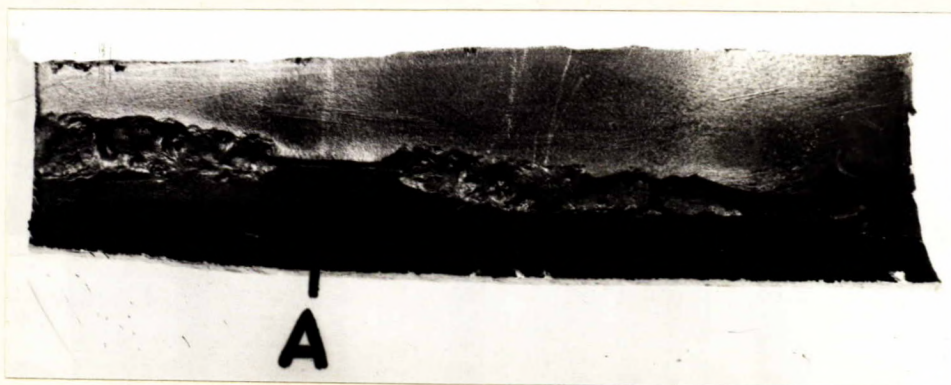
Figure 9.

Figure 9 illustrates inconsistent penetration of the weld metal. It will be noted that in some areas very complete penetration has been secured whereas in others the unfused edges of the joint are clearly visible. Incomplete fusion of this type is a very probable cause of cracking in parts subjected to rapid vibration at high temperatures.

INSIDE OF WELD.
Note incomplete penetration of
weld metal at A.
