R E P O R T  
of the  
ORE DRESSING AND METALLURGICAL LABORATORIES.

Investigation No. 1752.

Metallurgical Examination of Flange  
Discs for Smoke Generators.

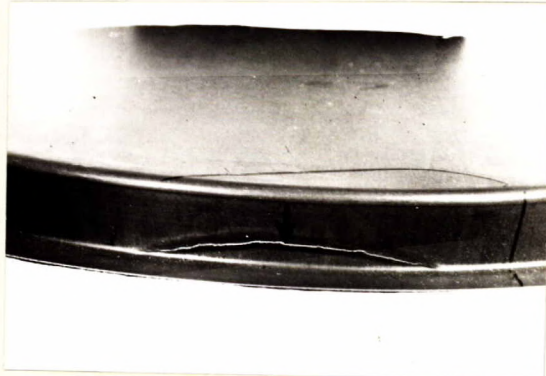
Figure 1.

Figures 1 and 2 are macrophotographs showing the cracklike imperfection in Disc A and the "blister"-like imperfection in Disc B, respectively.

DISC A.

Showing open cracklike imperfection.

The type of imperfection encountered in Disc A (see Figure 1), i.e. one which appears like a crack, results from the opening of the blister at the surface of the sheet (see Figure 3). The "blister" type of imperfection found in Disc B (Figure 2) is the result of an internal gas void which has not come to the surface (see Figure 4). The void shown in Figure 5 is similar to that shown in Figure 4, but in this case it has been flattened out during the rolling operation.

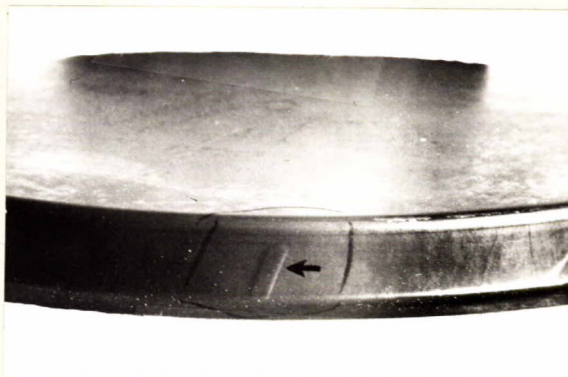
Figure 2.

DISC B.

Showing closed "blister"-like imperfection.

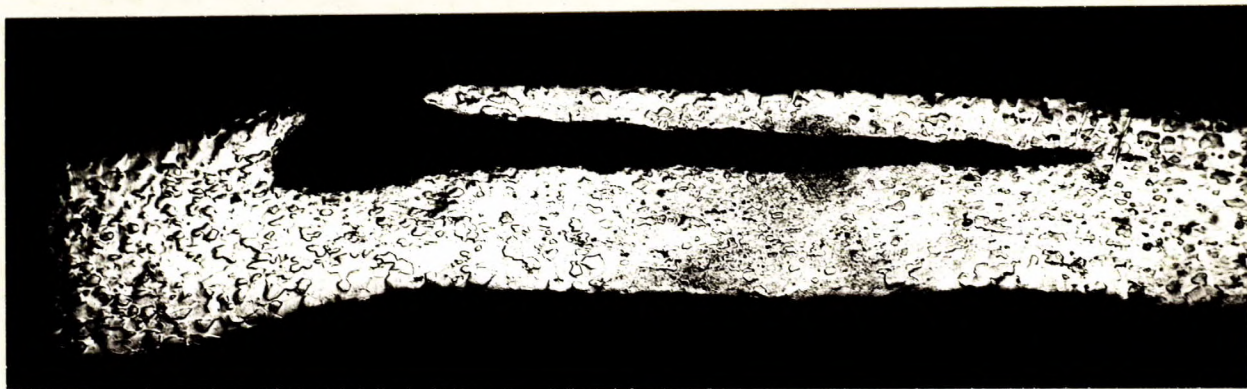
Figure 3.

X50, nital etch.

SHOWING NATURE OF IMPERFECTION  
FOUND IN DISC A.

It is obvious, from the photomicrographs shown in Figures 3, 4 and 5, that the imperfections in the finished discs are due to defects in the steel. These defects are caused by gas bubbles left in the steel as a result of faulty rimming technique during the solidification period.

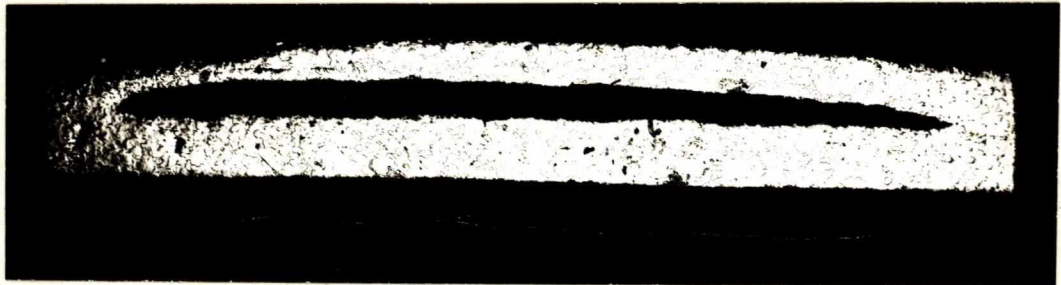
Figure 4.

X30, nital etch.

SHOWING THE IMPERFECTION IN  
THE STEEL OF DISC B.

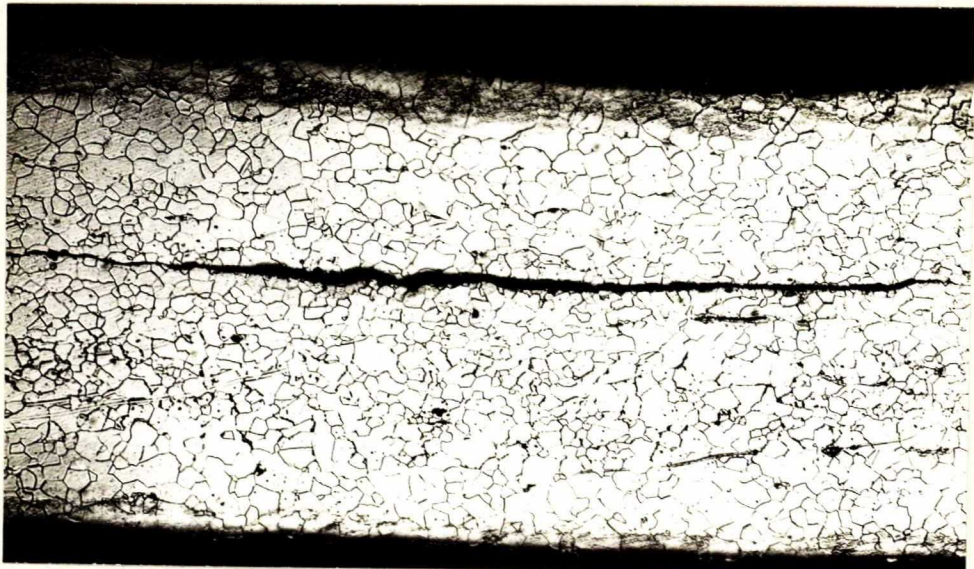
Figure 5.

Figures 3 and 4, taken at X50 and X30 magnifications respectively, show the exact nature of the imperfections found in Discs A and B. Figure 5 is a photomicrograph, at X125 magnification, of a section taken from Disc B, further illustrating the imperfection in the steel.

X125, nital etch.

INTERNAL IMPERFECTION IN DISC B.
