December 7th, 1944.

ORE DRESSING AND METALLURGICAL LABORATORIES.

Investigation No. 1757.

Examination of Broken Snowmobile Track
Adjusting Assembly.

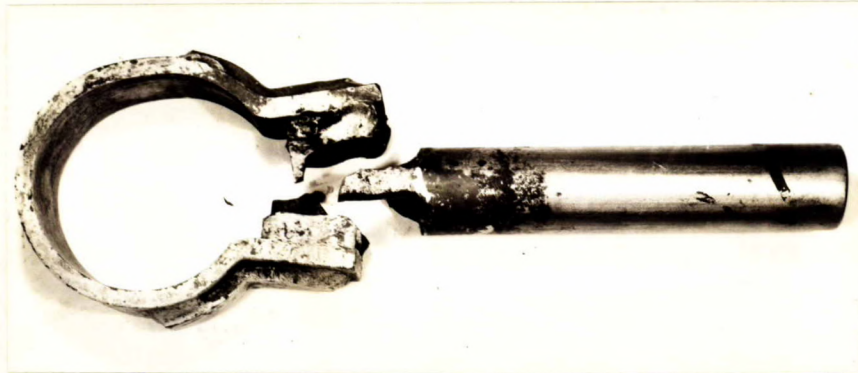
Figure 1.

On November 29th, 1944, one broken Snowmobile Track Adjusting Assembly (see Figure 1) was submitted, for examination, by Mr. H. J. Stevenson, Assistant Director General, Army Engineering Design Branch, Department of Munitions and Supply, Ottawa, under Requisition No. 678 (A.E.D.B. Lot No. 571, Report No. 107, Section "D", Test No. 23). The covering letter, dated November 29th, 1944, contained the following information:

"Material presently specified for the tubular part is SAE 1020. Assemblies are failing at very low mileages; the one submitted failed at approximately 35-45 miles."

GENERAL VIEW OF TRACK ADJUSTING
ASSEMBLY, SHOWING LOCATION OF
BREAK IN TUBING.

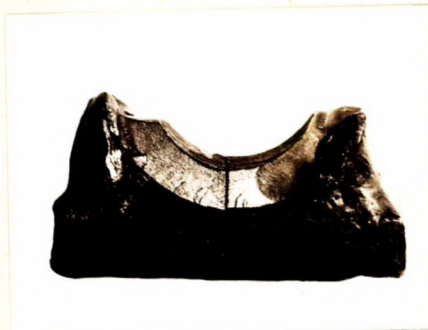
Visual examination revealed that failure of the tubing had occurred in areas near the weld.

A photograph of the fractured tubing is shown in Figure 2. The appearance of the fracture is that of a typical fatigue failure.

BRITTLE FATIGUE FRACTURE.

According to the specifications in Dwg. C-38036, the tubing for this part should be SAE 1020 steel. The results of the chemical analysis showed that the tubing examined was made of a material which in no way resembles a plain carbon steel. As a matter of fact, the steel was found to be a tool steel containing, in addition to high carbon, the alloying elements chromium, tungsten, molybdenum and vanadium. This type of steel, on being subjected to a temperature high enough to melt it, as in welding, becomes a very hard (60 Rockwell 'C') and extremely brittle product (see Figure 5) which is totally incapable of withstanding any shock. Hence, it is not surprising that the part failed after very limited service.

1. The steel tubing which failed in service was made of a tool steel containing the alloying elements tungsten, chromium, molybdenum and vanadium.
2. Since the steel specified was SAE 1020, it must be concluded that the wrong steel was employed due to an error in the selection of the materials.
3. Failure of the tubing resulted from the employment of a steel entirely unsuited for the purpose intended.

It is strongly recommended that a rigid system of inspection be installed, in order to prevent the use of faulty materials in the field.

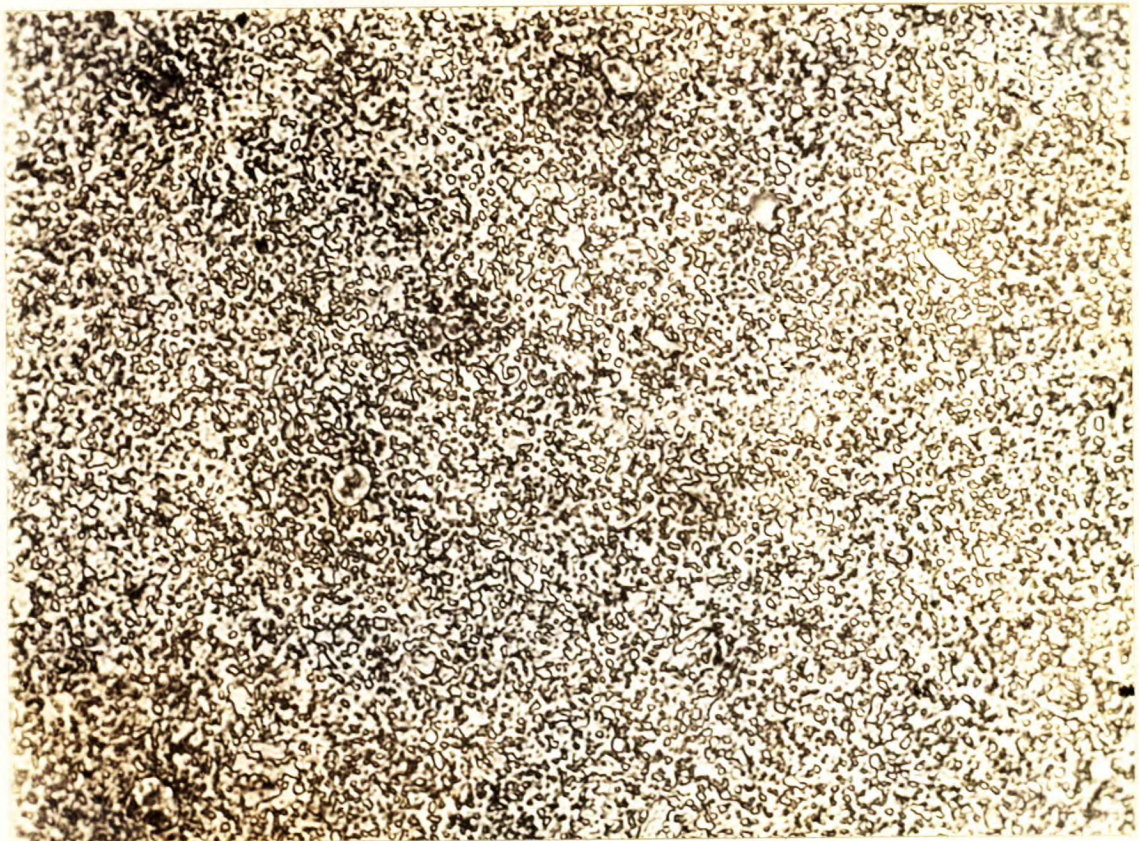
Figure 3 is a photomicrograph, taken at X1000 magnification, showing the normal spheroidized structure of

the tubing remote from the zone affected by the heat of welding.

X1000, nital etch.

NORMAL STRUCTURE OF STEEL TUBING
AWAY FROM WELD.

Carbide spheres in a background of ferrite.

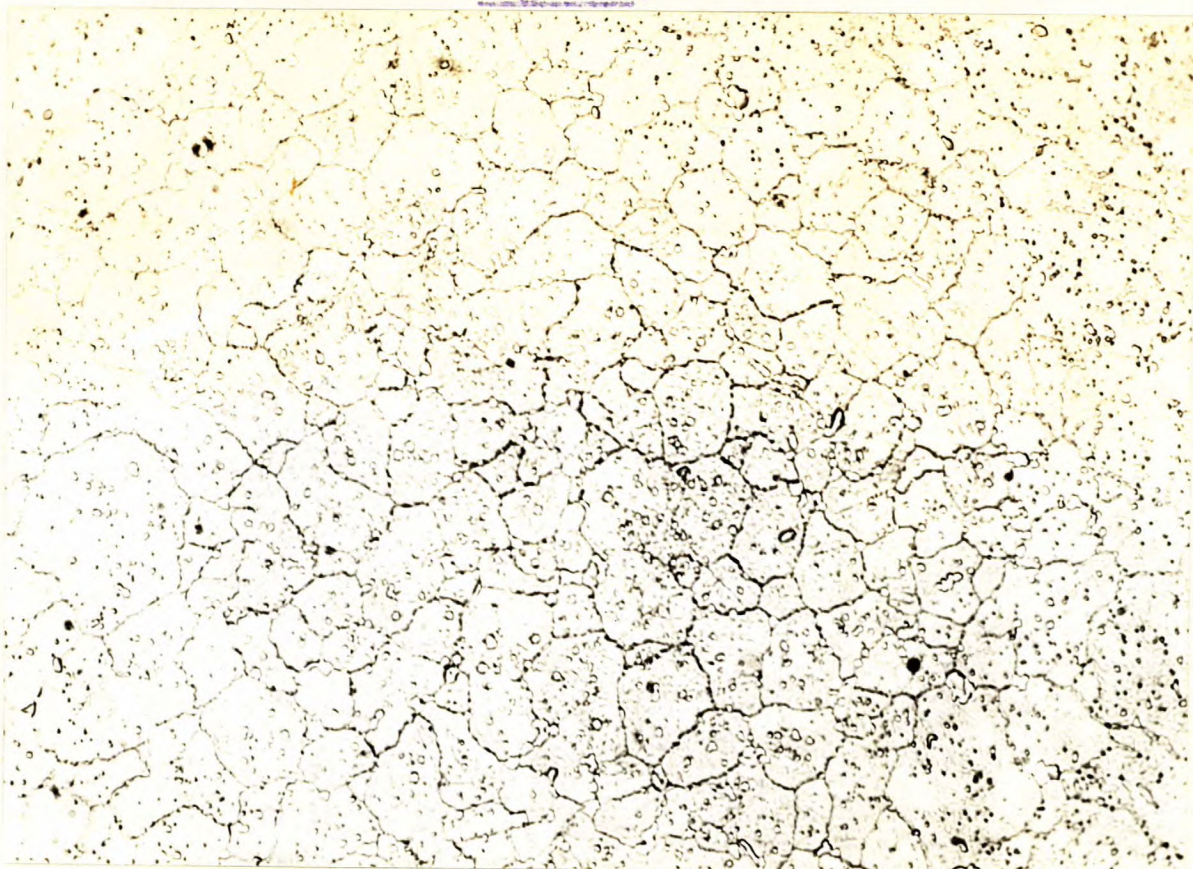
Figure 4.

Figure 4 shows the microstructure, at magnification X750, of the heat-affected zone of the tubing near the break. The structure consists of carbides in a background of martensite marked by austenite grain boundaries. Such a structure is very hard and brittle, approximately 60 Rockwell 'C'.

X750, nital etch.

HARDENED STRUCTURE NEAR WELD.

Carbides in a background of martensite.

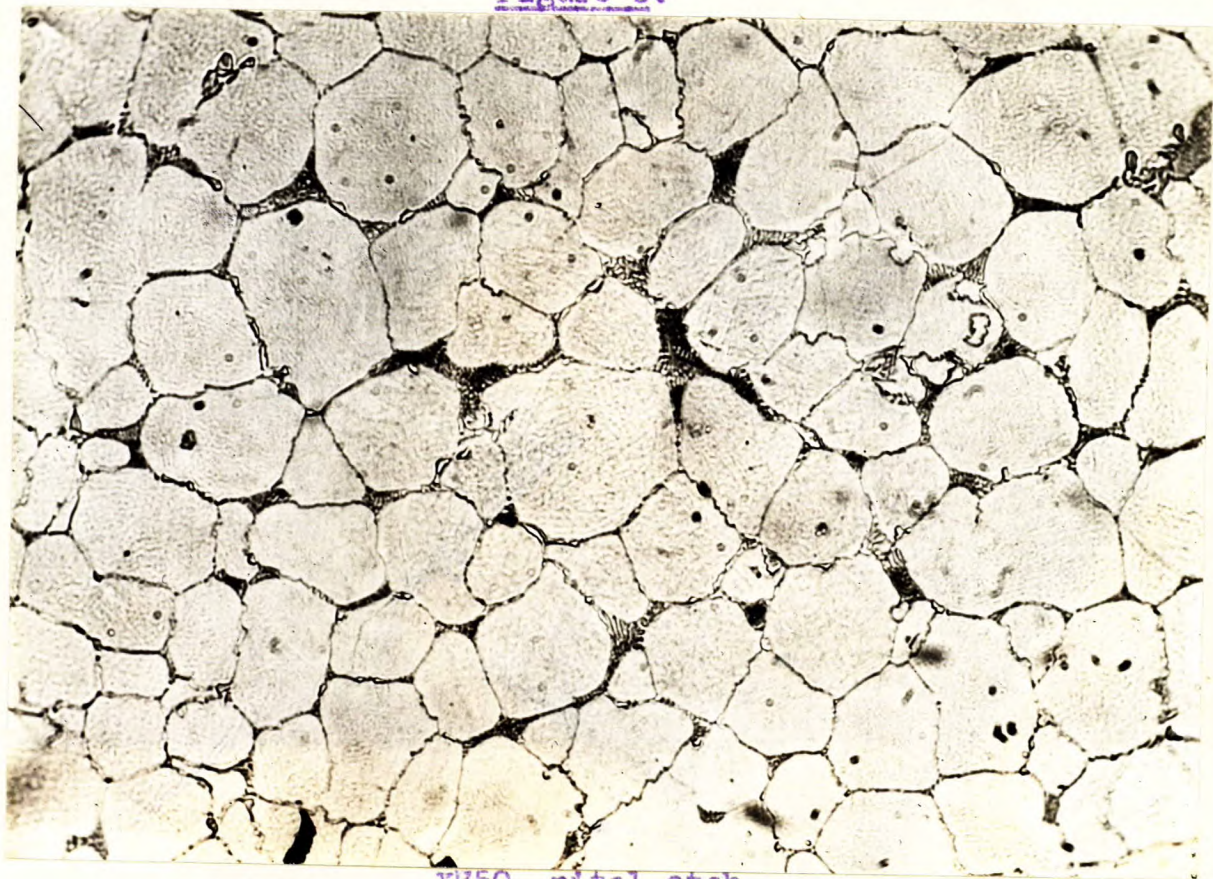
Figure 5.

Figure 5 is a photomicrograph, at X750 magnification, of a section adjacent to the weld. The microstructure consists of eutectic at the grain boundaries and a background of martensite. This structure is very hard and extremely brittle and was caused by the melting of the steel during the welding operation.

X750, nital etch.

HARD, BRITTLE STRUCTURE ADJACENT TO WELD,
SHOWING EUTECTIC IN A BACKGROUND OF MAR-
TENSITE, CAUSED BY ACTUAL MELTING OF THE STEEL.
