ORE DRESSING AND METALLURGICAL LABORATORIES.

Investigation No. 1768.

Metallurgical Examination of Two  
Steering End Ball Sockets.

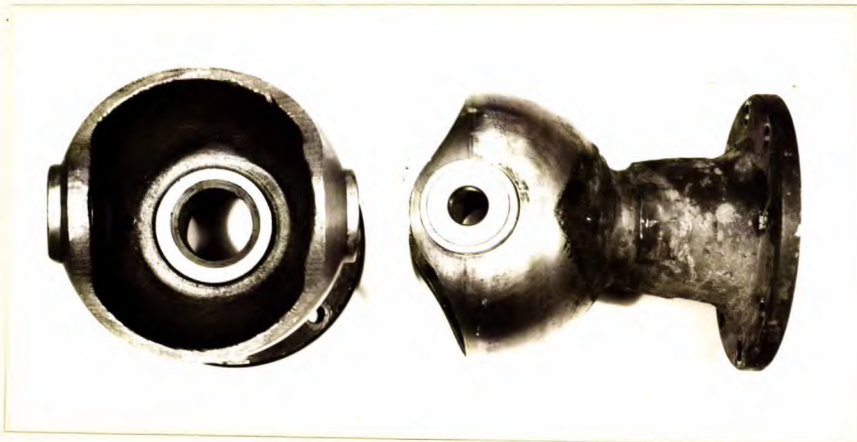
Figure 1.

On November 24th, 1944, the Controller General of the Inspection Board of the United Kingdom and Canada, Ottawa, Canada, submitted two (2) steering end ball sockets. It was reported that these parts had been removed from a vehicle after a field test of approximately 2,900 miles during which the ball sockets had deformed out of round. Under Analysis Requisition O.T. 4307, a complete metallurgical examination was requested.

The ball socket joints deformed in service because the yield strength of the material was not sufficient to resist the stresses imposed. Either they were overstressed or the yield strength, corresponding to the lower range of the specified hardness, was too low to withstand service requirements. If the failure was not caused by overstressing, then the yield point (and, therefore, the hardness) must be increased to obtain satisfactory performance. This must be done despite all consideration of the effect of higher hardness on machinability.

STEERING END BALL SOCKETS.

1. The Brinell hardnesses, 197 and 201, are slightly below specification.
2. Better resistance to deformation will be obtained by increasing the yield strength of the material.
3. Specifications covering the ball socket joints should contain a specified minimum yield strength as well as a hardness range.

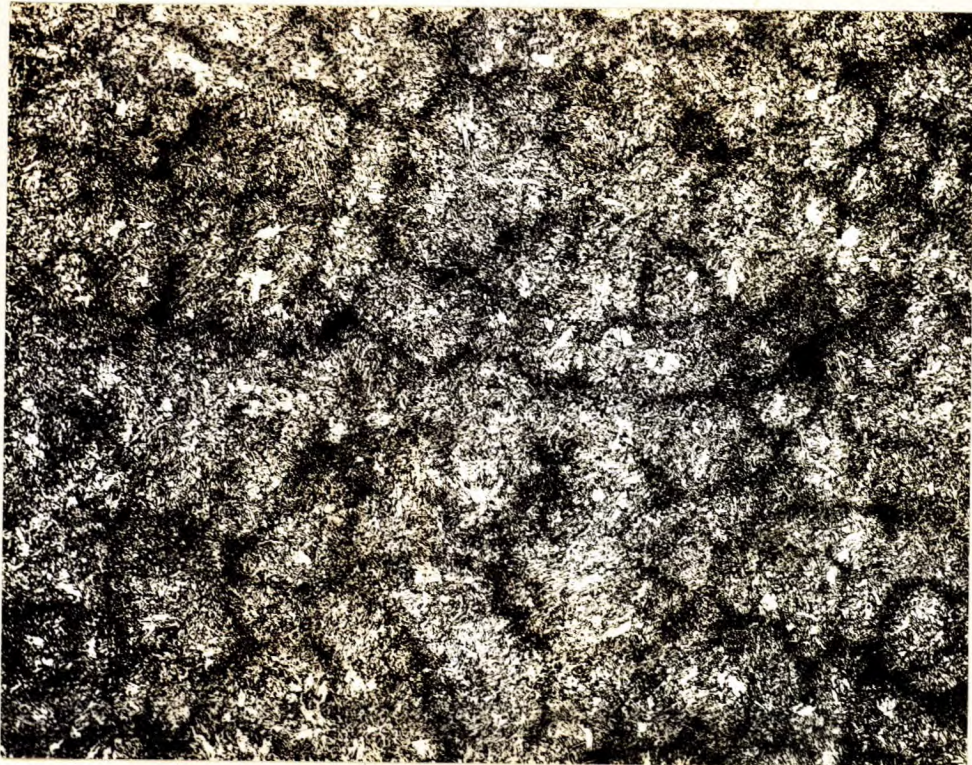
Examination of specimens from both castings disclosed a uniform microstructure of tempered martensite with a marked dendritic pattern. See Figure 2.

X100, etched in 2 per cent nital.

MICROSTRUCTURE.

Tempered martensite with  
marked dendritic pattern.
