R E P O R T
of the
ORE DRESSING AND METALLURGICAL LABORATORIES.

Investigation No. 1760.

Metallurgical Examination of Broken
Left Hand Idler Wheel Bracket.

December 12th, 1944.

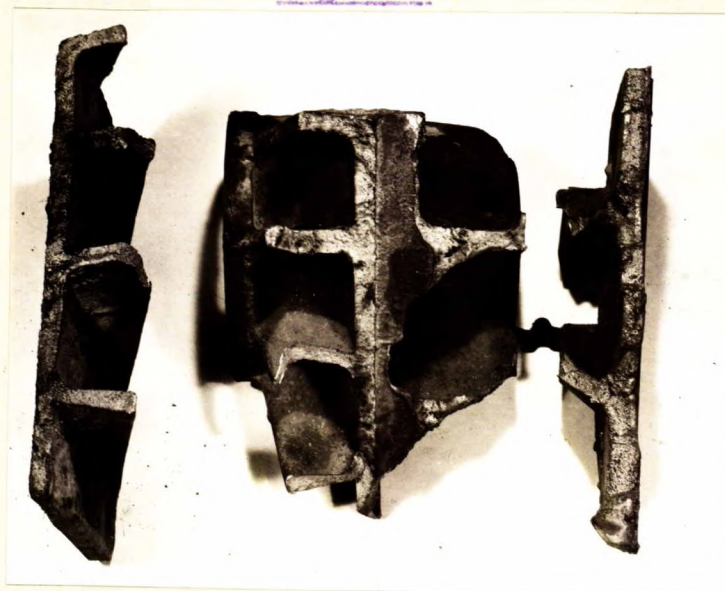
The bracket had broken in two places, the two plates having broken away from the hub. A view of the broken bracket is shown in Figure 2.

PHOTOGRAPH OF BROKEN BRACKET.

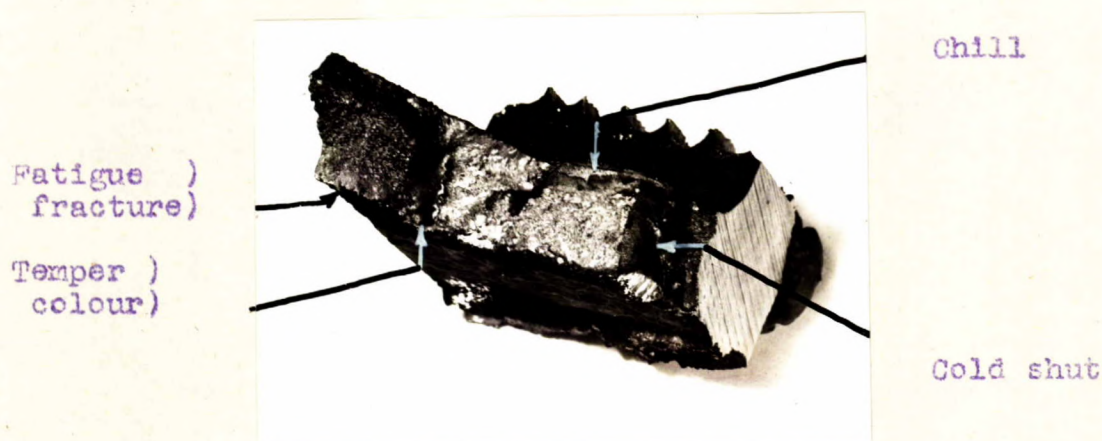
Figure 3.

A visual examination of the fracture revealed the presence of internal chills, fatigue fracture, and cold shuts. Temper colours and smooth areas on the fracture surface indicated that the broken portions had rubbed together after fracture. Figure 3 illustrates these various details.

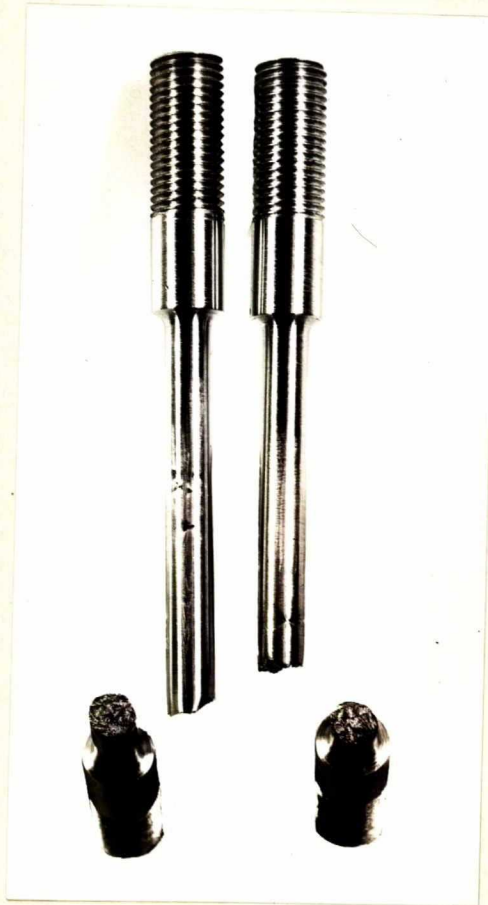
Figure 4.

Several checks, or "crow's feet", showed up in the tensile specimens and the fracture was brittle and granular (see Figure 4).

Note "crow's feet".

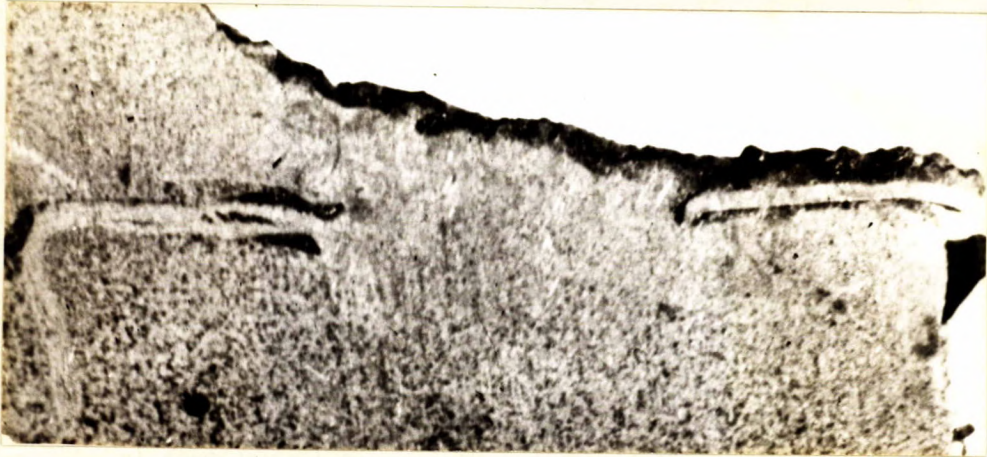
Figure 5.

On macro-etching a section through the fracture, the wire used as chills showed up (Figure 5). Proper fusion had not taken place, leaving planes of weakness.

The use of internal chills, a practice resorted to to pass X-ray tests, seldom produces fusion in steel castings.

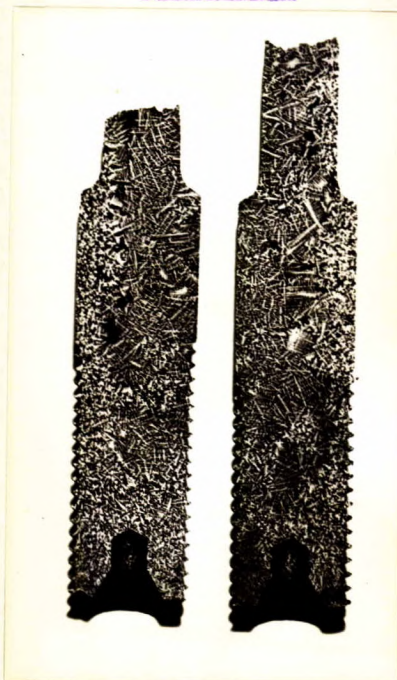
Figure 6.

The tensile bars were sectioned and deep-etched, and the dendritic structure of the casting was revealed. Severe porosity was also revealed (see Figure 6).

DENDRITIC STRUCTURE AND POROSITY.

The low elongation and reduction in area are due to foundry defects, i.e. chills (presence of unfused material), cold shuts, and porosity, predominantly porosity. The Widmanstätten structure, or alloy segregation, might be eliminated by faster cooling in the mould but this would have much less effect on mechanical properties than would improving casting soundness.
