December 15th, 1944.

ORE DRESSING AND METALLURGICAL LABORATORIES.

Investigation No. 1761.

Examination of Welded Tail Pieces of
120-mm. Mortar Bombs.

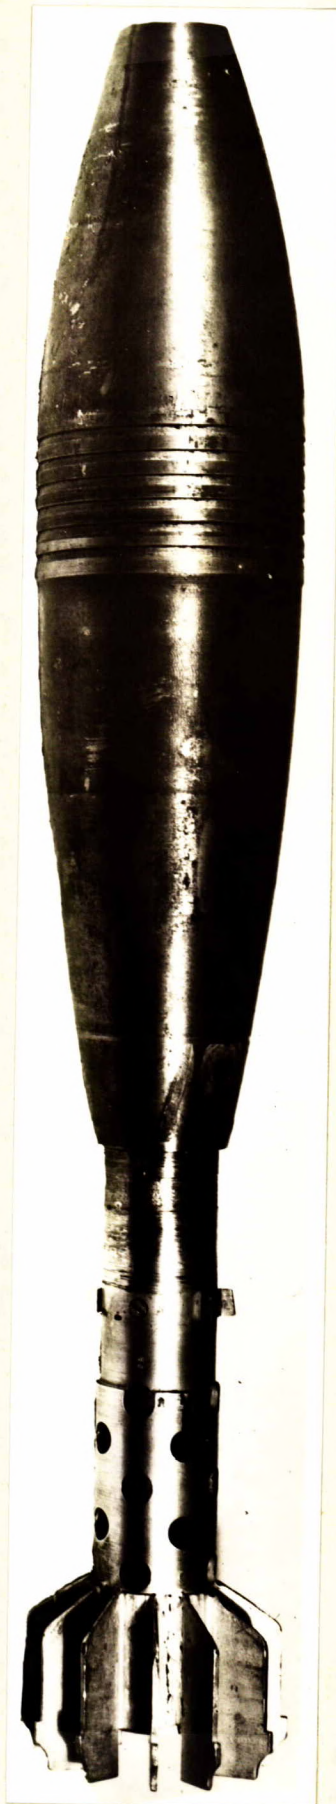
Figure 1.

MORTAR BOMB AS RECEIVED.

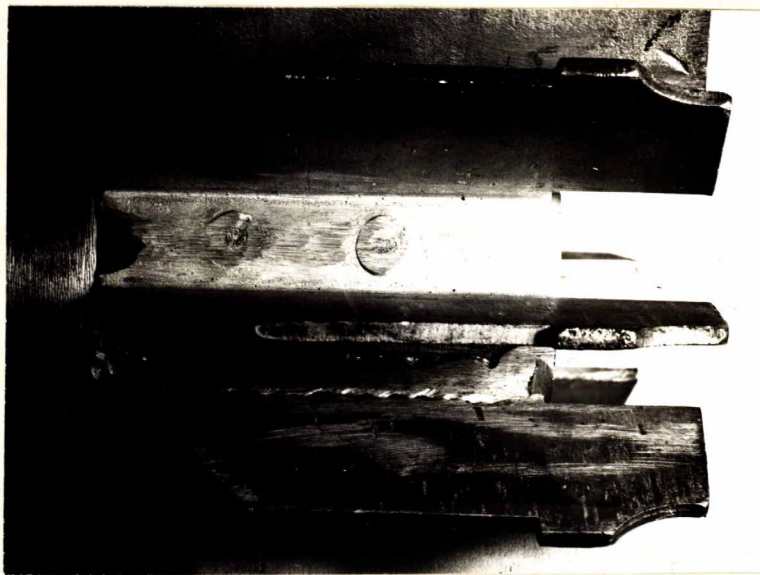
Figure 2.

TOP OF SPOT WELDS JOINING TAIL FIN
UNIT TO TAIL PIECE.

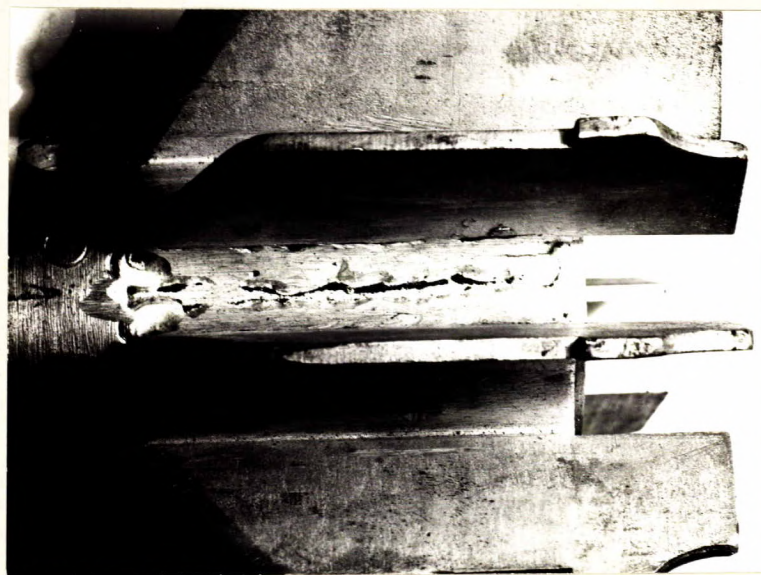
Figure 3.

The defects found in the fillet welds are to be expected in view of the difficulty of proper electrode manipulation within the narrow spaces between fin units. It is not thought, however, that slag inclusions at the root of these welds would be a serious source of difficulty, provided that they are kept to a minimum. The possibility does exist that explosions of secondary charges placed between the fins may result in severe distortion of the fins. This action would be enhanced by the presence of welding defects in the fillet welds.

FILLET WELDS JOINING TAIL FIN
UNITS TO TAIL PIECE.

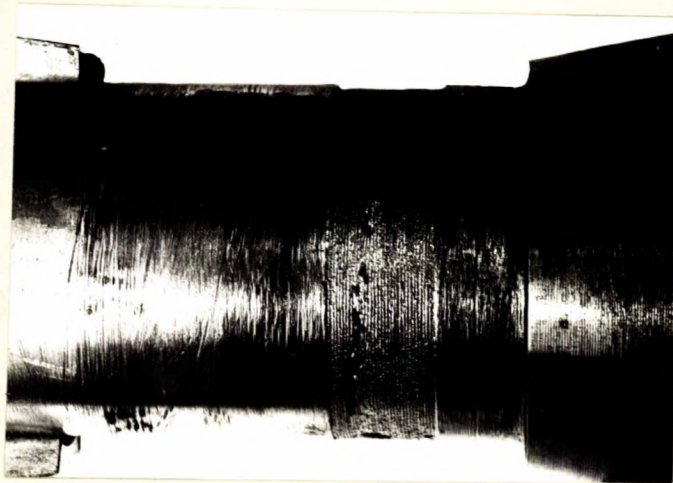
Figure 4.

The weld joining the tail piece to the bomb body, although machined flush, showed serious welding defects such as slag inclusions, unfilled craters, and undercutting. Figure 4 is a photograph of this weld and shows a long slag inclusion.

(3) The machining shown in Figure 4 was such as to indicate improper alignment of the tail piece with the bomb body. This alignment was checked in the following manner: An accurately machined threaded plug was fitted into the threaded nose hole of the bomb. This plug was then gripped in the chuck of a lathe and the bomb body supported in a jack rest accurately centred on the centre of the machined plug. The bomb was then rotated and the alignment checked by means of a micrometer spring gauge at three areas, namely, at the nose, at the end of the tapered bomb body, and as close to the end of the tail piece as the tail fins would permit. It was found that the nose hole was 0.012 inch off centre, the tapered end of the body 0.003 inch out of alignment, and the

MACHINED SURFACE OF TAIL-PIECE-TO-BOMB-BODY WELD.

Note heavy slag inclusion.

- 1. The welding of the tail piece to the bomb body should be performed as fully detailed in Memorandum V-70.
- 2. Firing trials should be conducted with four groups of bombs, as follows:
 - (a) Those now welded and containing serious welding defects.
 - (b) Those now welded and showing the worst alignment but still passing the bore gauge test.
 - (c) Those now welded and subjected to a straightening operation.
 - (d) Those to be welded with the improved technique and subsequently straightened.

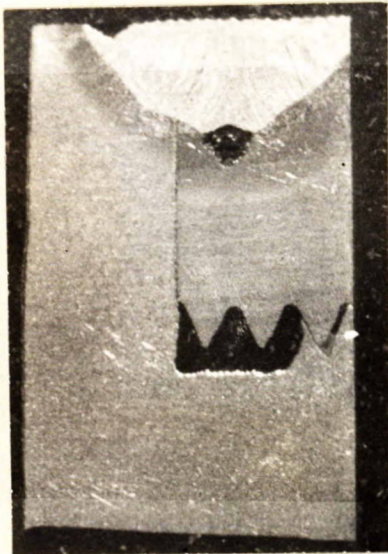
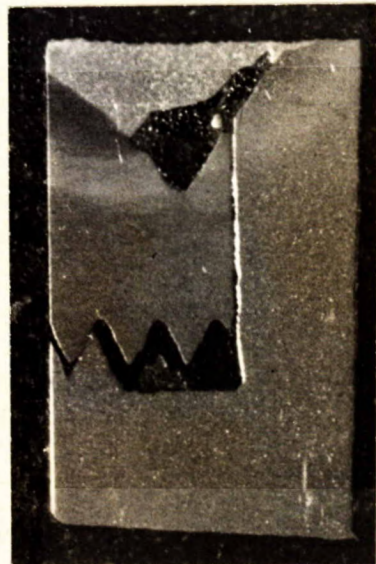
(5) A microscopic examination of three sections reveals a crack in each of the samples shown in Figures 5 and 6. These cracks extend completely through the weld metal to the surface and originate at the welding defects. In the case of the tail fin unit, the spot weld contains a large gas cavity surrounded by numerous cracks.

Of the weldings examined, the single-pass butt weld joining the tail piece to the bomb body exhibits the grossest defects. The slag inclusions and unfilled craters are the result of careless or unskilled welding. The cracks found have all originated in these areas of slag inclusion and emphasize their stress-raising effect. The fact that the threaded joint resulted in failure indicates that severe stresses

are imposed on this joint in firing. The improvement noted after welding would be expected, since the area of metal resisting the stresses is increased. However, the fundamental fault of the joint still remains. This is the severe stress-raising effect of the right-angled joint where the threaded end of the tail piece joins into the tail piece proper. The welding was such as to leave this area unaffected (see Figures 5 and 6). This condition should be rectified as by recommendations previously made (in P.M.R.L. Memorandum V-70, November 28th, 1944), together with changes of electrode and the use of a jig. The extreme hardening of the body and tail piece material, due to the thermal cycle of welding, would be expected from the high hardenability of both materials (see Figure 10). This condition is aggravated by the use of a single-pass technique, and can be considerably reduced by multiple-pass welding.

MACRO SECTIONS OF TAIL-PIECE-TO-BOMB-BODY WELD.

Note heavy slag inclusions at roots of welds. Note, also, that machining is not evenly distributed between bomb body and tail piece. The right-angled change of section at bottom of joint is a severe stress raiser.

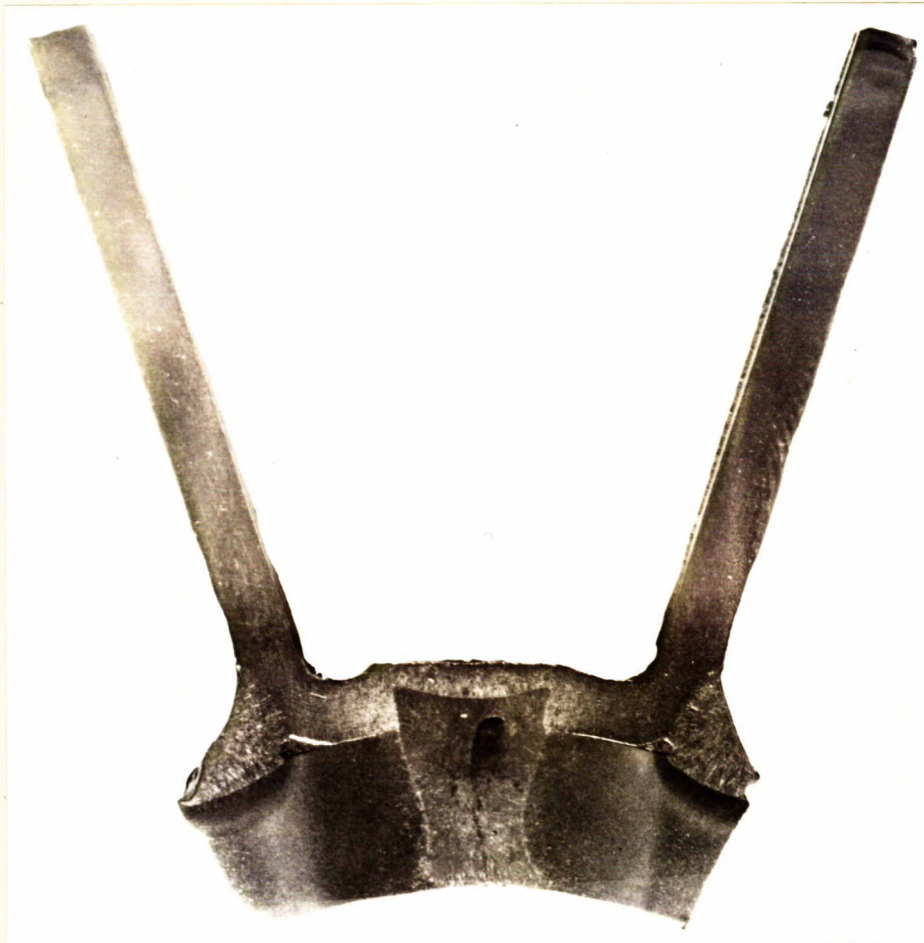
Figure 7.

of the defects found in the spot welds. In Figure 7 it will be noted that there is considerable projection of the tail-piece material into the fin material. It is improbable that this is a result of the spot-welding technique. It would appear that a stud has been machined onto the surface of the tail piece in the welding area. If this is the case it is very unusual and its necessity is open to question. The gas cavities and cracks in this weld are probably due to either of the following, (1) excessive welding current and/or welding time or (2) too small electrode surface. It must be borne in mind that the tail piece is of such a composition as to be very sensitive to the thermal cycle of welding and that, consequently, hard brittle structures may be produced.

MACROPHOTOGRAPH OF WELDS JOINING
TAIL FIN UNITS TO THE TAIL PIECE.

Note slag inclusions at roots of fillet welds.
Note, also, gas cavities and cracks in the
nugget of the spot weld. The projection of
the nugget into the fin material is probably
the result of a machined projection on the
outer surface of the tail piece.

- 3. To prevent spot-weld cracks, the welding current

should be followed by several surges of current to reduce the cooling rate and thereby avoid the production of hard, brittle structures.

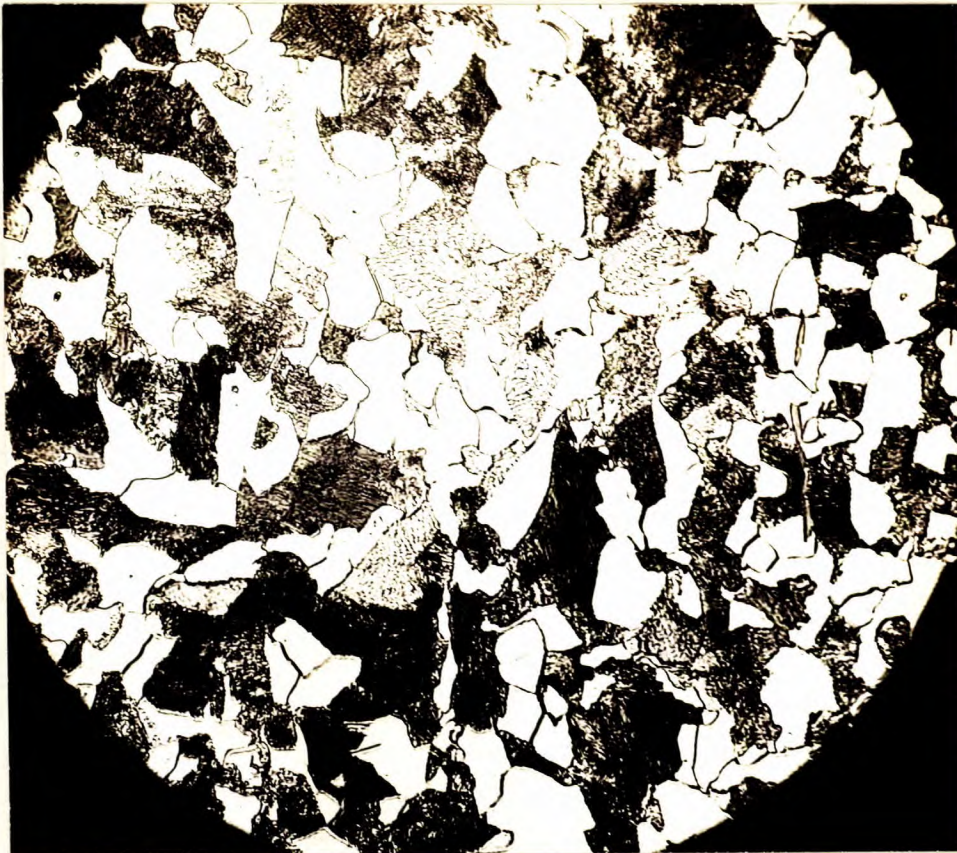
Figure 8.

X500, etched in 2 per cent nital.
NORMALIZED STRUCTURE OF THE TAIL PIECE.

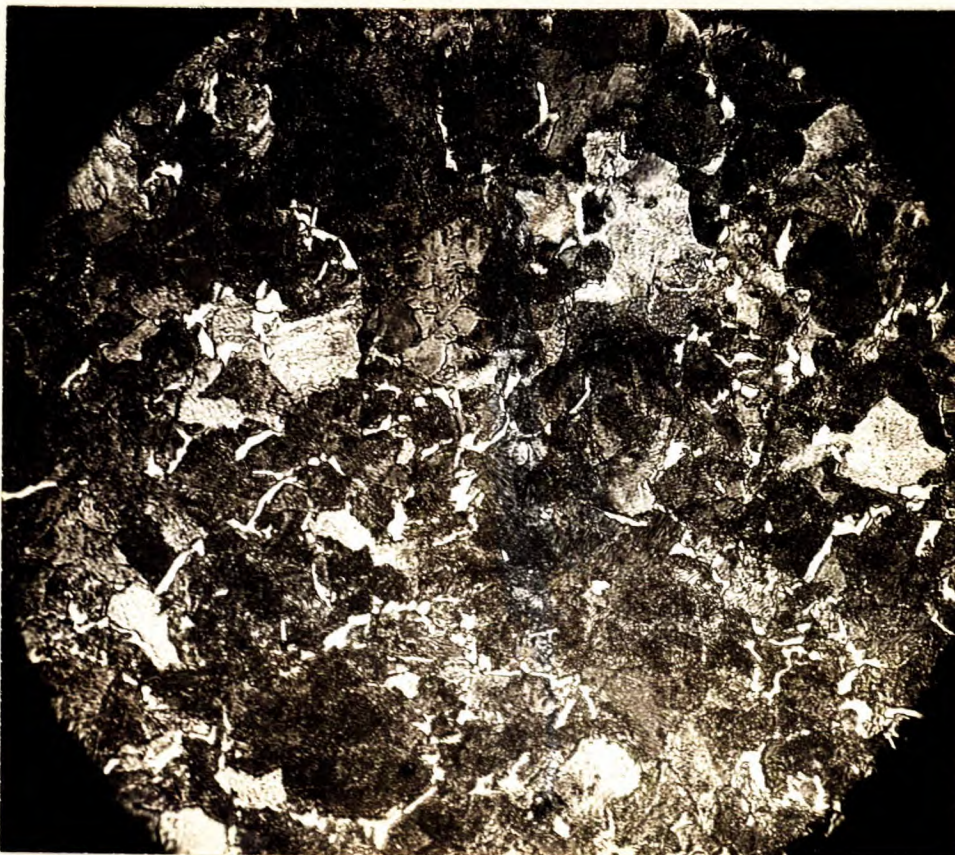
Figure 9.

The microstructure of the bomb body (see Figure 9) is interesting in that it reveals that the heat treatment, presumably quench-and-draw, has been unsatisfactory in that the suppression of ferrite precipitation has not been accomplished. This and the fine pearlite indicates too slow a cooling rate. The composition and microstructure (see Figure 11) of the tail fin units reveal that these are made by stamping from cold-rolled, low-carbon sheet material.

X500, etched in 2 per cent nital.
NORMAL STRUCTURE OF BOMB BODY.
Fine pearlite with ferrite (white constituent) in grain boundaries.

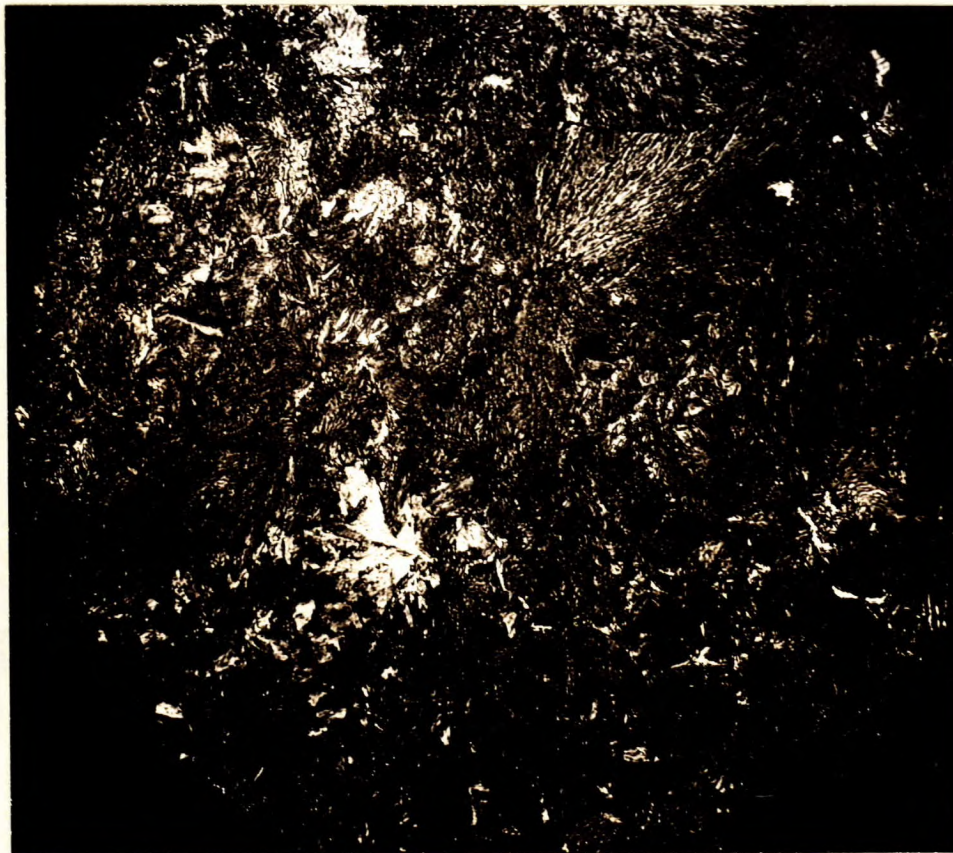
Figure 10.

X500, etched in 2 per cent nital.

TYPICAL STRUCTURE OF HEAT-AFFECTED ZONE OF BOTH
BOMB BODY AND TAIL PIECE MATERIALS.

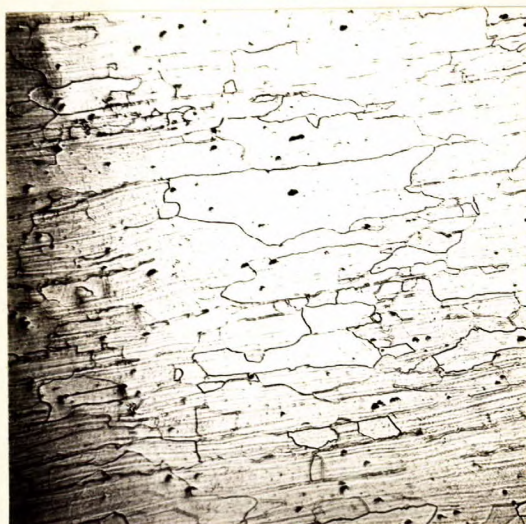
Figure 11.

X100, etched in 2 per cent nital.

COLD-ROLLED STRUCTURE OF LOW-CARBON TAIL FIN UNITS.
