ORE DRESSING AND METALLURGICAL LABORATORIES.

Investigation No. 1763.

Metallurgical Examination of Broken Snowmobile
Track Adjusting Assembly.

December 19th, 1944.

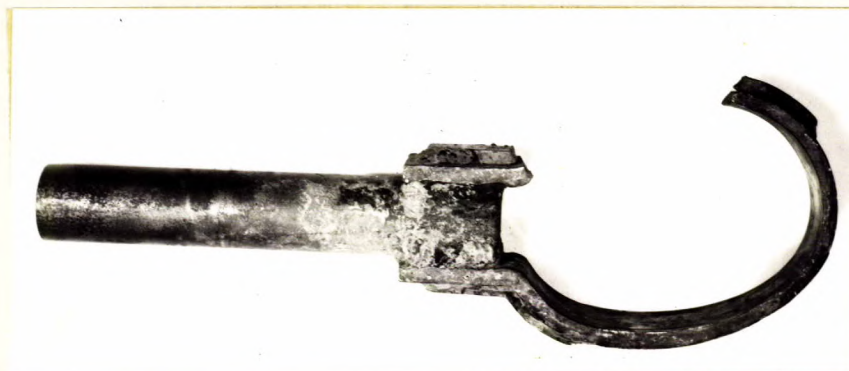
Figure 1.

GENERAL VIEW OF BROKEN SNOWMOBILE
ADJUSTING ASSEMBLY.

Visual examination showed that the fracture had occurred at one of the elbows (where a severe forming operation had been carried out), through both the ring and the reinforcing plate.

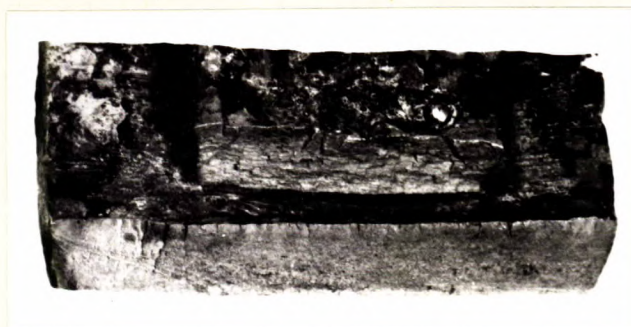
Figure 2.

Further visual examination revealed a smooth, brittle fracture of the ring and definite indications of fatigue failure (see Figure 2). The fracture of the reinforcing plate was rather "woody" or "fibrous" in appearance; the reason for this was later determined by the microscopic examination.

PHOTOGRAPH SHOWING SMOOTH, BRITTLE FATIGUE
FRACTURE OF RING (BOTTOM) AND FIBROUS
FRACTURE OF REINFORCING PLATE (TOP).

Visual and microscopic examinations both contribute strong evidence in support of the opinion that the ring failed in fatigue.

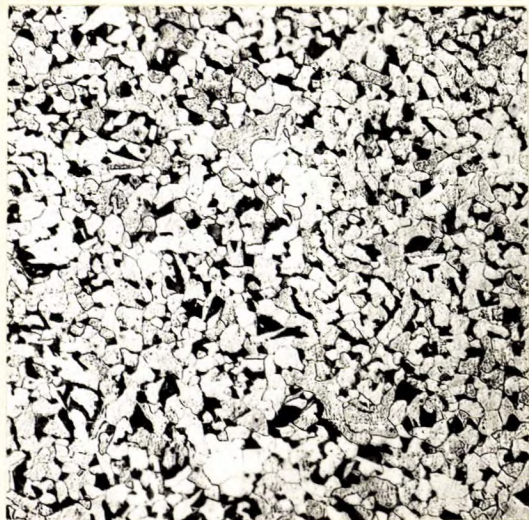
Figure 3.

Figure 3 is a photomicrograph, at X100 magnification, showing the microstructure of the tubing. This structure is typical of SAE 1020 steel.

MICROSTRUCTURE
OF TUBING.

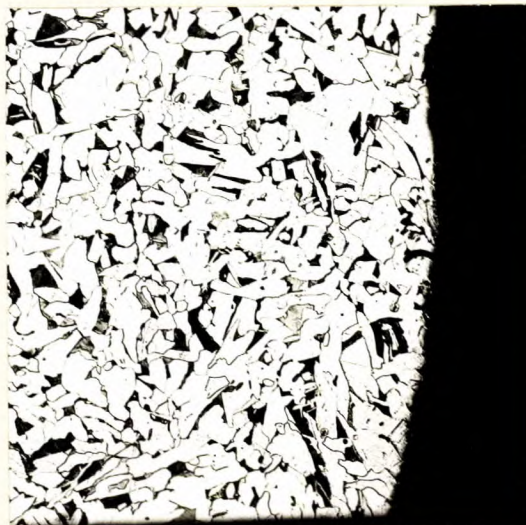
Figure 4.

Figure 4, taken at X100 magnification, shows the microstructure of the ring at the break. Note smooth contour of fracture and absence of distortion, indicating a brittle fracture.

FRACTURED EDGE
OF RING.

Note lack of distortion,
indicating brittle
fracture.

Another factor which may have contributed to the failure of the ring is the rather abrupt change of contour at the elbow of the ring, causing a notch effect which

invariably acts as an area of high stress concentration.

1. It is recommended that the parts of the assembly be painted with anti-splatter compound before welding.
2. The ring should be so formed as to avoid the sharp notch effect at the elbow.
3. The temperature of the ring during the formation of the elbow should be high enough to prevent the setting up of high stresses in this area.

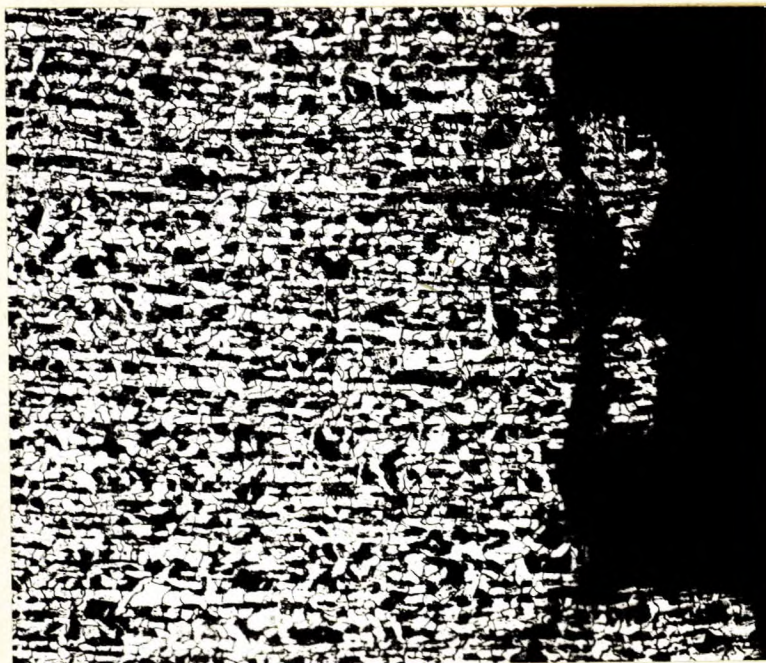
Figure 5.

Figure 5, also taken at X100 magnification, shows the fractured edge of the reinforcing plate. Note the banded structure of the steel, which is responsible for the "woody" or "fibrous" appearance of the fracture.

FRACTURED EDGE OF REINFORCING PLATE.

Note banded structure.

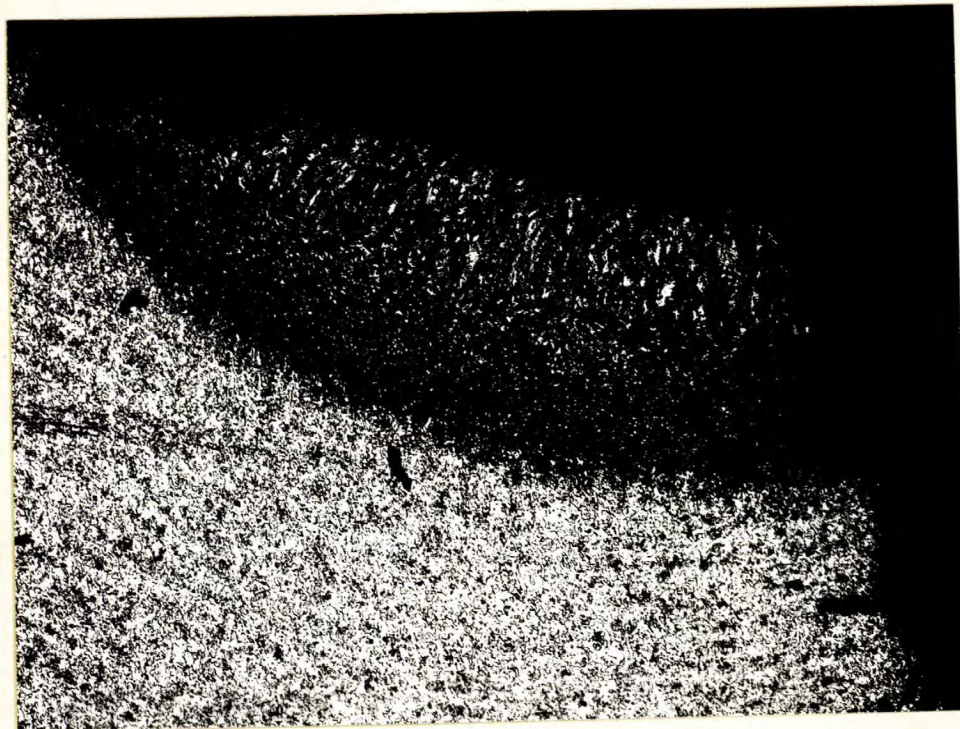
Figure 6.

Figure 6, taken at X40 magnification, is a photomicrograph showing the fractured edge of the reinforcing plate, at the surface. Note the heat-affected zone caused by welding splatter.

FRACTURED EDGE OF REINFORCING
PLATE, AT SURFACE.

Note hard, heat-affected area
caused by weld splatter.

The hardness tests taken on the reinforcing plate, in the areas affected by the weld splatter, show that these areas are extremely hard (as high as 40 Rockwell 'C'). In view of the fact that the fracture in the reinforcing plate occurred through one of these areas (see Figure 6), it is quite possible that the initial crack in the reinforcing plate occurred in this area. When the plate had broken completely through, the additional load suddenly applied to the ring caused a rapid, brittle fracture of the latter component.

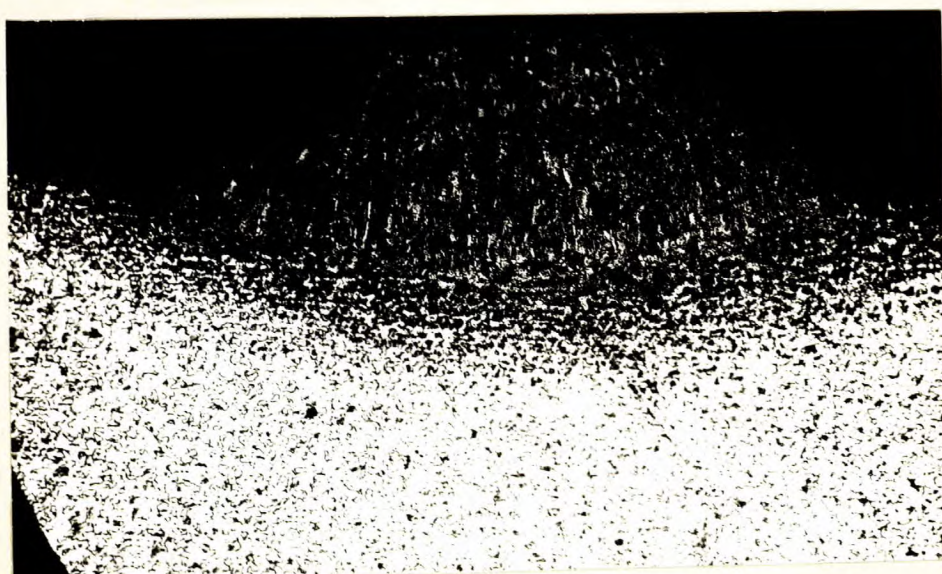
Figure 7.

Figure 7, shows another weld splatter on the surface of the reinforcing plate. The magnification is approximately X45.

WELD SPLATTER ON SURFACE OF
REINFORCING PLATE.
