ORE DRESSING AND METALLURGICAL LABORATORIES.

Investigation No. 1766.

Metallurgical Examination of Three Snowmobile
Track Cross Links.

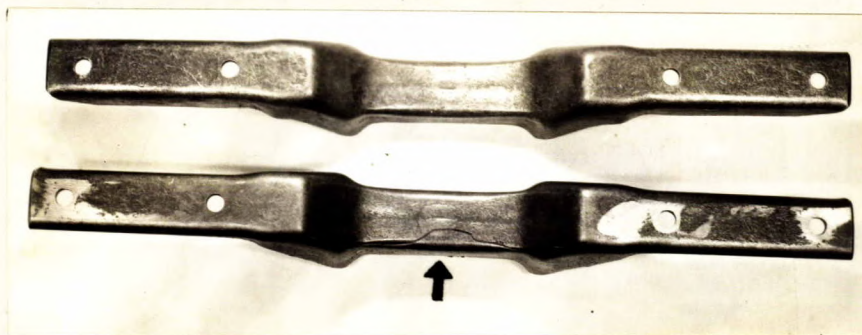
Figure 1.

Figure 1 shows one unbroken link alongside the cracked link. The crack was opened up and the fractured surface was found to be free from any noticeable staining. It was not possible to establish the exact point where the crack started.

Note the crack on the surface of the bottom link.

The fractured surface of the cracked link revealed no oxidation. This would normally indicate that cracking occurred in the last operation, i.e. during the rubber curing process. Since only one link was examined it is not considered sufficient evidence to definitely establish this fact.

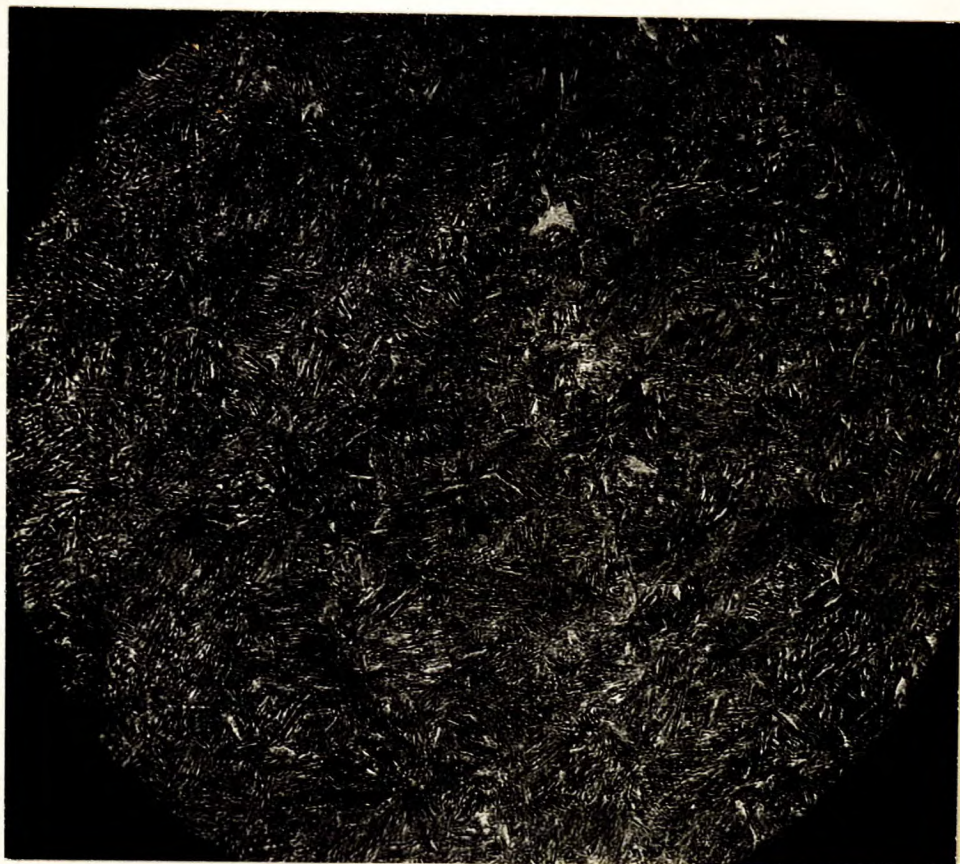
Figure 2.

STRUCTURE OF CRACKED LINK A.

followed by an oil quench and a 700° F. draw. The cracked link A had a finer tempered martensite structure. This structure was achieved in these Laboratories by heating a piece of link (having a tempered martensite structure originally) to 2000° F., then lowering the temperature to 650° F., which is below the AR_1 point. The piece was next placed into neutral salt at 1500° F., oil-quenched, and drawn at 700° F.

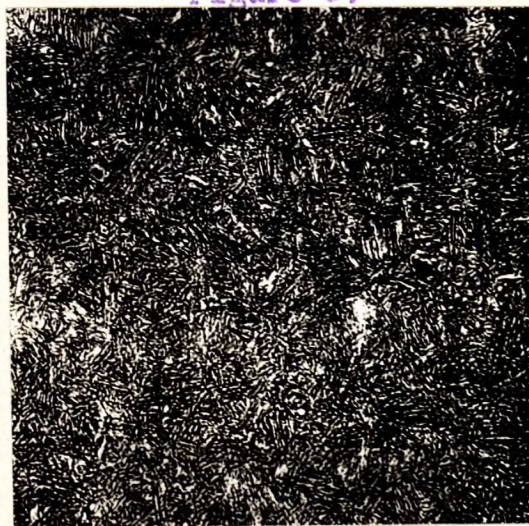
Figure 3.

Note: Structure obtained after tempered martensitic bar stock is heated to 2000° F. for 30 minutes, quenched in salt at 650° F. for 15 minutes, transferred to salt at 1500° F. for 30 minutes, oil-quenched, and drawn at 700° F. for 30 minutes.

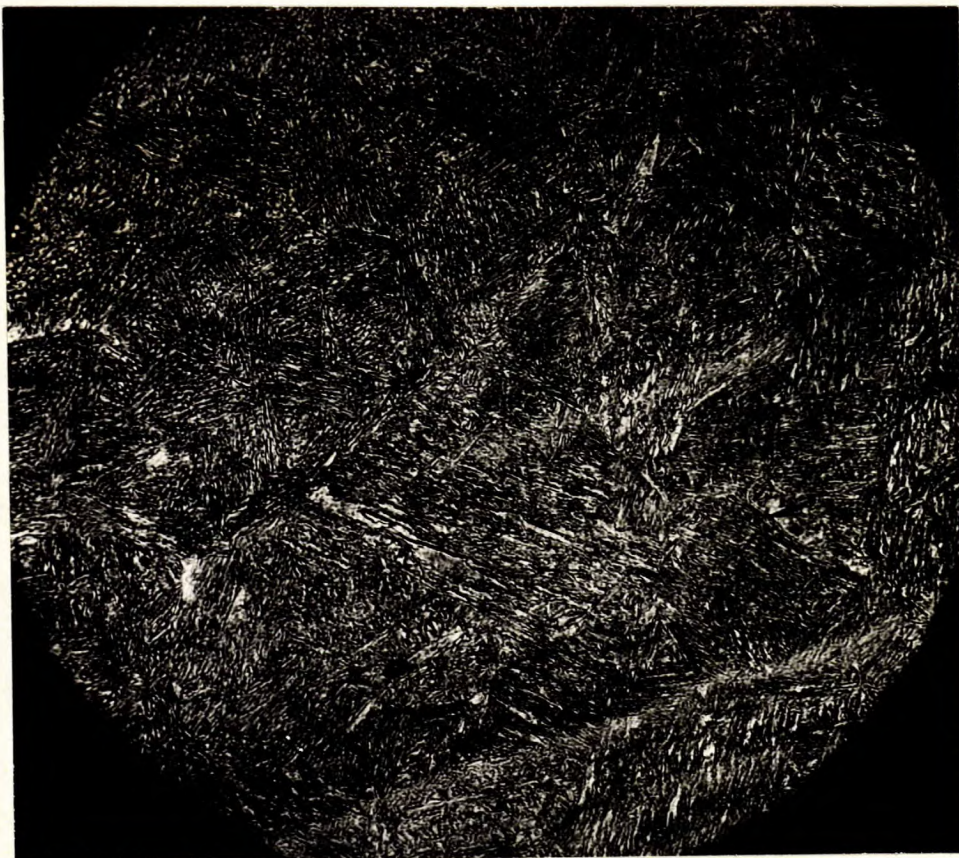
Figure 4.

COARSE MARTENSITE STRUCTURE OF UNBROKEN LINK B.

The microstructures of the three links vary. Some banding was visible in all the structures. The unbroken link B had a coarse tempered martensitic structure. This was duplicated by heating a piece of link (with an original structure of tempered martensite) to 2000° F., then lowering the temperature to 1500° F., which is above the A_{R_3} ; this was

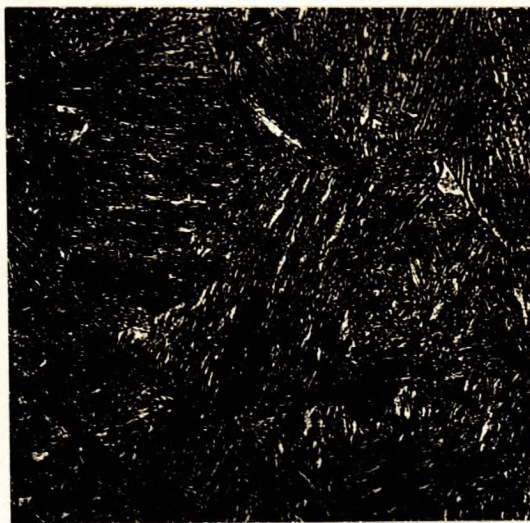
Figure 5.

Note: Structure obtained after heating tempered martensitic bar stock to 2000° F., holding for 30 minutes, then transferring to salt at 1500° F., holding for 30 minutes, then quenching in oil and drawing at 700° F. for 30 minutes.

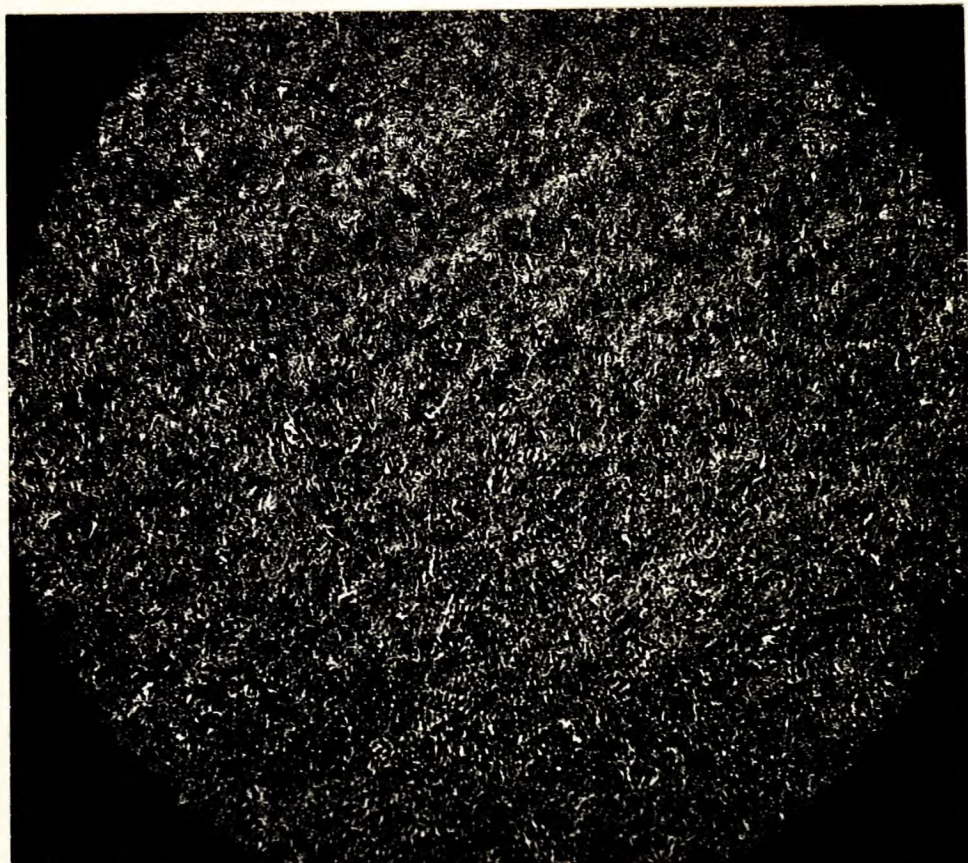
Figure 6.

LINK G.

Heterogenous structure of nodular martensite
and spheroidal carbides.

The structure of Link C was nodular tempered martensite combined with spheroidal carbides. This structure could only be duplicated by the following treatment:

This points to the fact that the old die links were in the spheroidized state prior to the heat treatment for the forming operation. The new die links were, in all probability, in the tempered martensitic condition.

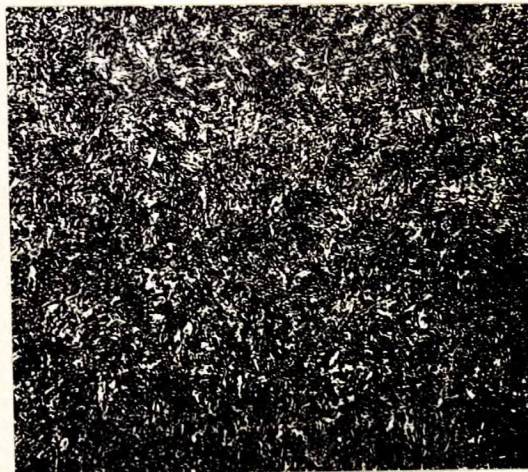
Figure 7.

Note: Link B was spheroidized at 1225° F. for 40 hours.
Above structure was obtained by heating this spheroidized
link in neutral salt for 5 minutes at 1650° F., oil quench-
ing, then drawing at 700° F. for 15 minutes.

A link was first spheroidized by heating to 1225° F. and holding for 40 hours. The spheroidized stock was then held in neutral salt at 1650° F. for 5 minutes, oil-quenched, and drawn at 700° F.
