ORE DRESSING AND METALLURGICAL LABORATORIES.

Investigation No. 1772.

Metallurgical Examination of a Belleville Spring Washer.

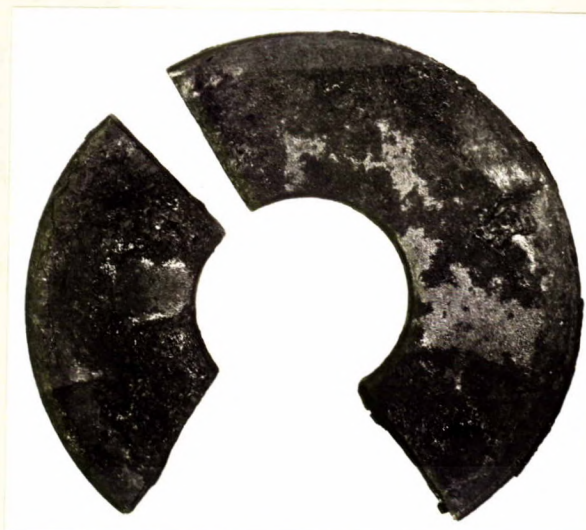
Figure 1.

PORTIONS OF BELLEVILLE SPRING
WASHER AS SUBMITTED.

Note that surface is heavily rusted.

the spring washer failed when the endurance limit was exceeded and, also, that the endurance limit was lowered by the rusting action at the surface.

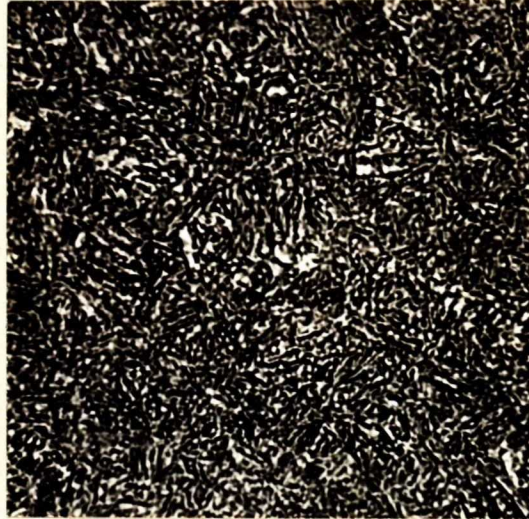
Figure 2.

Microscopic examination of longitudinal and transverse specimens disclosed a clean steel which had been heat-treated to produce a uniform microstructure of tempered martensite (see Figure 2). There was no evidence of decarburization back of

X1000, etched in 2 per cent nital.

Tempered martensite.
