ORE DRESSING AND METALLURGICAL LABORATORIES.

Investigation No. 1777.

Examination of Dominion Magnesium Limited Alloy Steel Retert No. C-995.

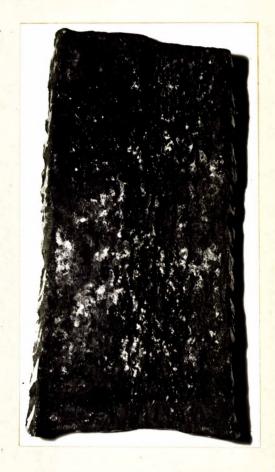
# Figure 2.

The outside and inside surfaces of the sample submitted are shown in Figures 1 and 2.

There was a heavy scale deposited on the inside surface.

The part of this scale immediately adjacent to the metal was a metallic grey in colour and was magnetic.

PHOTOGRAPH SHOWING INSIDE SURFACE OF RETORT SAMPLE.

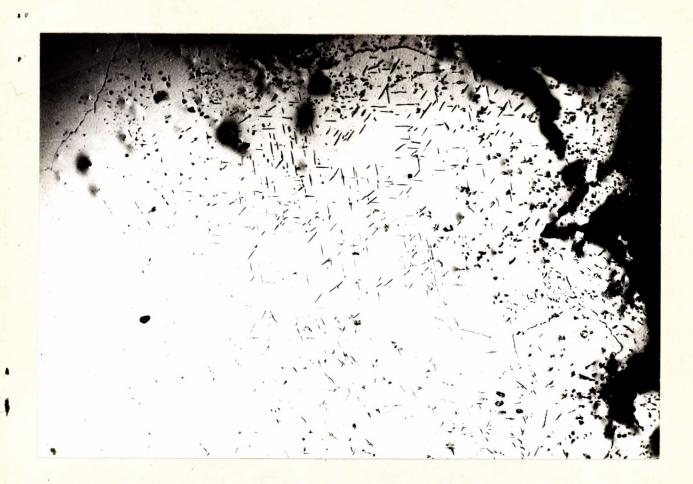
# Figure 4.

A cross-section adjacent to the failure was prepared for microscopic examination. Figure 4 is a photomicrograph of the structure of the metal adjacent to the inner surface of the retort. It will be noted that carbides are present in the metal immediately below this surface. The section has been decarburized through almost the entire thickness.

Note, also, the unevenness of this surface.

The photomicrograph in Figure 4 indicates that nene of this decarburization occurred on the inside surface of the retort but, as in the case of all previous retorts examined, proceeded from the outside surface. The presence of a magnetic scale containing chromium, iron and nickel on the inside of the retort indicates that there is some corrosive action taking place on the inside surface, apparently resulting in the formation of magnetic exides.

PHOTOMICROGRAPH SHOWING STRUCTURE AT INSIDE SURFACE OF RETORT SAMPLE.

Note distribution of carbide.
