R E P O R T  
of the  
ORE DRESSING AND METALLURGICAL LABORATORIES.

Investigation No. 1779.

Examination of Fractured Composite Tail  
Tubes of a Piat Bomb.

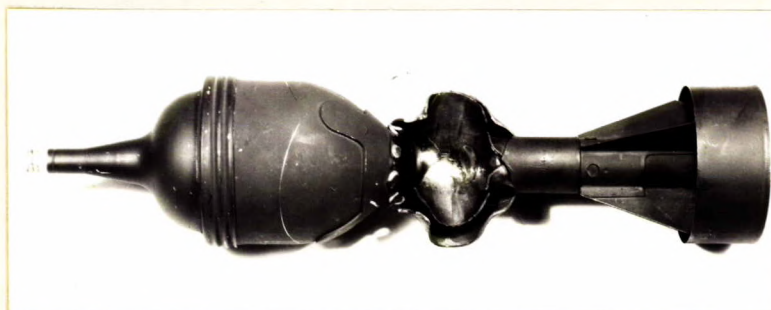
The nature of the side burst fracture of the composite tail tubes of the Fiat bomb after proof firing is illustrated in Figure 1.

SAMPLE AS RECEIVED.

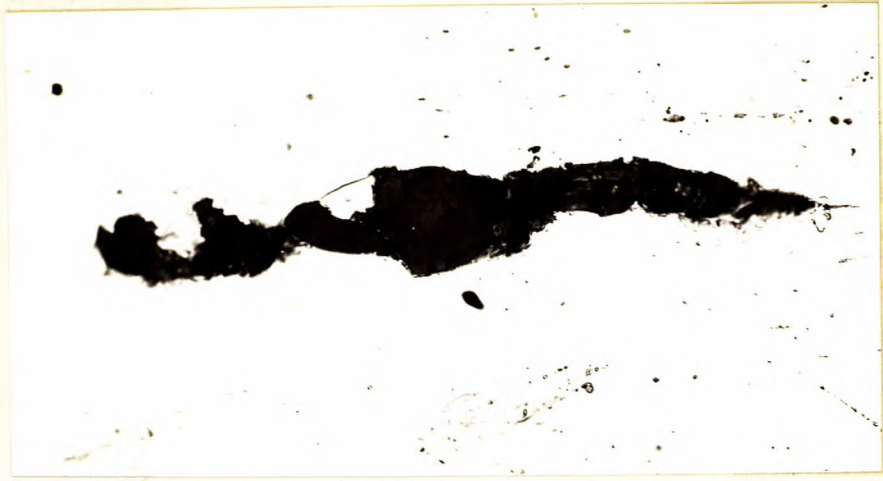
Figure 2.

Sections of the inner and outer tubes were cut from the fractured and unaffected zones, mounted, polished, and examined under the microscope in the unetched condition. The steels were found to be fairly clean. However, several fairly large silicate inclusions were observed in the steel of the inner tube. Figure 2 is a photomicrograph, at X500 magnification, showing one of these inclusions. The unetched and nital-etched structures of the inner and outer tube are shown, at X100 magnification, in Figures 3, 4, 5, and 6.

SHOWING SILICATE INCLUSIONS IN INNER TUBE.

The steel used in the manufacture of these tubes was found to be fairly clean. Several fairly large inclusions were observed in the inner tube. It is not felt that these inclusions would materially affect the tensile properties in the longitudinal direction. However, their presence would lower the transverse properties of the tubing. The microstructure of both tubes is typical of normalized low-carbon steel of similar composition. While too much reliance cannot be placed in microtensile specimens, the results obtained would seem to indicate that failure cannot be attributed to poor mechanical properties. It is also considered unlikely that failure was due to the presence of silicate inclusions such as were observed in the inner tubing. From the results of this investigation it is concluded that failure was due to mechanical rather than metallurgical causes.

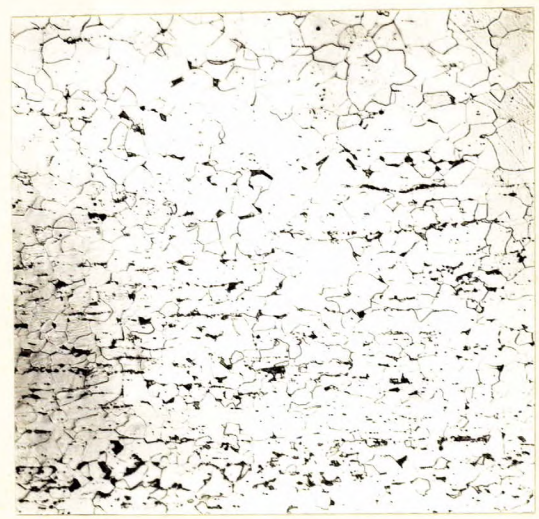
Figure 4.

INNER TUBE.

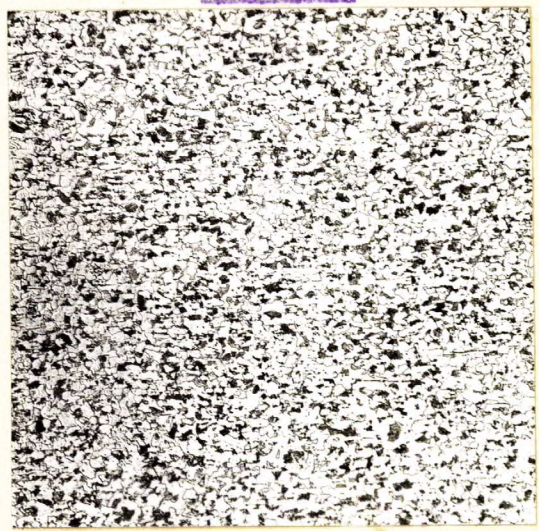
Figure 6.

OUTER TUBE.
