January 25, 1945.

ORE DRESSING AND METALLURGICAL LABORATORIES.

Investigation No. 1781.

Examination of Dominion Magnesium Limited
Alloy Steel Retort No. C-951.

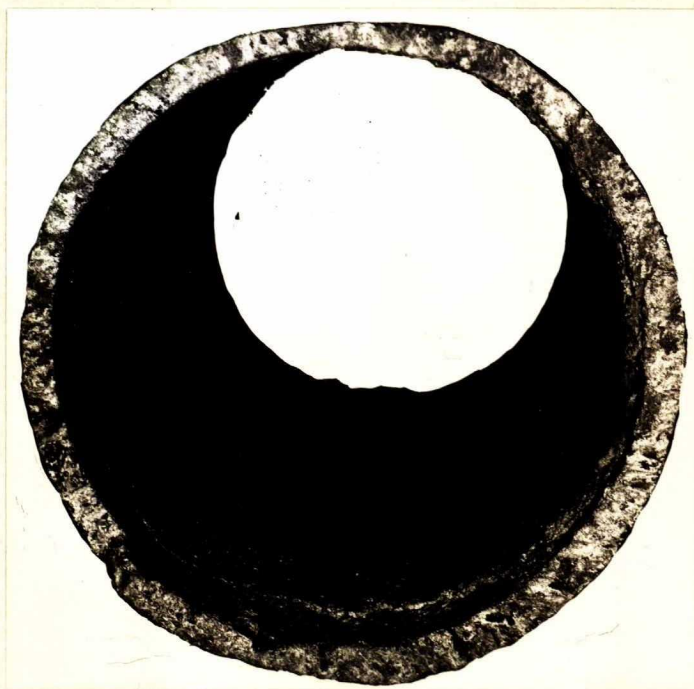
Figure 1.

The examination of the section of the retort revealed a considerable variation in the wall thickness around the complete periphery.

END VIEW OF SECTION OF RETORT
IN "AS RECEIVED" CONDITION.

Note variations in wall thickness.

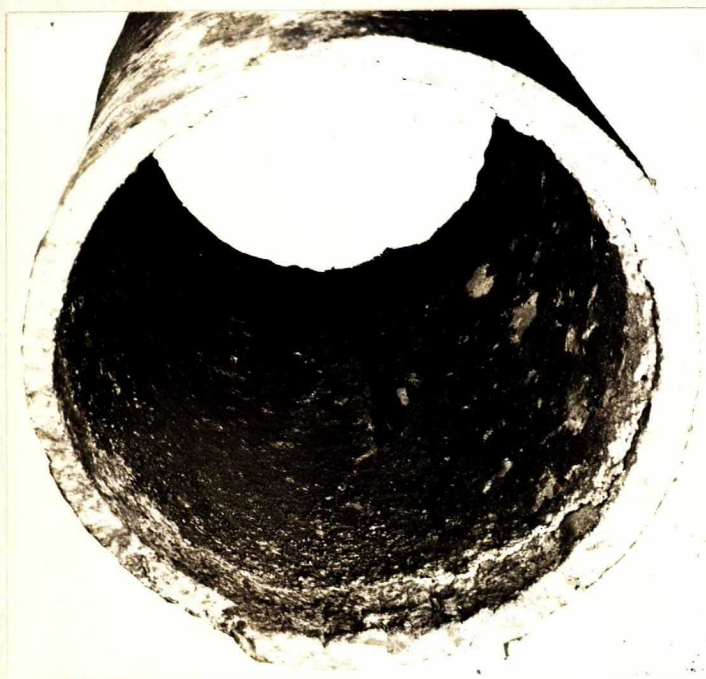
Figure 2.

An examination of the outside of the repair area produced no clue as to the cause of failure of the repair. However, on the inside of the retort the repair area was clearly visible as a depression approximately $3/16$ inch in depth below the general level of the retort wall. The sharp edges, regular depth and outline of the depression precluded any possibility of this being the result of localized corrosion.

INSIDE VIEW OF RETORT "AS RECEIVED".

Note depression which is the weld repair
area. Note, also, crack extending from
the weld repair area out into the retort
wall.

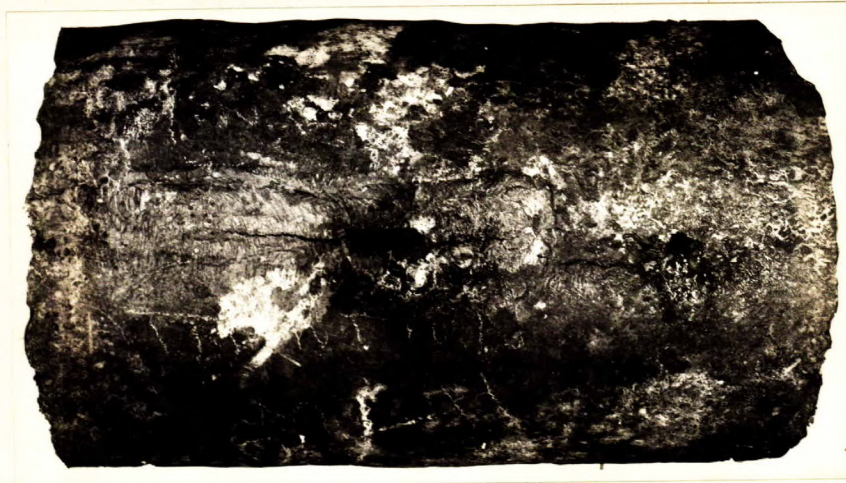
Figure 3.

(1) The section of retort was examined in the "as received" condition. Figure 1 shows a photograph of the retort in this condition. Figure 2 is a photograph of the inside of the section, showing the weld repair area and the crack formed in the short additional service. Figure 3 is a photograph of the outside of the retort, where ultimate failure occurred, and shows the cracking extending from the holes.

OUTSIDE OF WELD REPAIR AREA.

Note the cracks in the weld, and their position.

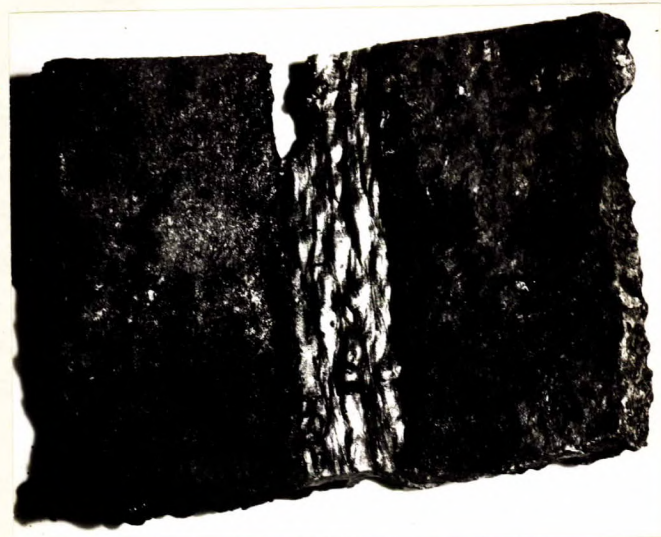
Figure 4.

repair area, the bottom of the weld could be seen to be made in a series of string beads running parallel to the major length of the repair. A cross-section of the repair area revealed that the weld thickness was only two-thirds of that of the retort wall. This had left an unwelded root which was fully one-third of the wall thickness, with the result that a deep notch had been formed between the bottom of the weld and the retort wall. Failure by cracking had occurred at this deep notch and once started had progressed beyond the original repair area.

The formation of a notch of the type found is the result of a defective welding procedure. From the appearance of the bottom of the weld it would seem that either a plastic back-up material such as carbon paste had been used or the retort had been positioned so that the bottom layer of the weld was deposited in the manner of horizontal fillet welds. If the plastic back-up material was used it must have projected up into the cavity to be filled with weld metal. If positioning for horizontal welding was used the operator failed to reach the bottom of the repair area. In either case the procedure is defective, in that the full thickness of the retort wall has not been welded.

BOTTOM OF A SECTION OF THE WELD REPAIR
AREA AFTER SCALE REMOVAL.

Note string-bead type of weld. Note, also, sharp edges of the depression and the location of a part of one of the holes with relation to the weld.

1. The welding procedure should be such as to permit welded repairs to be fully as thick as the retort wall.

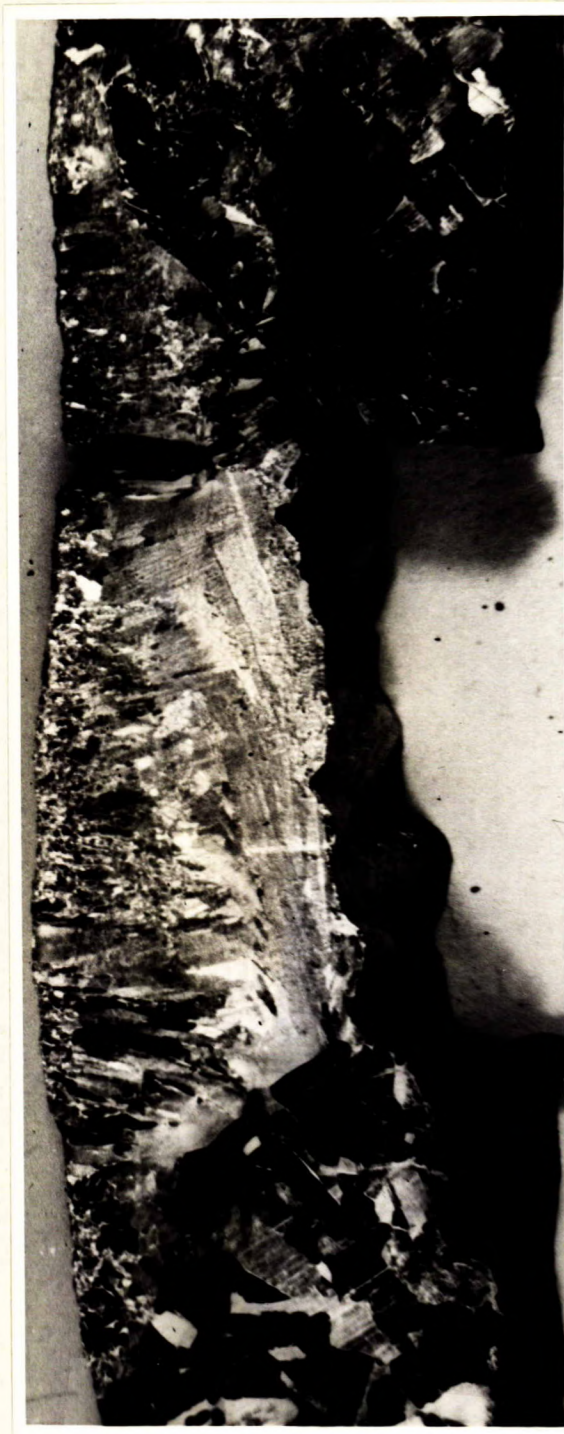
Figure 5.

A notch of this type will inevitably produce cracking troubles. The severe stress-raising effect of the defect is such as to readily cause the formation of a crack. It is interesting to note that the crack follows the notch along the entire length of the repair area and extends into the sound metal beyond. This is a normal characteristic of metals in that cracks in highly stressed materials produce their own notch effect and thereby produce progressive failure.

Failure of the welded repair has been the result of a defective welding procedure. This procedure has resulted in shallow weld with a deep notch at the root. The stress-raising effect of the notch has resulted in cracking.

TRANSVERSE SECTION OF WELD REPAIR AREA,
ETCHED IN AQUA REGIA.

Note that weld depth is only approximately
two-thirds of retort wall thickness.
Note notch at right side of root where
cracking has occurred.

2. A type of welding joint design previously recommended should be used.
