January 25, 1945.

ORE DRESSING AND METALLURGICAL LABORATORIES.

Investigation No. 1783.

Investigation of Corrosion Resistance of
Lightened Mortar Base Plates and Bipod.

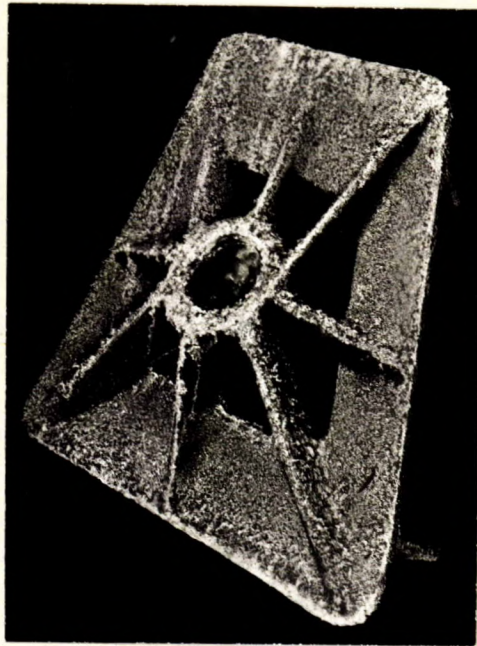
Figure 1.

1. The khaki-coloured service paint gives little protection to magnesium.
2. Chrome-pickling the magnesium surface delays the corrosion for a short time but does not prevent it.
3. Whether or not the corrosion of magnesium is accelerated by being in contact with iron depends upon the relative areas of the magnesium and iron surfaces exposed to the corroding agent. If the exposed area of magnesium is great compared with that of the iron, then little or no acceleration of the corrosion rate will take place. If, on the

MAGNESIUM BASE PLATE AFTER 200 HOURS IN
THE 5 PER CENT SALT (SODIUM CHLORIDE)
SPRAY AT 95° F. (35° C.). UNCLENED.

A suitable protective coating would prolong the useful life of the magnesium considerably.

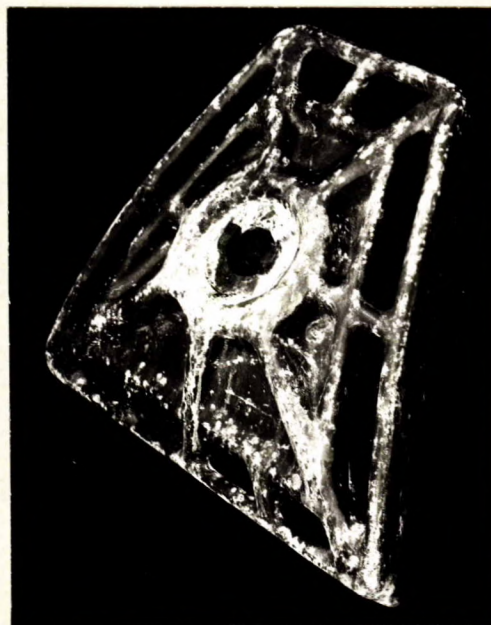
Figure 2.

could be predicted on the basis of electrochemical principles. Aluminium surfaces on both bipod and base plate were only slightly affected. Those adjacent to iron surfaces were slightly attacked.

ALUMINIUM BASE PLATE AFTER 200 HOURS IN
THE 5 PER CENT SALT (SODIUM CHLORIDE)
SPRAY AT 95° F. (35° C.). UNCLENED.

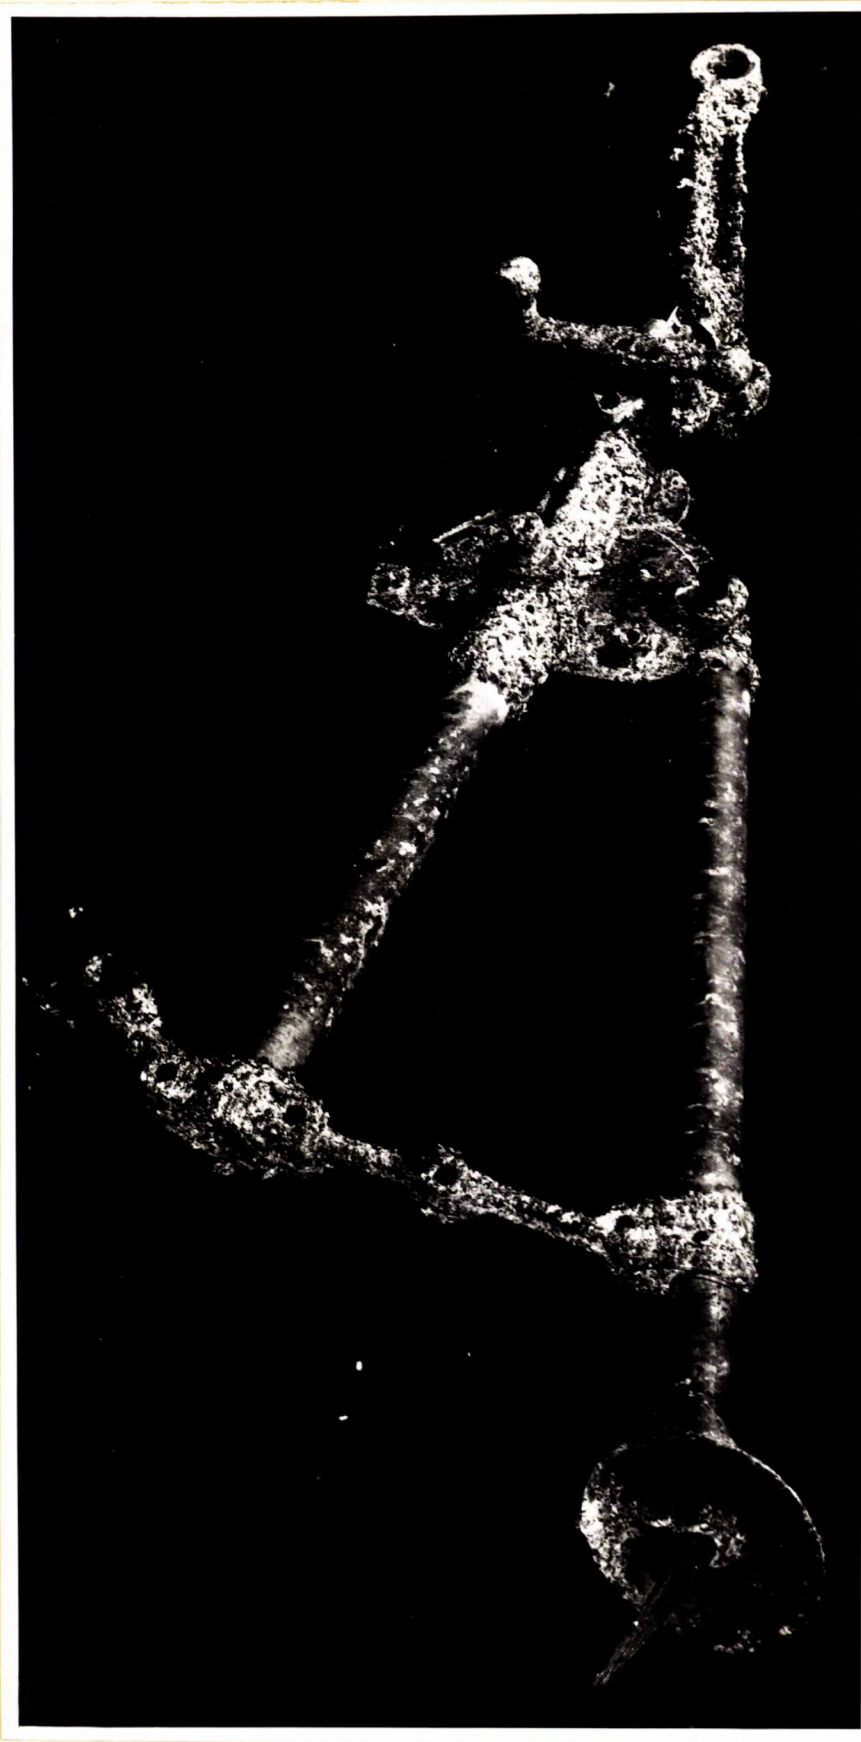
UNTREATED SECTION OF LIGHTENED BIPOD,
CONSISTING OF MAGNESIUM, ALUMINIUM
AND IRON PARTS. AFTER 200 HOURS IN
THE 5 PER CENT SALT (SODIUM CHLORIDE)
SPRAY AT 95° F. (35° C.). UNCLEANNED.

The small dark circular parts are of iron, the long
cylindrical parts which are comparatively free from
corrosion are of aluminium and the badly corroded
parts are of magnesium.

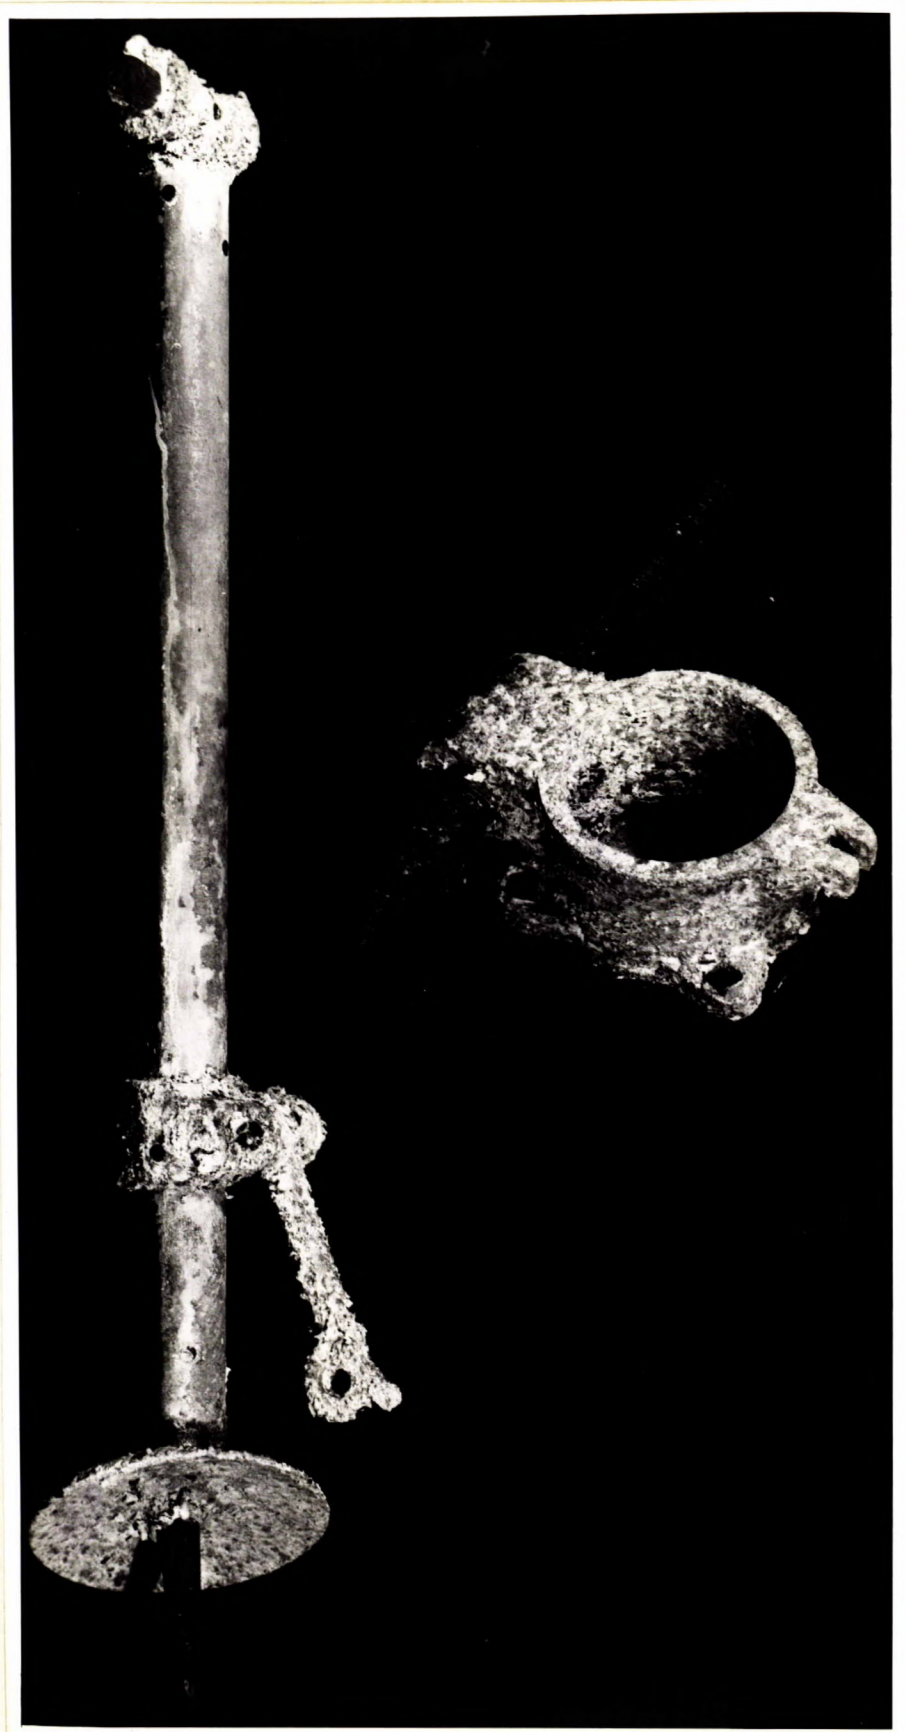
Figure 4.

After 60 hours. The chrome-pickled magnesium surfaces showed some signs of corrosion but much less than the surfaces which had not been treated.

PARTS OF LIGHTENED BIPOD WHICH WERE CHROME-PICKLED AND THEN SUBJECTED TO 5 PER CENT SALT (SODIUM CHLORIDE) SPRAY FOR 200 HOURS AT 95° F. (35° C.). UNCLEANED.

The small dark parts and the large threaded part are of iron, the long cylindrical part is of aluminium, and the badly corroded parts are of magnesium.

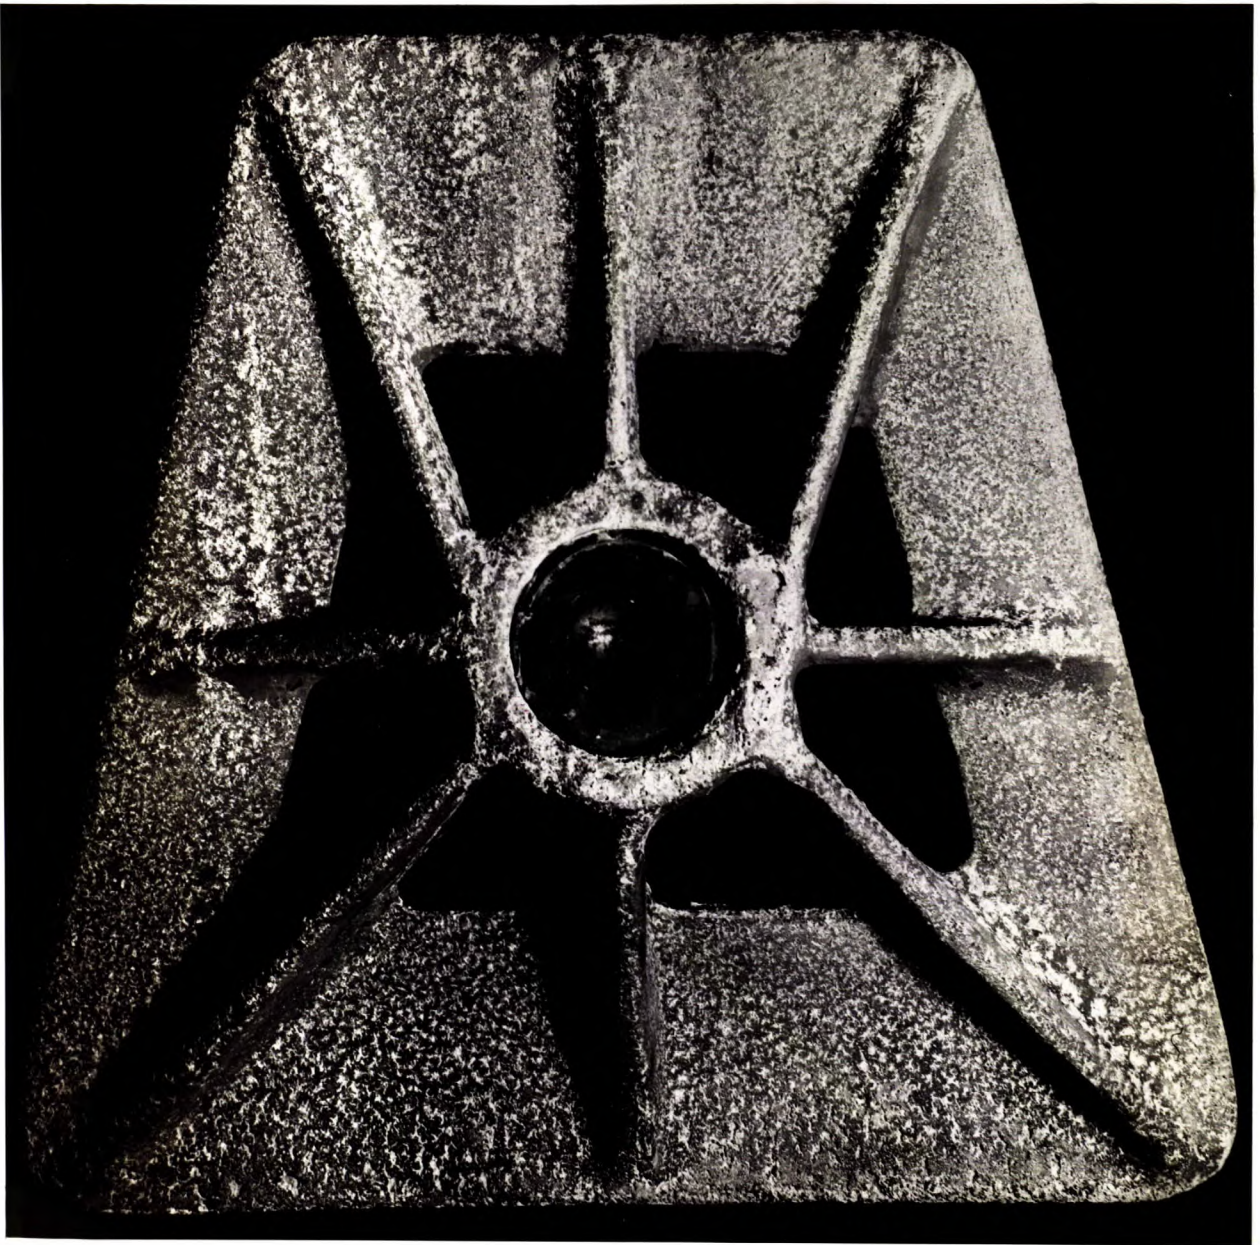
Figure 5.

MAGNESIUM BASE PLATE AFTER SALT
SPRAY TREATMENT. CLEANED.

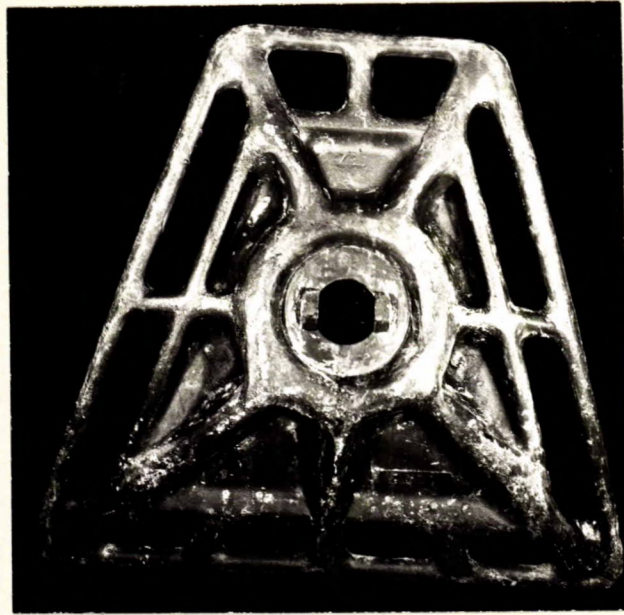
Figure 6.

ALUMINIUM BASE PLATE AFTER SALT
SPRAY TREATMENT. CLEANED.

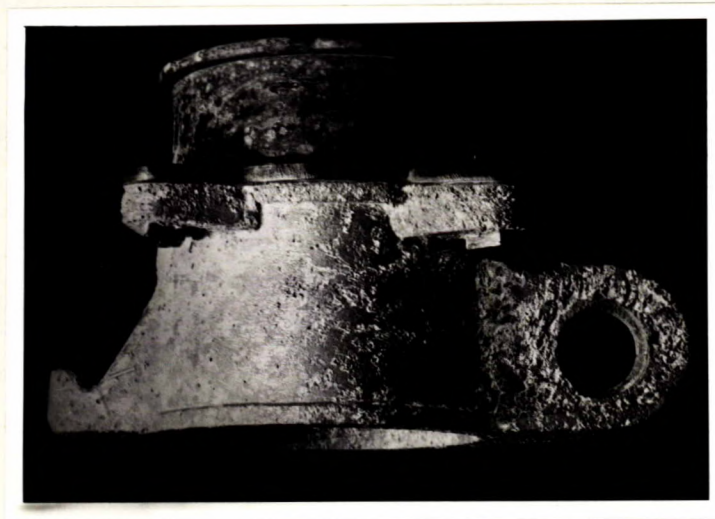
After 200 hours. All magnesium surfaces were corroded badly. Those which were in contact with a small area of iron were in little or no worse condition than the other surfaces, as shown in Figure 9. Those which were in contact with a large area of iron were corroded to a greater extent than other surfaces, as shown in Figure 7. (As mentioned above, a large threaded piece of iron had been screwed into the hole in the magnesium collar before the test began). This phenomenon

MAGNESIUM SLEEVE (BOTTOM) BOLTED TO BRASS
SLEEVE (TOP) FROM WHICH IT IS SEPARATED
BY A NON-METALLIC GASKET. AFTER SALT
SPRAY TREATMENT AND CLEANING.

Note the unusually deep pits around the hole in
the magnesium sleeve. During the salt spray
treatment a large threaded iron part was screwed
into this hole.

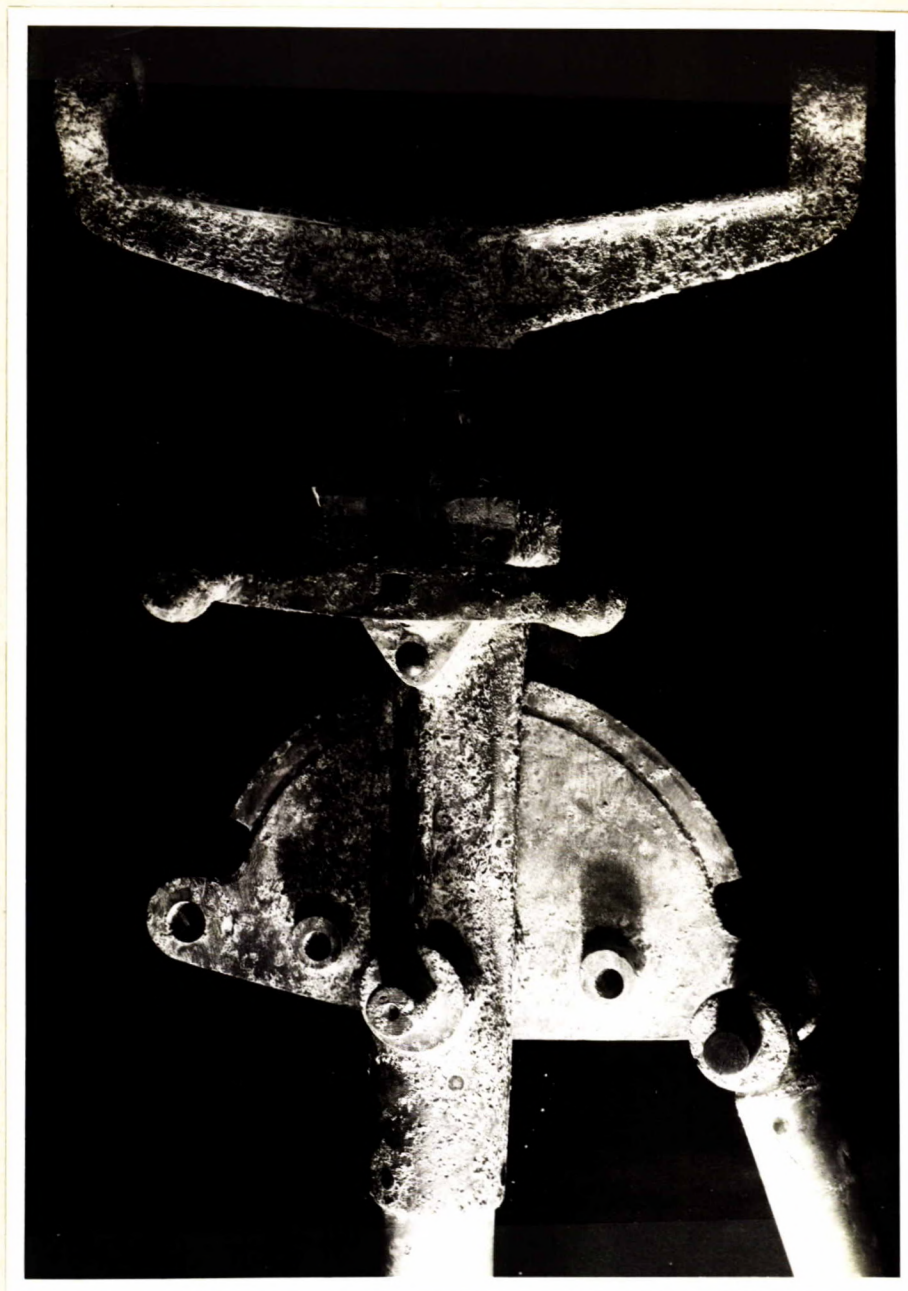
Figure 8.

PART OF THE UNTREATED SECTION OF THE BIPOD
SHOWN IN FIGURE 5, AFTER CLEANING.

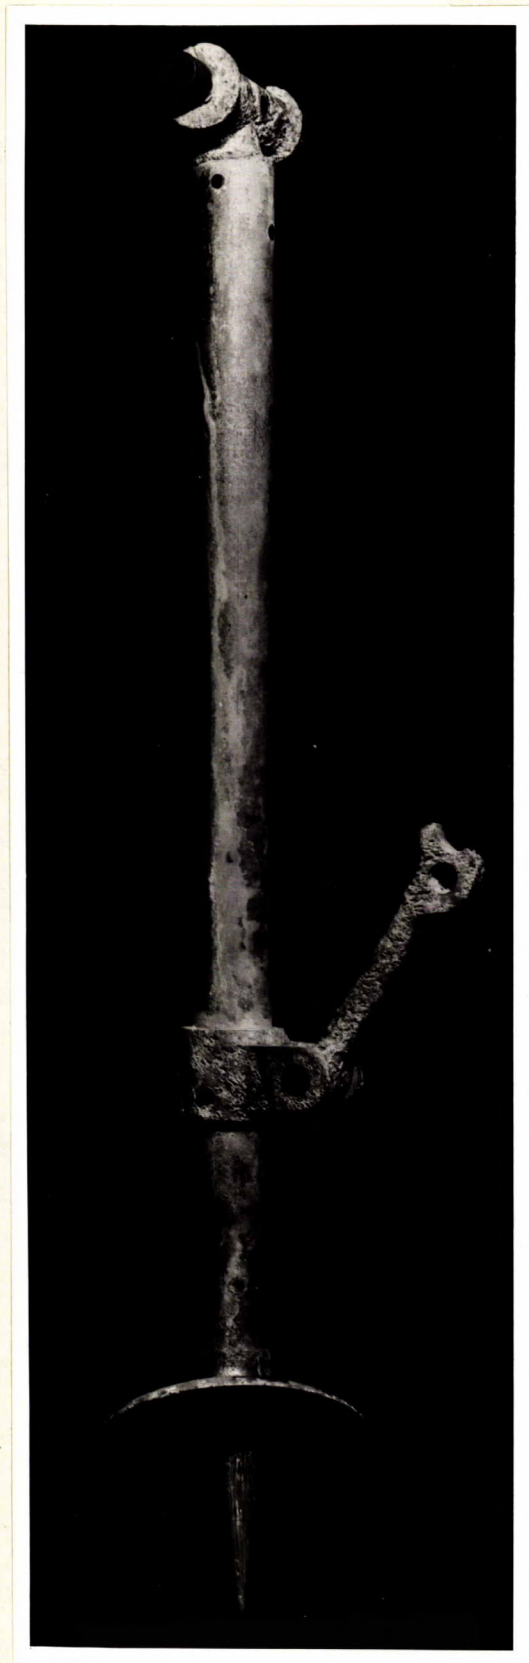
Figure 9.

CHROME-PICKLED SECTION OF THE BIFOD
SHOWN IN FIGURE 4, AFTER CLEANING.

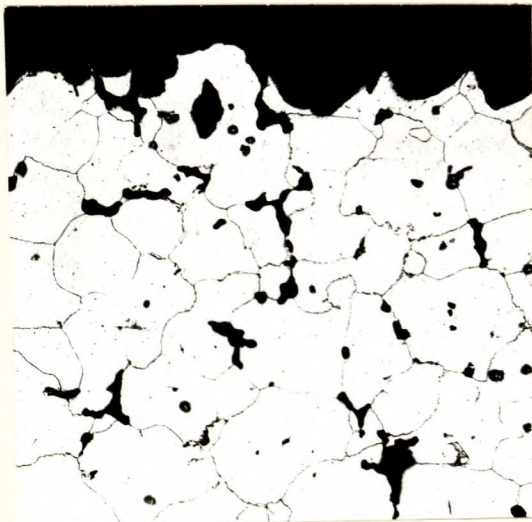
Figure 10.

The structure of the metal at and near the pitted surface of the bipod (Figure 12) was the same as that in the interior of the specimen. In the case of the sample from the base plate the metal near the surface was found to be much more porous (Figure 10) than the metal in the interior (Figure 11). It is believed that this porosity is not due to corrosion but to some peculiarity of the casting process.

X100.

THE CORRODED SURFACE OF
THE MAGNESIUM BASE PLATE
AND THE METAL IMMEDIATELY
UNDERNEATH.

Note the large cavities under-
neath the surface.

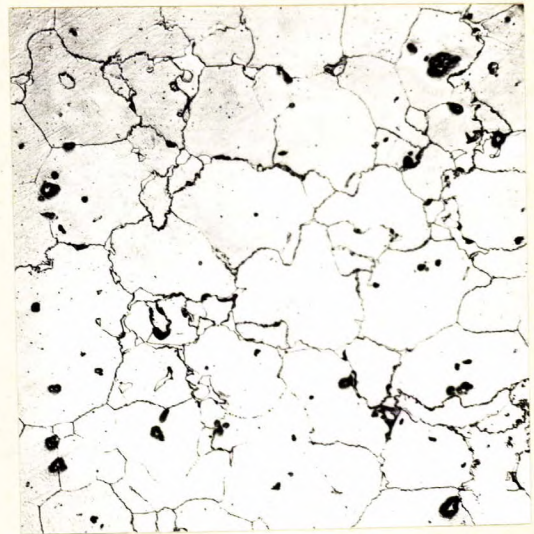
Figure 11.

X100.

INTERIOR OF THE
MAGNESIUM BASE PLATE.

Note the absence of large
cavities similar to those
which appear in Figure 10.

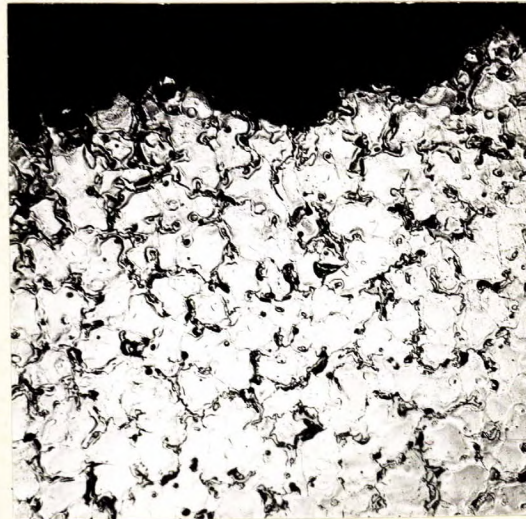
Figure 12.

X100.

CORRODED SURFACE OF ONE OF THE MAGNESIUM
CASTINGS IN THE BIPOD, AND THE METAL
IMMEDIATELY UNDERNEATH.

Note the absence of cavities similar to those
which appear in Figure 10.
