ORE DRESSING AND METALLURGICAL LABORATORIES.

Investigation No. 1785.

Metallurgical Examination of a Broken
High Speed Steel Mill Cutter.

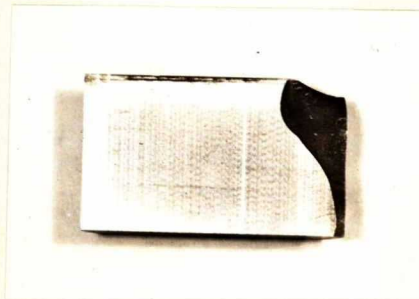
Figure 1.

On January 6, 1944, one broken High Speed Steel mill cutter (see Figure 1) was received for metallurgical examination from Alexander Fleck Limited, Ottawa. This tool, which had failed in service, was one of a batch of eighteen cutters which had been heat-treated in these Laboratories. The remaining seventeen were reported to be satisfactory.

BROKEN HIGH SPEED MILL CUTTER
AS RECEIVED.

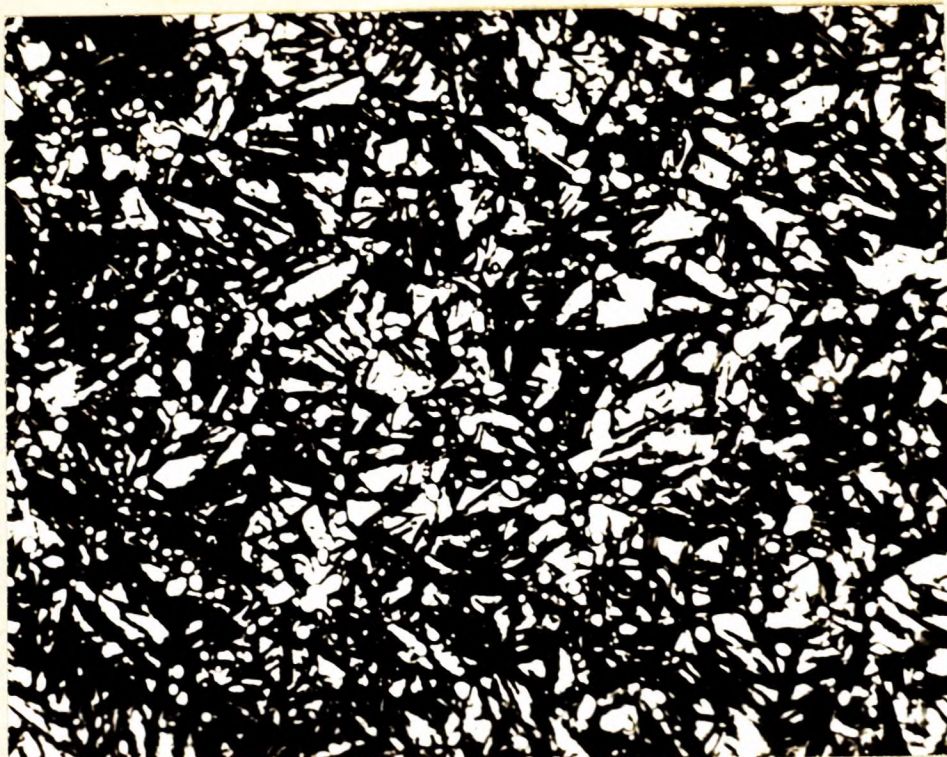
Figure 2.

MICROSTRUCTURE OF STEEL "AS RECEIVED".

Note large quantities of untempered martensite (white).

Microscopic examination of the steel, as received, revealed considerable areas of white, untempered martensite and retained austenite (Figure 2). Such a structure can result from an arrested quench by either of two methods:

1. Failure of the mill cutter was due to improper heat treatment.

2. The steel must have been given an arrested quench, i.e., it was transferred to the tempering or drawing furnace while still hot.

3. Only one draw was given the steel following the arrested quench. This was insufficient to completely transform all of the retained austenite to tempered martensite.

1. It is recommended that high speed tool steels which have been heat-treated in a similar manner, that is, quenching to a temperature above room temperature, followed by a single draw, should be given at least one more draw at 1050° F. for 2½ hours, in order that optimum mechanical properties be obtained.

2. High speed tools of simple design should be quenched down to room temperature, followed by two separate draws.

3. High speed tools of intricate design should be quenched at some temperature above room temperature, and must be followed by two or more separate draws.

4. Cooling after drawing may be done in air.

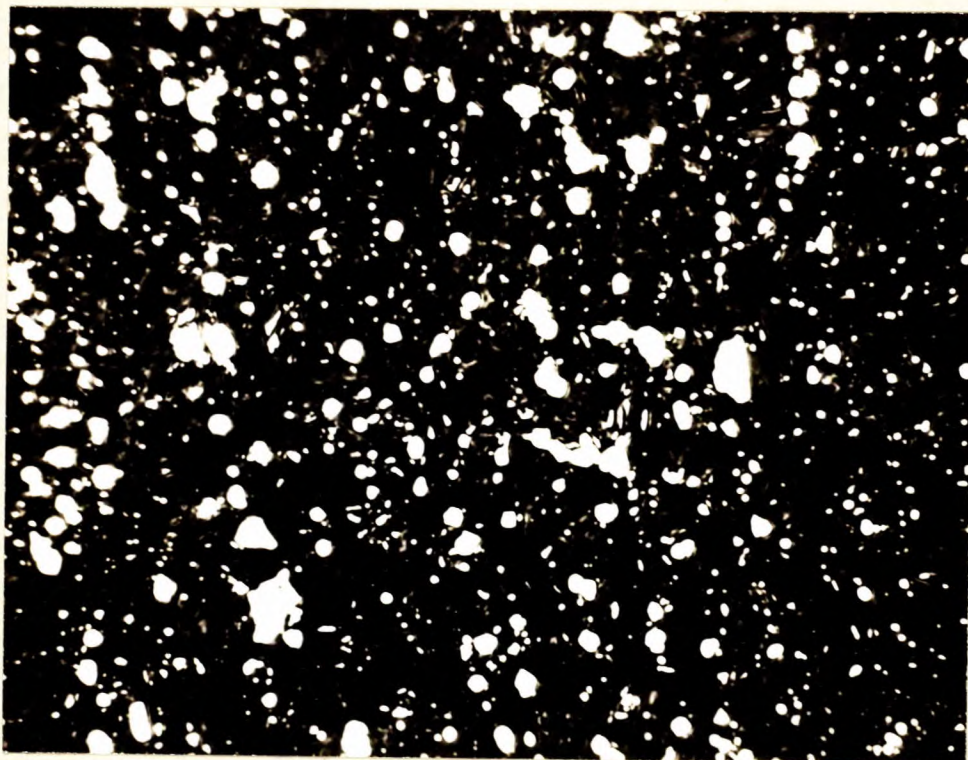
MICROSTRUCTURE OF STEEL AFTER TEMPERING
AT 1050° F. FOR 2½ HOURS.

Note carbides in a dark mass of tempered martensite.

When a high speed steel is given an arrested quench a considerable quantity of retained austenite results. Most of this austenite transforms to white-etching, untempered martensite in the first drawing operation, which takes place at 1050° F. A second draw would then be necessary to convert the white-etching untempered martensite to the dark-etching tempered martensite shown in Figure 3.

2½ hours, and cooled in the furnace. (The steel does not have to be cooled in the furnace after drawing, but may be cooled in air with equally good results). Microscopic examination revealed that the white, untempered martensite had been transformed into dark-etching, tempered martensite as shown in Figure 3. This is the normal structure of a properly hardened and heat-treated high speed steel.

The change in the micro constituents resulting from the second draw was also manifested by an increase in the hardness, from 810 to 862 Vickers (64 to 66 Rockwell 'C'). This increased hardness, which results from the transformation of retained austenite to martensite, proves that there must have been present some retained austenite even after the first draw. It also indicates that the increase of hardness resulting from the transformation of retained austenite to untempered martensite was greater than the decrease of hardness resulting from the tempering of the martensite already formed.

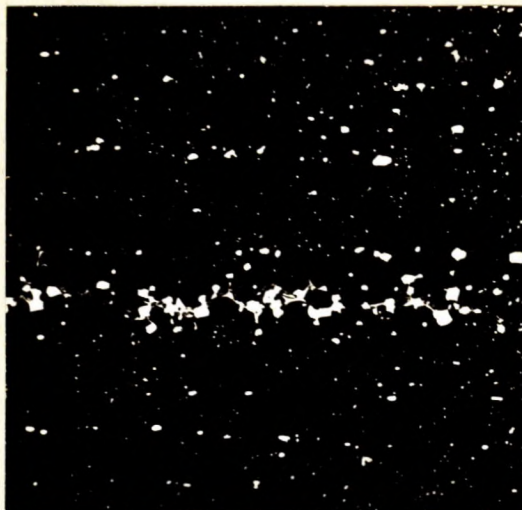
Figure 4.

SHOWING BANDING.

The photomicrograph shown in Figure 4 indicates that there is considerable segregation or banding in the steel. This banding may or may not have deleterious effects upon the mechanical properties of the steel.
