ORE DRESSING AND METALLURGICAL LABORATORIES.

Investigation No. 1787.

Examination of Broken Tail Units of
4.2-inch Trench Mortar Bombs.

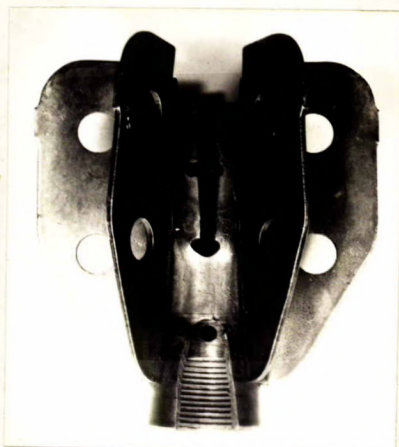
Figure 1.
(Approximately $\frac{1}{2}$ actual size).

The unit was stated to have been made to Specification IC466. The cartridge container requires a seamless steel tube. Figures 1, 2 and 3 are photographs showing the condition of the three broken tail units. It was noted that rough-machining tool marks were present on the inner surface of some of the tubes. These can be observed in Figure 2.

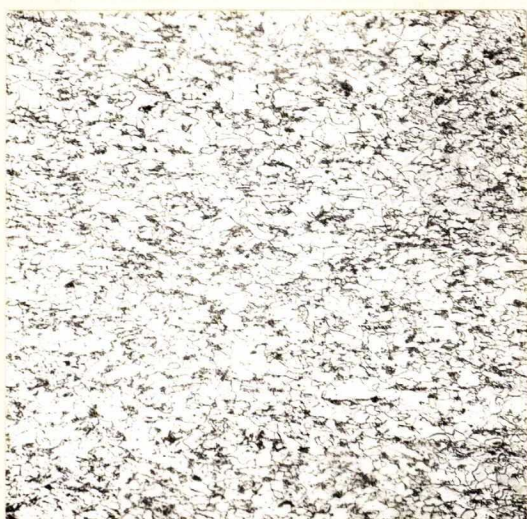
Figure 4.

The structure of the failed tubing is shown in Figures 4 and 5. The steel tube is fine-grained, with the iron carbides in the spheroidized condition.

TYPICAL STRUCTURE OF
FAILED TUBING.

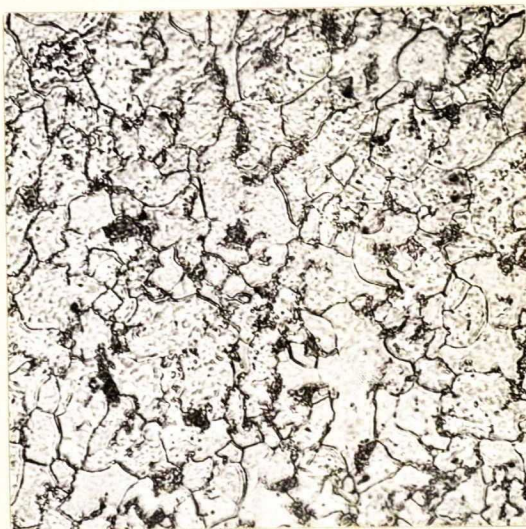
Figure 5.

STRUCTURE OF FAILED
TUBING.

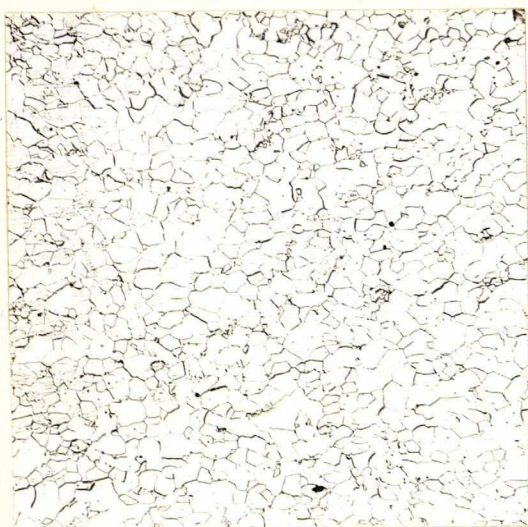
Figure 6.

The structure of the fin is typical of low-carbon

STRUCTURE OF FIN.

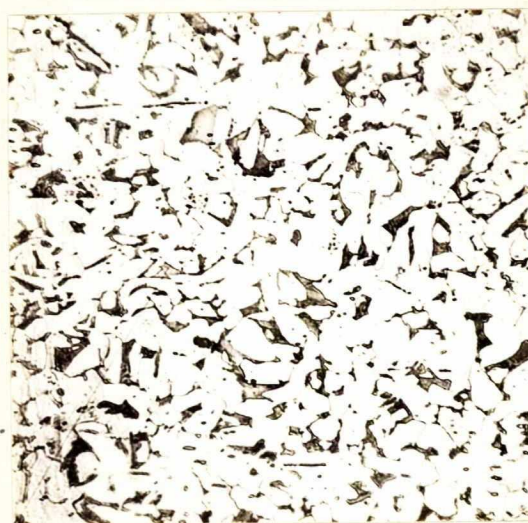
Figure 7.

normalized steel. Figure 7 shows the structure of the steel after normalizing. The structure consists of a dark etching pearlite, the iron-iron carbide constituent, and light etching ferrite, the iron constituent.

STRUCTURE OF TUBE AFTER
NORMALIZING AT 1750° F.
