R E P O R T
of the
ORE DRESSING AND METALLURGICAL LABORATORIES.

Investigation No. 1791.

Examination of Welded Disc Wheel Clamping Bolts.

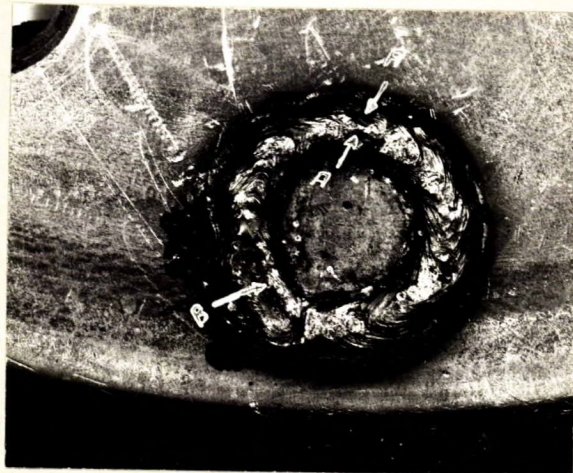
Figure 2.

A surface examination of the welds revealed considerable undercutting and unfilled craters. Figure 3 shows a ring of blue oxide extending 7/16 inch around the bolt, indicating that a temperature of approximately 600° F. had been attained in this area. These factors indicate the use of high welding currents and high welding speeds with consequent uncertainty of control.

PHOTOGRAPH OF WELD JOINING
BOLT HEAD TO DISC.

Note unfilled crater (B) and undercutting (A).

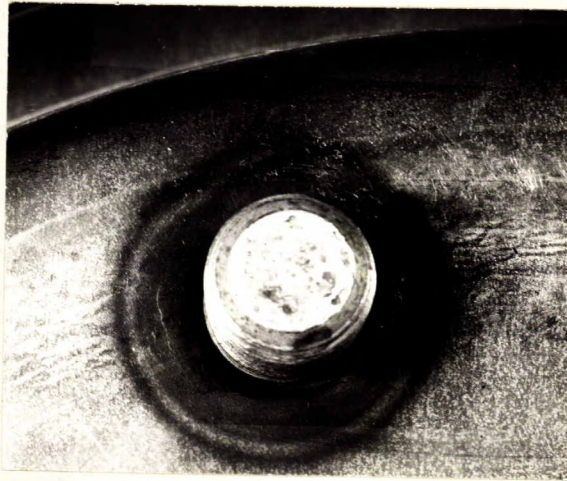
Figure 3.

BOLT PROPER EXTENDING THROUGH DISC.
Note the ring of blue oxide on disc material.
(Approximately 7/16 inch wide).

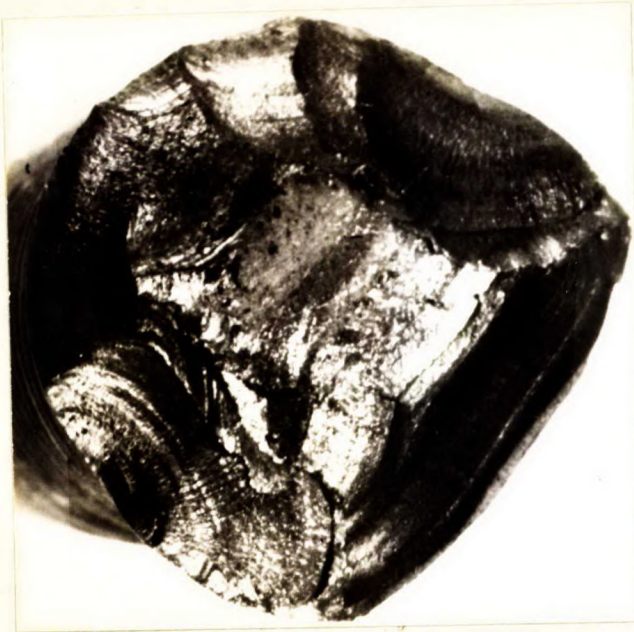
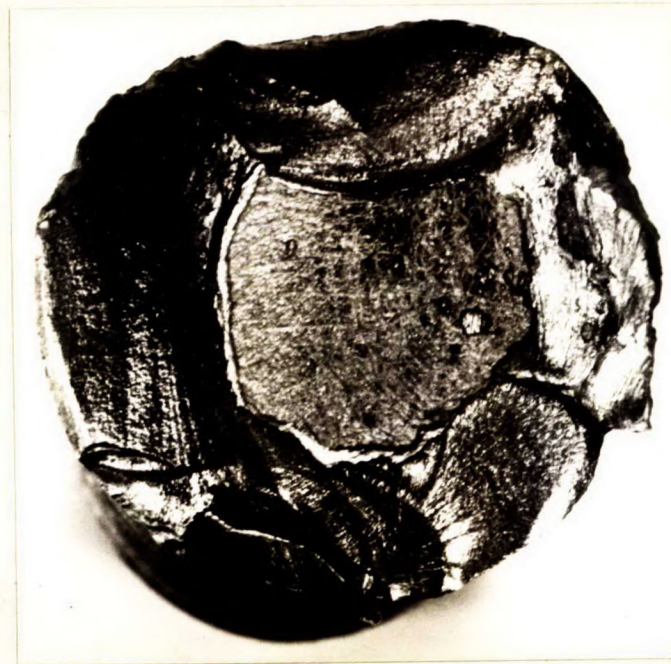
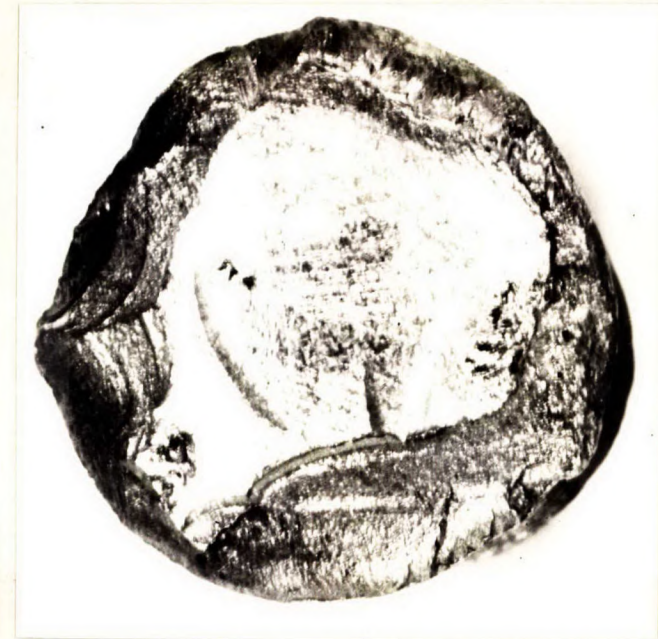
Figure 4.

An examination of the fractured areas of the broken bolts reveal that in every case the fractures are characteristic of the fatigue type of failure. This evidence points to the necessity of assessing present service life against the desirability of design changes.

It should be emphasized that the cracks at the roots of the welds are probably responsible, under the action of alternating stresses, for the failure of the bolt. An examination of the broken bolts indicates that failure began at the roots of the welds. The cracks, which are well-nigh impossible to avoid in this type of joint design, act as severe stress raisers and as such can lead to failure in a very short time. In this application the service conditions of alternating stresses, together with cracks formed in fabrication, are such as to drastically lower fatigue strength.

PHOTOGRAPHS OF BROKEN BOLT HEADS AS RECEIVED.

Note the "oyster shell" type of fracture typical of fatigue failures.

Single-V types of welds in which the root cannot be fused should not be used where fatigue may be an important factor. In this case this is the type of joint used. Ordinarily a change of joint design would be recommended without hesitation, to ensure a completely fused root. In this case, however, it is felt that if the average service life is satisfactory a design change should be avoided. On the other hand, unsatisfactory service life could probably be rectified by a change of joint design which would make possible a completely fused root.

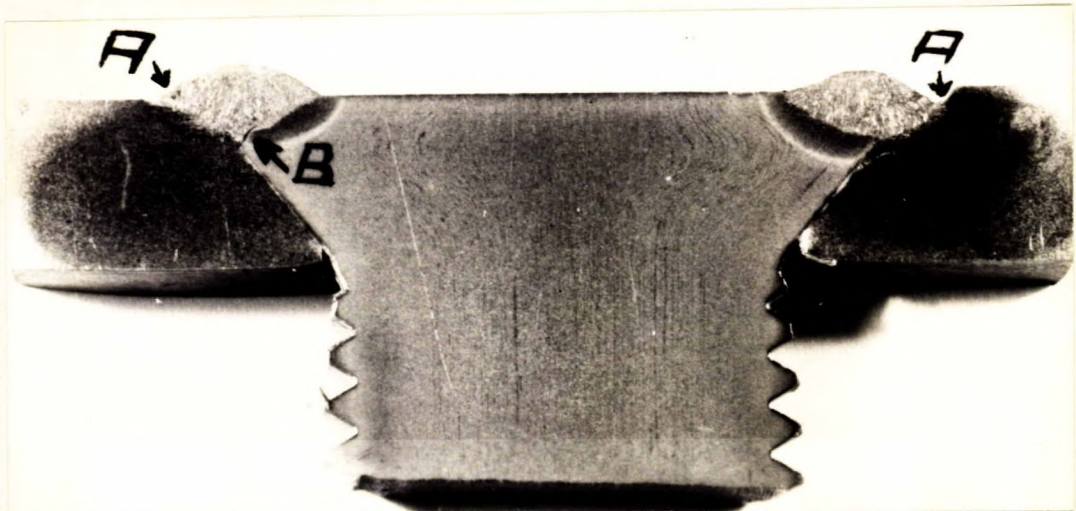
Figure 5.

of the weld confirm the presence of undercutting and unfilled craters. It also disclosed cracks originating at the centres of unfilled craters and others originating at the unfused roots of the weld. The heat-affected zone structure and that of the normal bolt material are quite normal. This normality is reflected in the hardness readings obtained.

MACRO SECTION OF WELD AND BOLT HEAD.

Note undercutting (A) at right side and root crack (B) at left side.

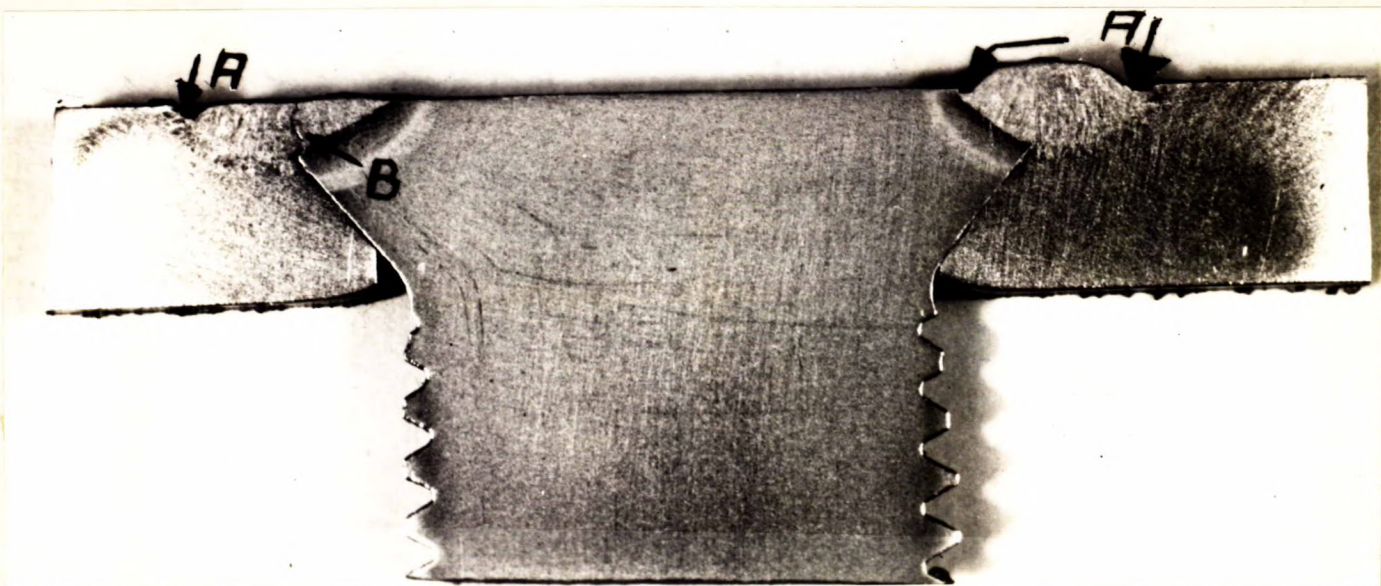
Figure 6.

MACRO SECTION OF WELD AND BOLT HEAD.

Note undercutting (A) at both sides and crater crack (B) at right side.

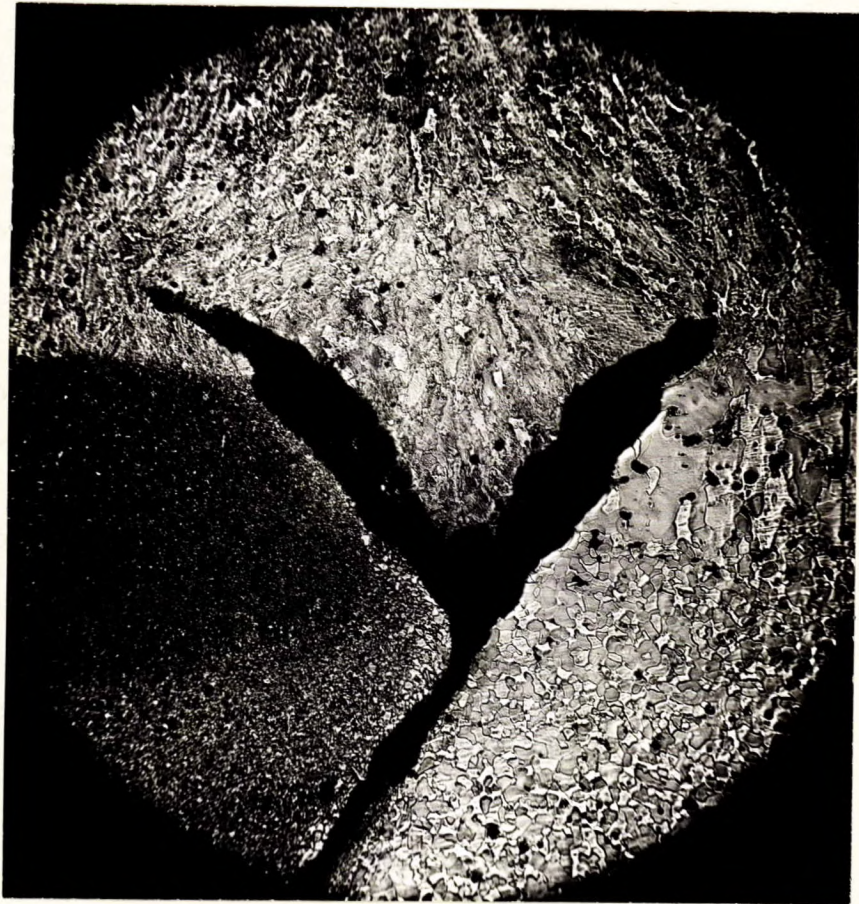
Figure 7.

UNFUSED AREAS AT ROOT OF WELD.

Bolt material, lower left; disc material,
lower right; and weld at top.

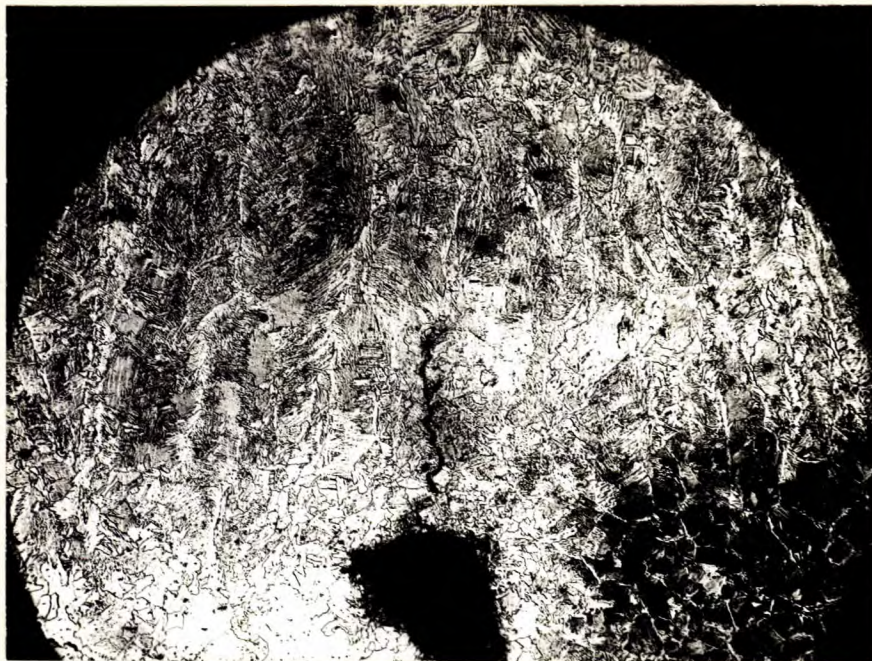
Figure 8.

X100, etched in 2 per cent nital.
CRACK EXTENDING INTO WELD AND ORIGINATING
AT THE UNFUSED ROOT AREA.

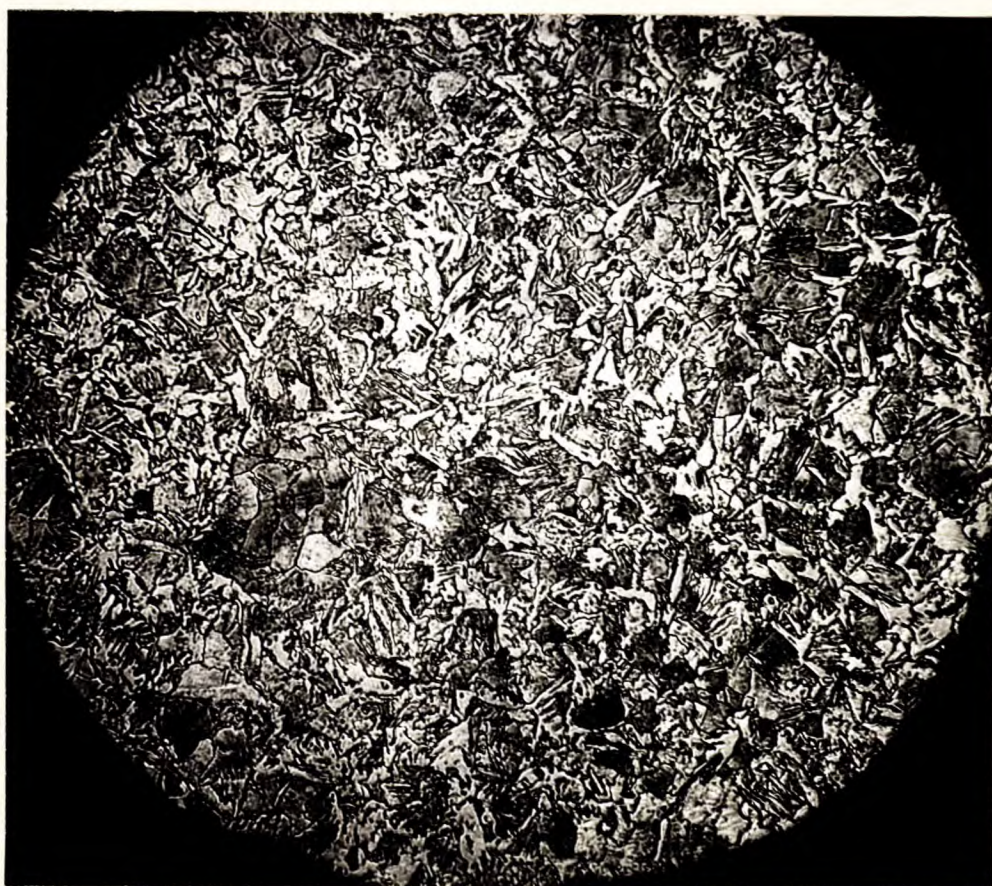
Figure 9.

X500, etched in 2 per cent nital.
NORMAL STRUCTURE OF BOLT MATERIAL.
Low-carbon martensite in a matrix of ferrite.

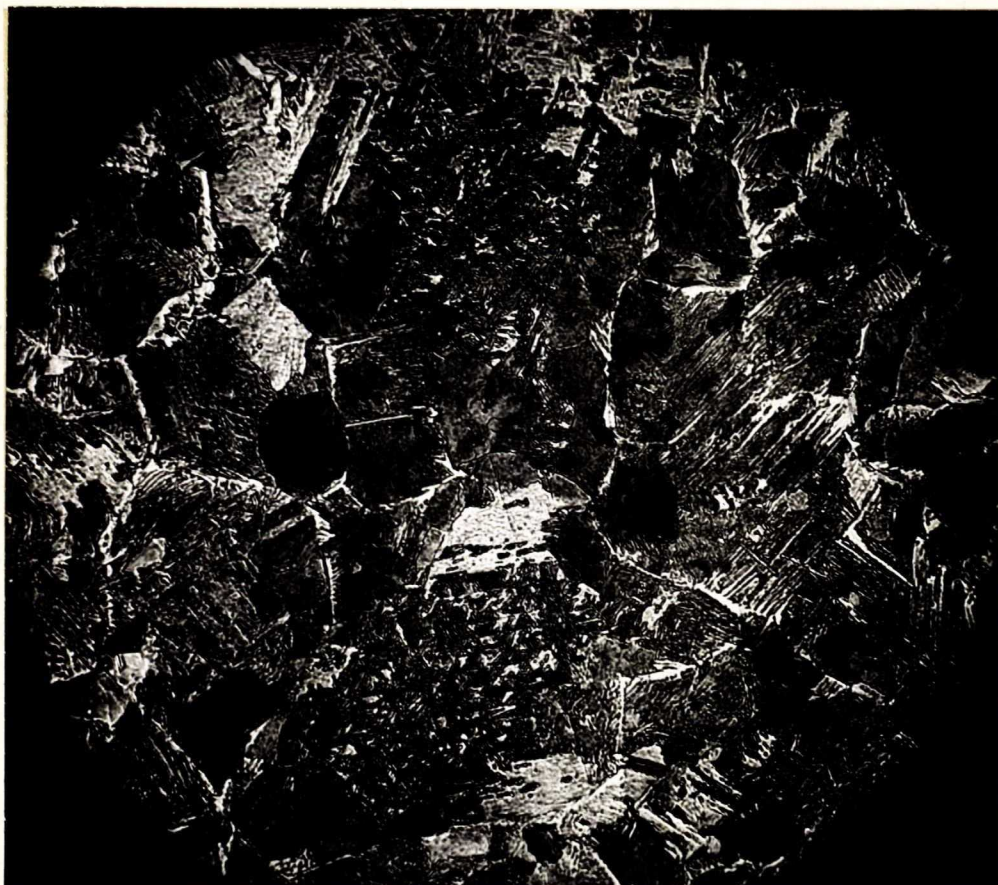
Figure 10.

STRUCTURE TYPICAL OF HEAT-AFFECTED ZONES OF WELDS.

Mainly low-carbon martensite with some fine pearlite, plus a small amount of ferrite in grain boundaries.
