March 1, 1945.

ORE DRESSING AND METALLURGICAL LABORATORIES.

Investigation No. 1802.

Examination of Rivetted C.D.P. Track Pins and Washers.

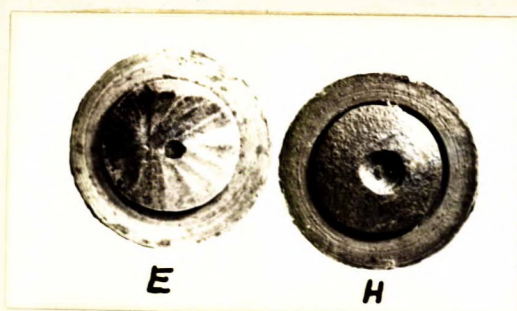
Figure 1.

Figure 1 illustrates the rivetted surface of the pins representative of both firms. The Electric Steels operation evidently flattens the pin tip much more than the Hull process. Figures 2 and 3 show this more clearly on the cut section of the peened tips. The letters H and E in the pictures stand for Hull Iron and Steel Foundries and Electric Steels respectively.

RIVETTED TIPS OF BOTH TYPES OF PINS.

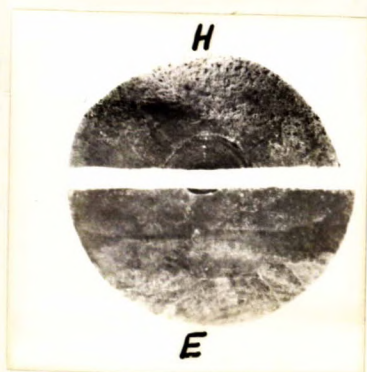
Figure 2.

Note slightly larger diameter of Electric Steels tip.

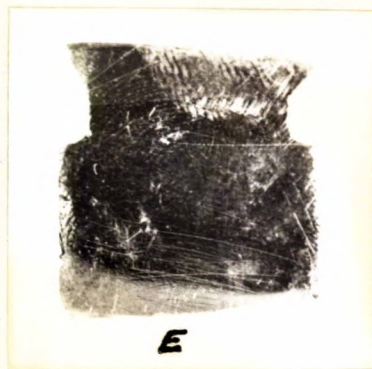
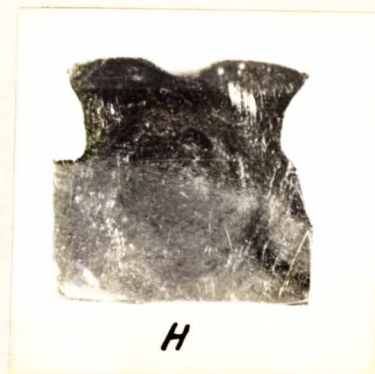
Figure 3.

Note flatness of Electric Steels tip.

1. The pin tip is flattened more severely by the Electric Steels method of rivetting. This may cause cracking if the tip is hard.
