March 5, 1945.

ORE DRESSING AND METALLURGICAL LABORATORIES.

Investigation No. 1805.

Examination of Welded Tubing from  
Fuselage of Harvard Aircraft.

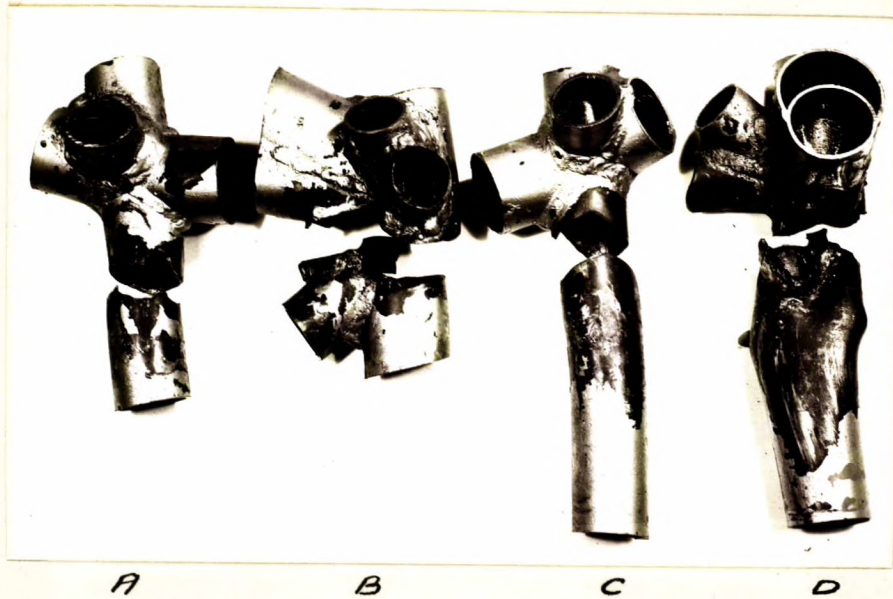
Figure 1.

On December 8, 1944, samples of tubing (see Figure 1) taken from the fuselage of a Harvard aircraft which had broken up in the air were submitted, for metallurgical examination, by the Chief of the Air Staff, Department of National Defence for Air, Ottawa, Ontario. The locations of the samples (arbitrarily called A, B, C and D) on the fuselage frame structure are shown in Figure 2.

FRACTURES IN HARVARD AIRCRAFT FUSELAGE TUBING.  
(Approximately 1/3 Normal size).

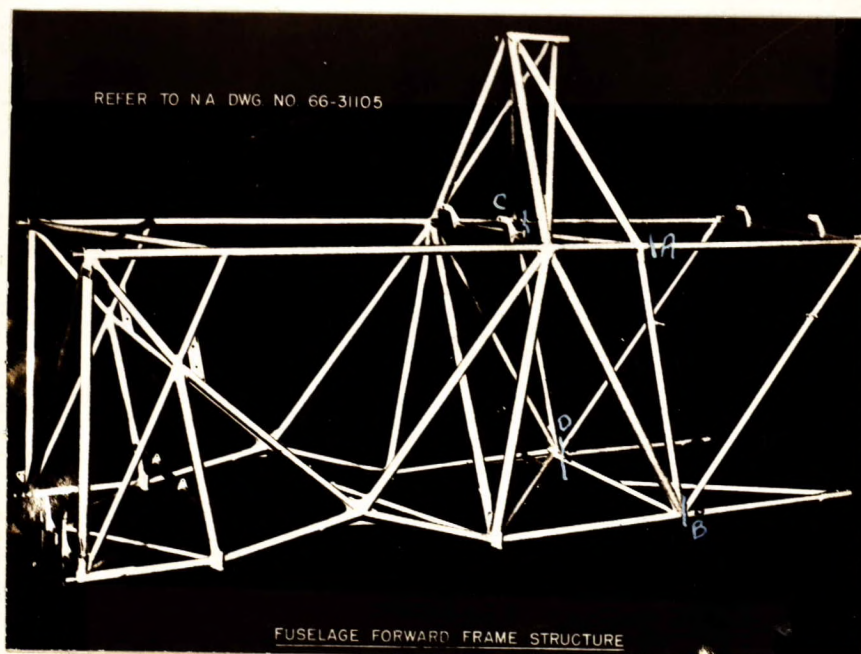
Figure 2.

POSITION OF FRACTURES IN THE FUSELAGE.

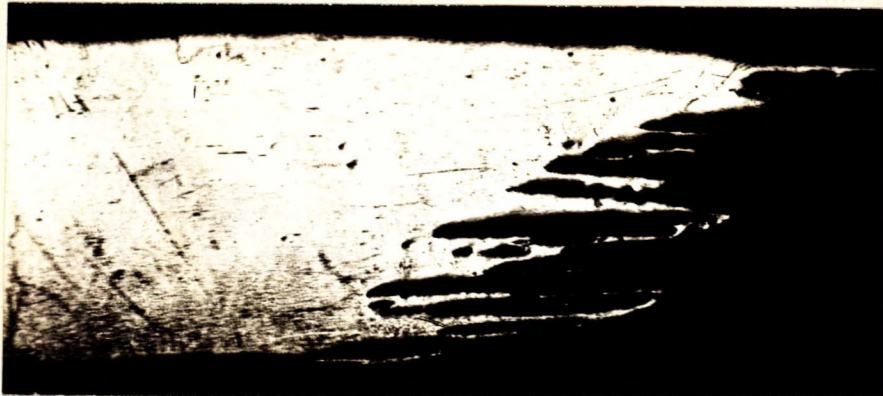
Failure at section A occurred in the tubing proper, a short distance away from a weld (see Figure 1). The nature of the fracture is shown in Figure 3.

Hardness readings obtained at the fracture of the tubing in section A, along the periphery, showed a range from 21 to 52 Rockwell "C", because of the heat effect from the welding. It is quite possible that a crack may have been initiated at a location of high hardness and failure have resulted by the tearing of the softer portion of the tubing, resulting in the jagged, ductile fracture apparent in Figure 3.

X32. Section "A".  
SHOWING DUCTILE NATURE OF  
FRACTURE IN TUBING.

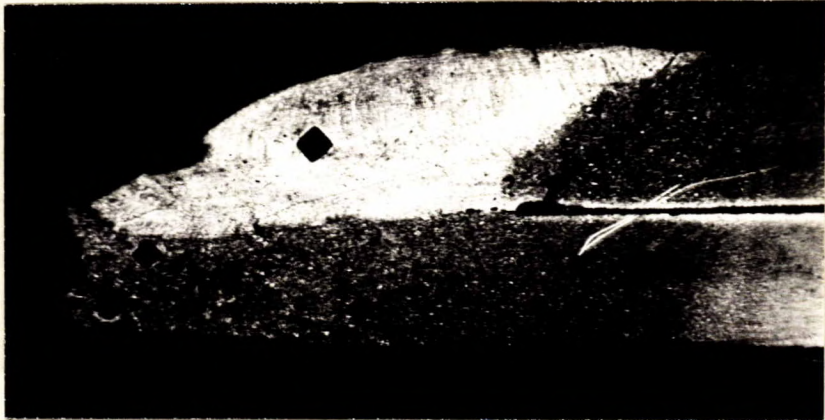
Figure 5.

Failures at sections B, C and D were located in weld areas, the fractures in B and C occurring at the toe of the weld (see Figures 4 and 5) whereas the fracture at D occurred through the weld metal (see Figure 6).

Figures 4 to 8 show typical welding defects found in all sections. The most common defect is that of unfused roots, which, in some cases, have resulted in cracks (see Figures 5 and 6) and, in others, voids (see Figures 7 and 8).

Other failures have been noted in the toes of the weld (Figures 4 and 5) and are presumably due to high hardness in the heat-affected zone, already discussed.

X11 $\frac{1}{2}$ . Section "C".

FRACTURE AT TOE OF WELD.

Note crack originating at toe of weld.

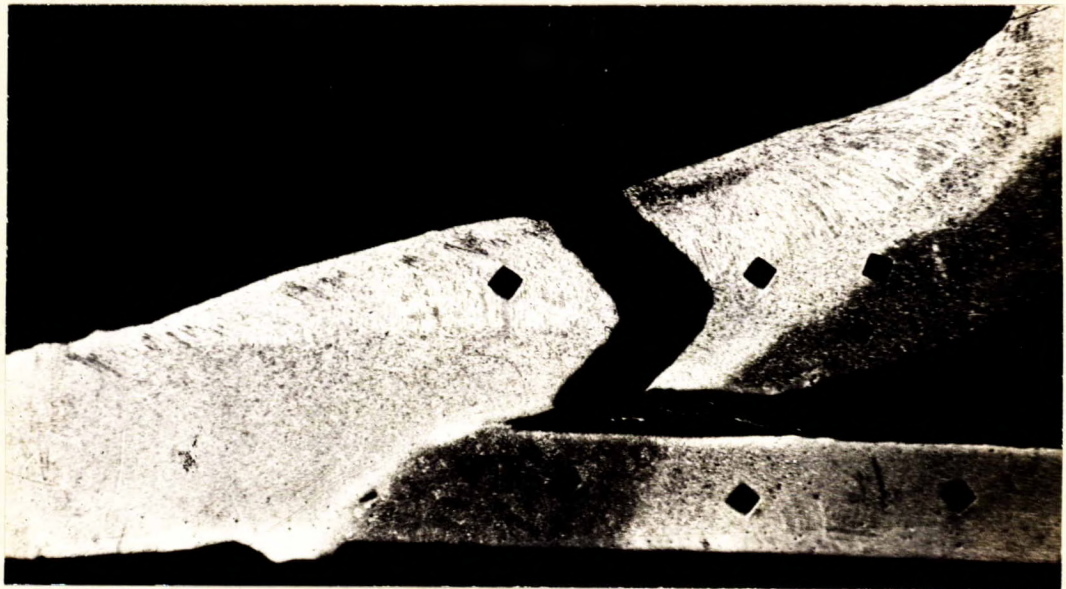
Figure 6.

It is also noted that in some cases the welds are improperly placed, that is, although sufficient weld metal has been applied this metal has not been placed in areas of maximum efficiency (see Figures 4 and 6).

X11 $\frac{1}{2}$ . Section "D".

FRACTURE THROUGH THROAT OF WELD.

Probably started at unfused root.

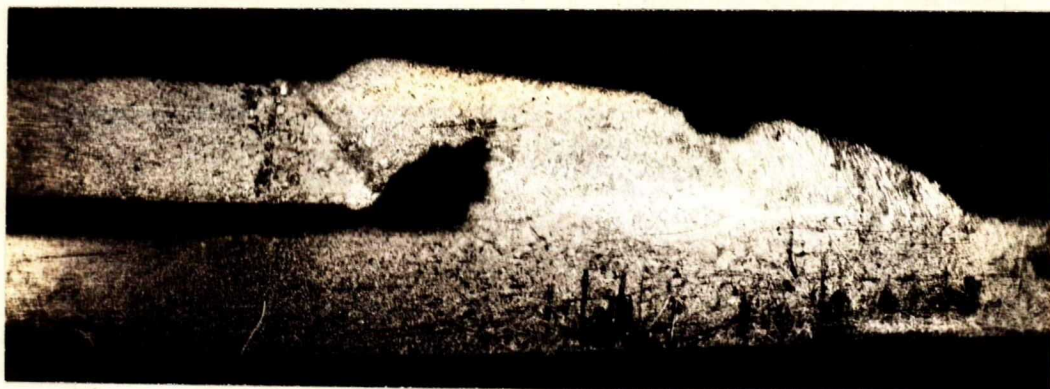
Figure 7.

X11 $\frac{1}{2}$ . Section "A".

Note cavity in root of weld, resulting from improper direction of welding flame and subsequently covered with weld metal.

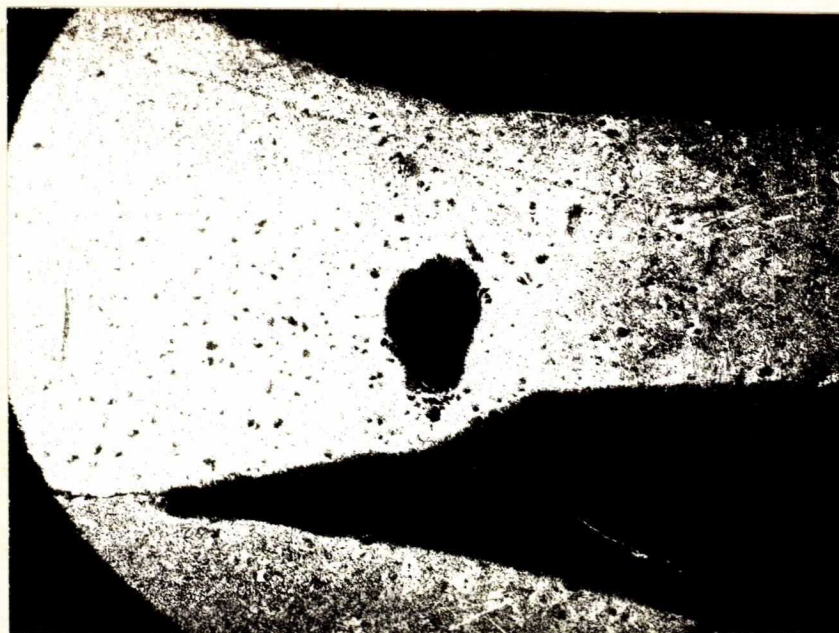
Figure 8.

X30. Section "D".

CAVITY IN TOE AREA OF WELD.

Due to improper flame manipulation.

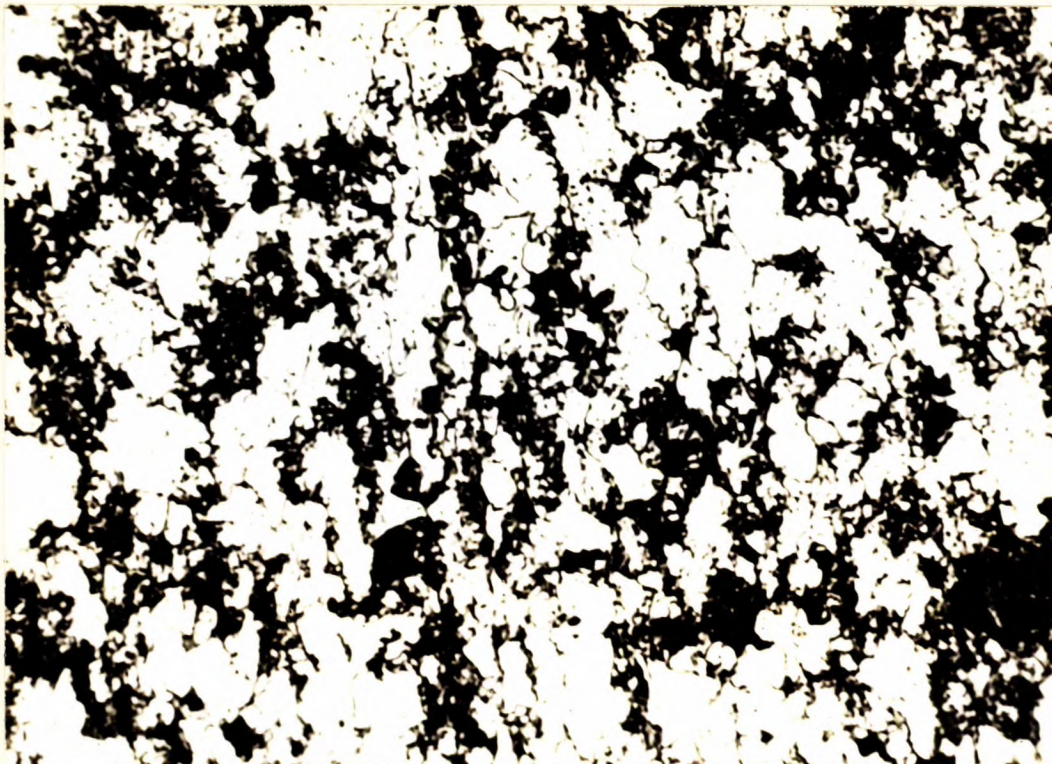
Figures 9 and 10, both at X1000 magnification, are photomicrographs of tubing taken from section A at the fracture, away from the heat effect of a weld. The microstructure consists of ferrite, pearlite, and undissolved carbides. The structure shown in Figure 10 appears to be more greatly spheroidized than that of Figure 9.

X1000, nital etch.  
SECTION "A" AT FRACTURE.  
Ferrite, pearlite, and carbides.

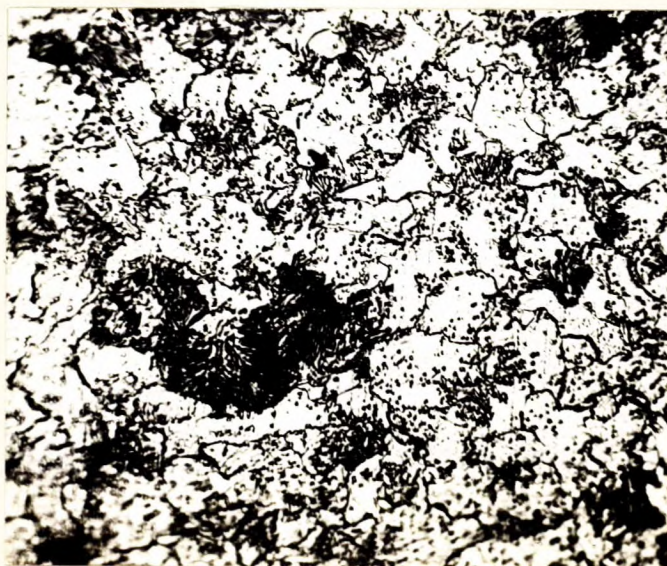
Figure 10.

The spheroidized structure of the tubing (see Figures 10, 11 and 12) as delivered to the welder, indicates that the steel in this condition has a minimum of tensile strength and maximum ductility. If sufficient tubing had been provided to perform tensile tests, it would have been possible to determine the strength of the tubing as supplied to the welder. In the absence of the required length of tubing, it is not possible to state any accurate figure for the tubing in this condition. Rough approximations can be made, however, on the basis of hardness tests.

Microscopic examination, as well as hardness tests taken along the fracture in section A, shows that the microstructure varies from that of spheroidized carbides (see Figure 10) to martensite, and the hardness from 21 Rockwell "C" to 52 Rockwell "C" (see Table II). This unusually great range

X1000, nital etch.  
SECTION "A" AT BREAK.  
Ferrite, pearlite, and carbides.

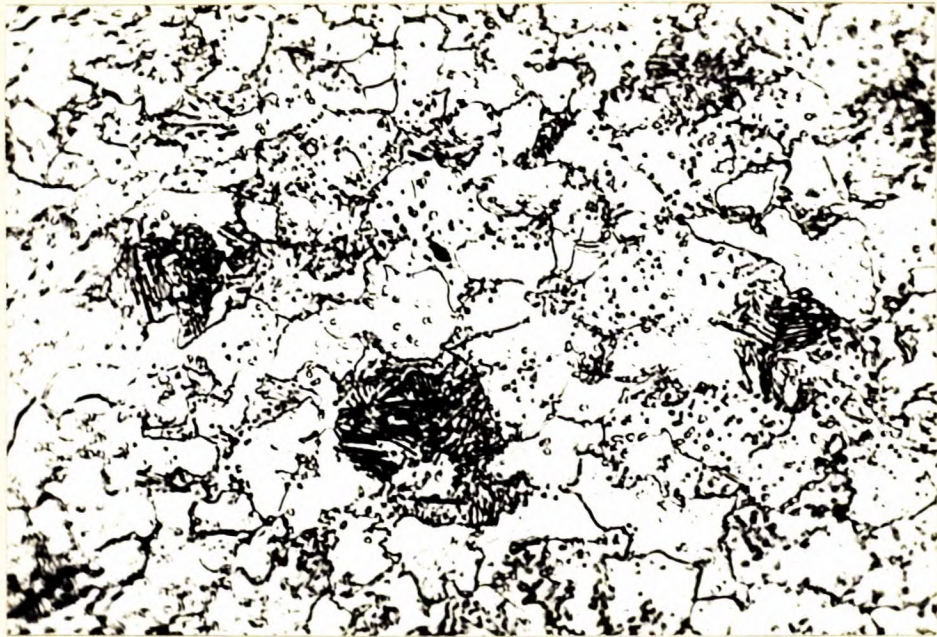
Figure 11.

Figures 11 and 12, both at X1500 magnification, are photomicrographs of tubing taken from section C, at areas away from the weld. The microstructure of Figure 11 consists of lamellar pearlite, spheroidized carbides, and ferrite, whereas the microstructure of Figure 12 consists of spheroidized carbides and ferrite. This latter structure may be considered typical of this tubing as delivered to the welder. It should be noted that the tubing of section A, containing the fracture, had the same structure away from the weld as that of C.

X1500, nital etch.

Section "C".

STRUCTURE OF TUBING "AS RECEIVED".

Spheroidized carbides, lamellar partially  
spheroidized pearlite, and ferrite.

2. The tubing should have been supplied to the welder in a condition slightly harder than that called for in the specification, in order that the spheroidized condition might be avoided.

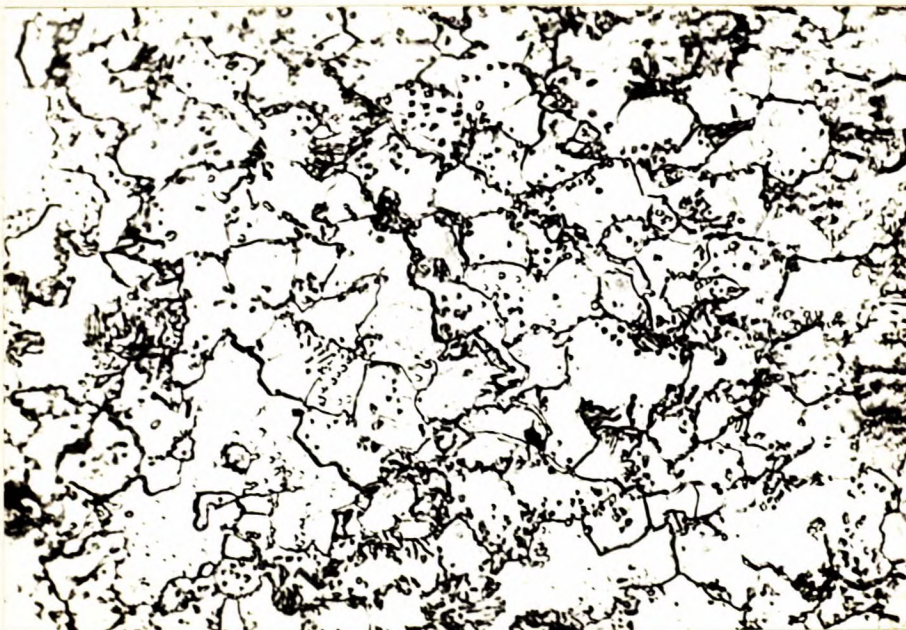
Figure 12.

X1500, nital etch.

Section "C".

TUBING "AS RECEIVED".

Spheroidized carbides in a  
groundmass of ferrite.

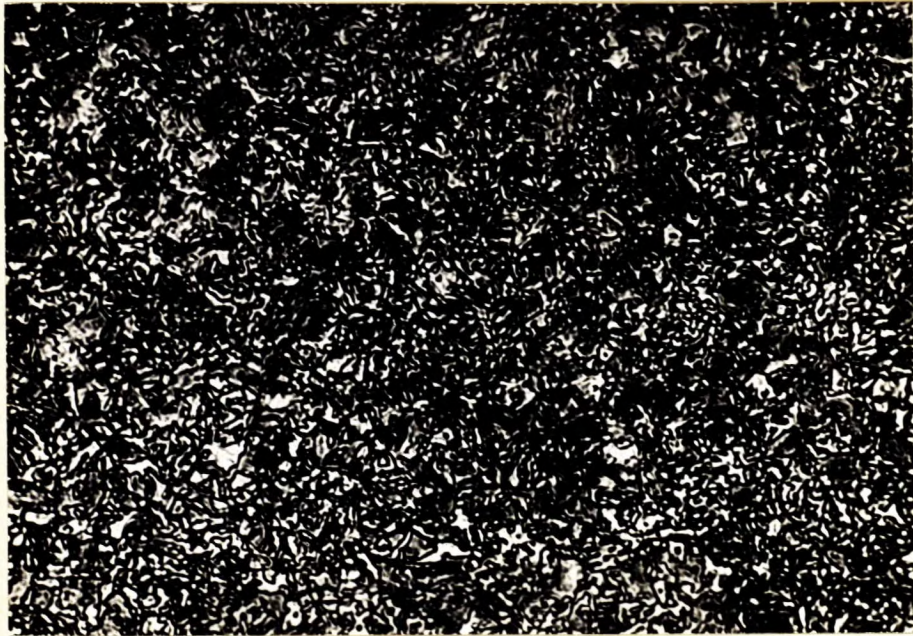
Figure 13.

Figure 13 shows the microstructure, at X1000 magnification, obtained by normalizing a piece of tubing A from 1650° F. The structure consists of a low-temperature transformation product, proeutectoid ferrite, and carbides. This photomicrograph should be compared with Figure 14, which shows the structure obtained by gas-quenching (rapid normalizing) SAE X4130 tubing of 0.35 per cent carbon content. (Transactions A.S.M. Vol. 33, 1944, p. 312).

X1000, nital etch.

SECTION "A", NORMALIZED FROM 1650° F.

Low-temperature transformation product, proeutectoid ferrite, and undissolved carbides.

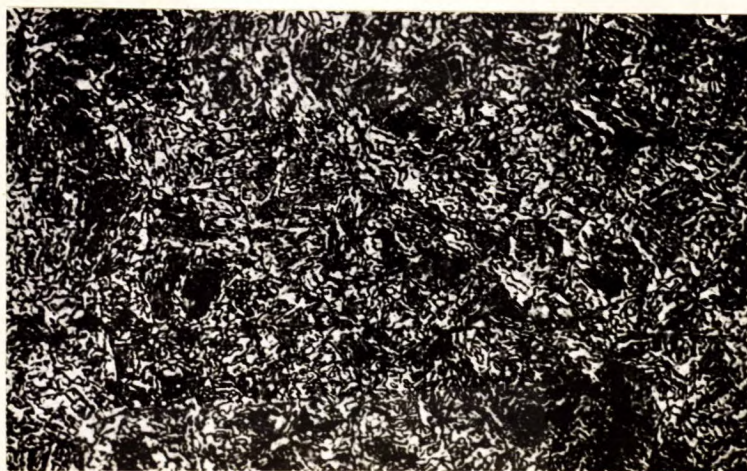
Figure 14.

X500.

GAS-QUENCHED SAE X4130 STEEL TUBE OF  
0.35 PER CENT CARBON CONTENT.

(Trans. A.S.M., 1944, Vol. 33, Page 312).

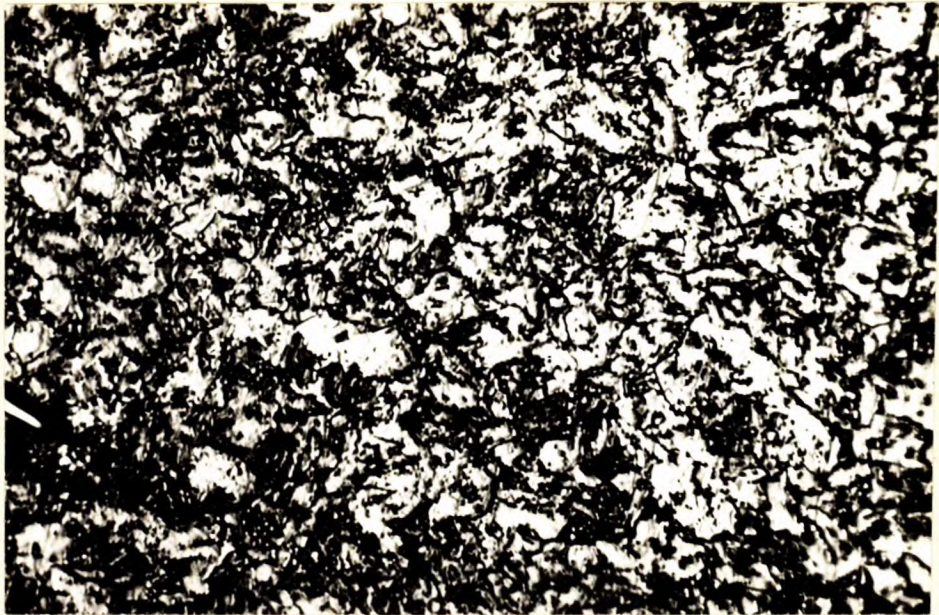
Figure 15.

Figure 15 is a photomicrograph, at X1500 magnification, of the structure obtained by normalizing a sample of tubing from 1650° F., followed by drawing at 1250° F. in a lead bath for 2½ hours. This structure, which consists of spheroidized carbides in a ground mass of ferrite, should be compared with the photomicrographs in Figures 11 and 12.

The microstructure of a sample which had been quenched and drawn, shown in Figure 15, consists of spheroidized carbides in a background of ferrite and is, to some extent, similar to the structure of the tubing "as received". The hardness was found to range from 17 to 20 Rockwell "C", which is slightly below that recorded for the "as received" tubing. It is likely, therefore, that the tubing may have been drawn at 1250° F. for a shorter period of time, or for the same length of time at 1200° F.

X1500, nital etch.

NORMALIZED FROM 1650° F. AND DRAWN AT  
1250° F. FOR 2½ HOURS.

Ferrite and spheroidized carbides.

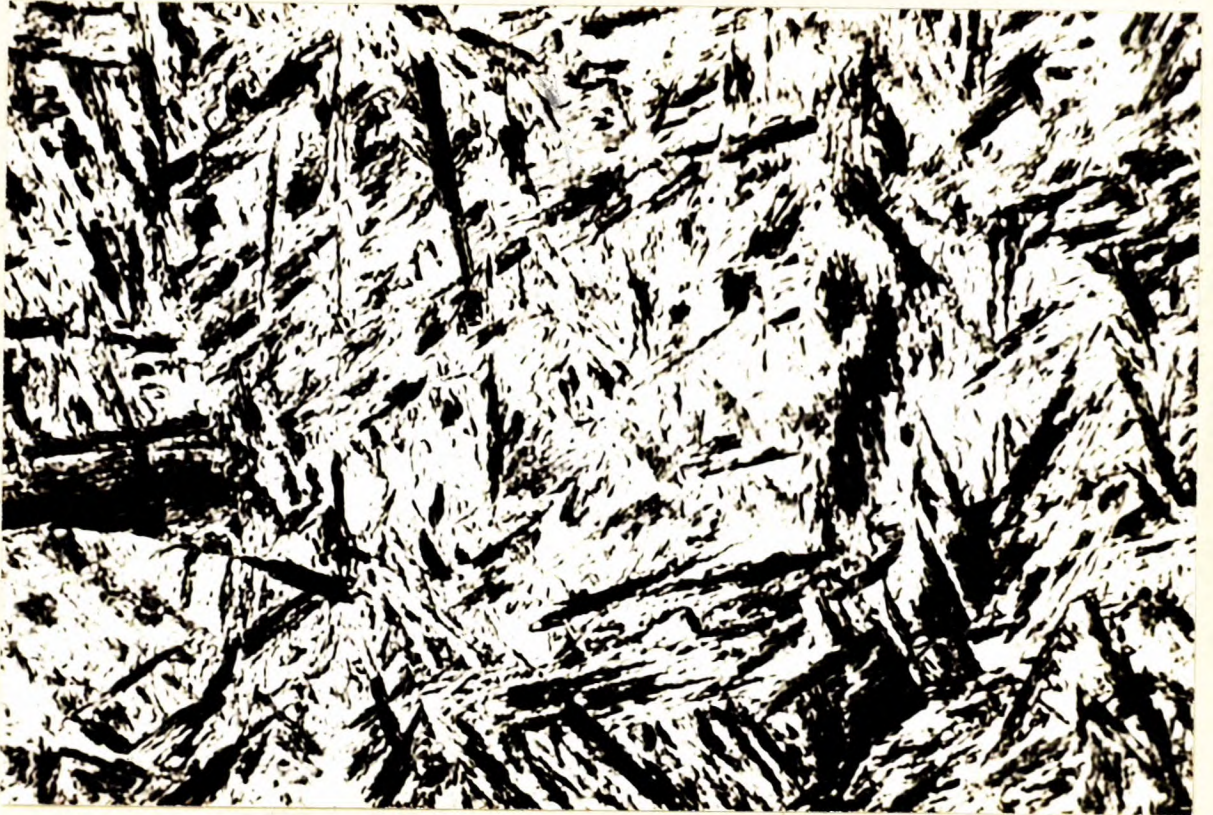
Figure 16.

Figure 16, taken at X1000 magnification, shows the microstructure in the tubing of section A at an area which was affected by the heat of welding. The structure is martensitic,

which accounts for the unusually high hardness readings obtained in the heat-affected zones (up to 52 Rockwell "C").

X1000, nital etch.

Section "A".

HEAT-AFFECTED ZONE, SHOWING MARTENSITE.

The deleterious effect occasioned by the high hardness resulting from welding heat could be eliminated by subjecting the welded structure to a drawing operation after welding. However, this heat treatment subsequent to welding is most likely unfeasible because of the large frame dimensions.

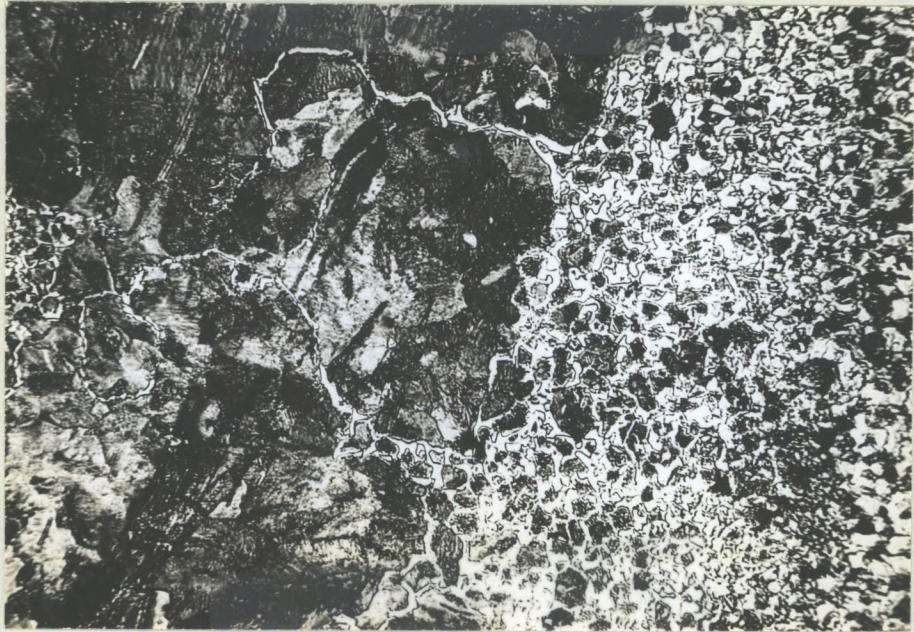
Figure 17.

The grain size was found to be mixed (see Figure 17).

The McQuaid-Ehn test (repeated in duplicate) showed a mixed grain size. (See Figure 17).

X200, nital etch.

MCQUAID-EHN TEST: MIXED GRAIN SIZE.
