ORE DRESSING AND METALLURGICAL LABORATORIES.

Investigation No. 1809.

Determination of Contraction of Parts of a Mark XXIII
Gun Sight at Sub-Zero Temperatures.

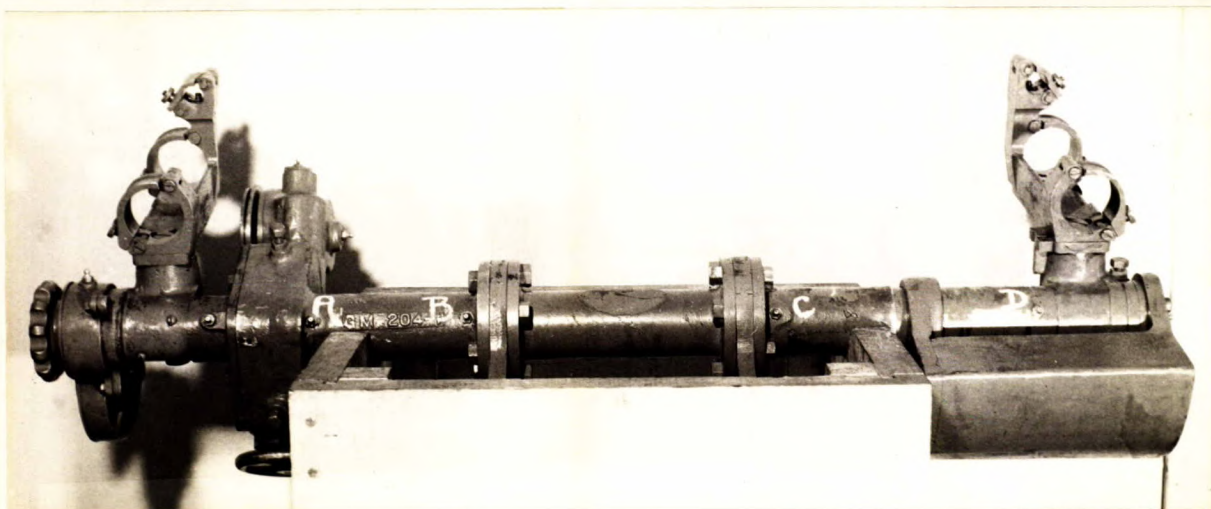
3. An inspection of the assembly was carried out in order to try to detect where the gears were binding. Several places on the bearing surfaces of the silicon-bronze casting were observed to be slightly scored and this indicated that the cause of the trouble might be due to unequal contraction of the silicon-bronze casting and the steel shaft at low temperatures.

4. Measurements were taken of the inside diameter of the bronze bearings and also the outside diameter of the steel shaft at room, -8° F., -15° F. and -20° F. temperatures, the measurements being made at points A, B, C and D shown in Figure 1.

MARK XXIII GUN SIGHT ASSEMBLY.

The results of measurements taken of the steel shaft and the silicon-bronze bearings show that the silicon bronze has a greater contraction at sub-zero temperatures than the steel shaft. From these results it is concluded that this difference in contraction is the cause of binding encountered in cold weather. This trouble could be eliminated by providing for slightly greater clearances. The same procedure could also be followed in overhauling sights already installed.
