ORE DRESSING AND METALLURGICAL LABORATORIES.

Investigation No. 1812.

Cause of Dark Streaks on Certain Types of Magnesium Alloys after Anodizing to Improve Corrosion Resistance.

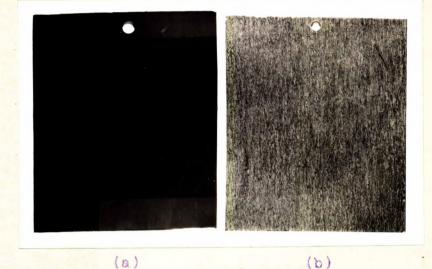
(Origin and Object of Request, contid) -Figure 1.

SAMPLIS OF #8 ALLOY SHEET ANODIZED AND SEALED.

- (a) Sheet produced by the Dow Chemical
- Company, Sheet produced by Dominion Magnesium Limited. (b)

1. The dark streaks observed on the anodized Dominion Magnesium #8 alloy sheet are due to manganese segregations, which are rather uniformly distributed throughout the sheet.

2. The dark streaks do not appear on the Dow #8 alloy sheet because the manganese is concentrated towards the centre
