O T T A W A March 19, 1945.

ORE DRESSING AND METALLURGICAL LABORATORIES.

Investigation No. 1814.

Examination of Compressed Air Cylinder.

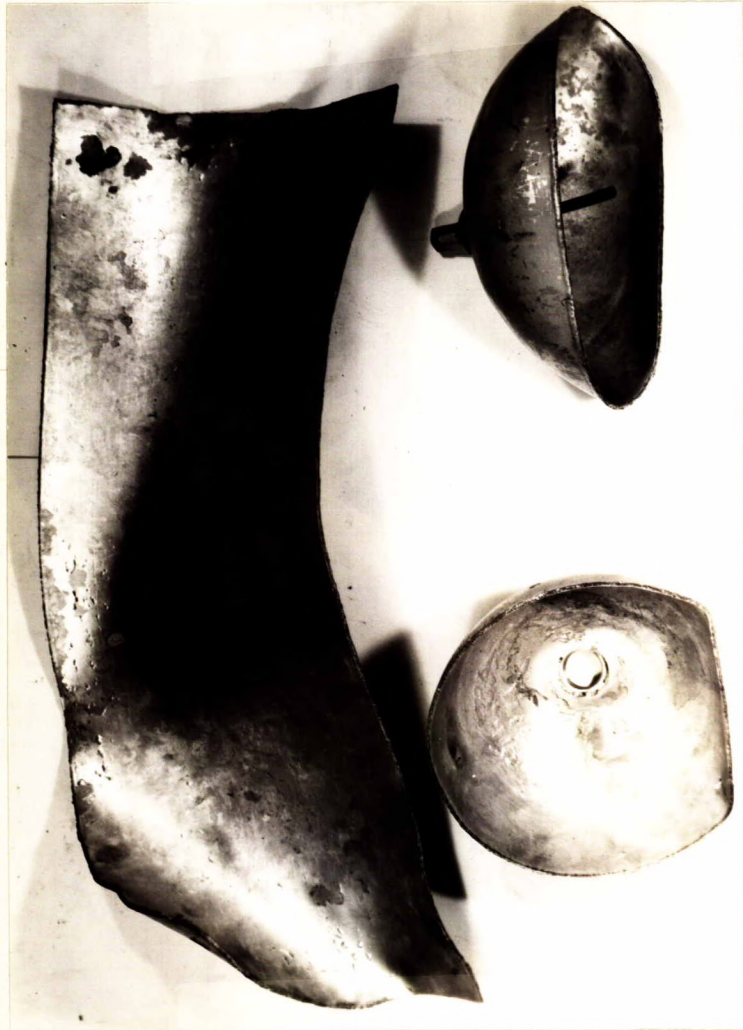
Figure 1.

MATERIAL AS RECEIVED.

Oblong plate forms the barrel of the cylinder.

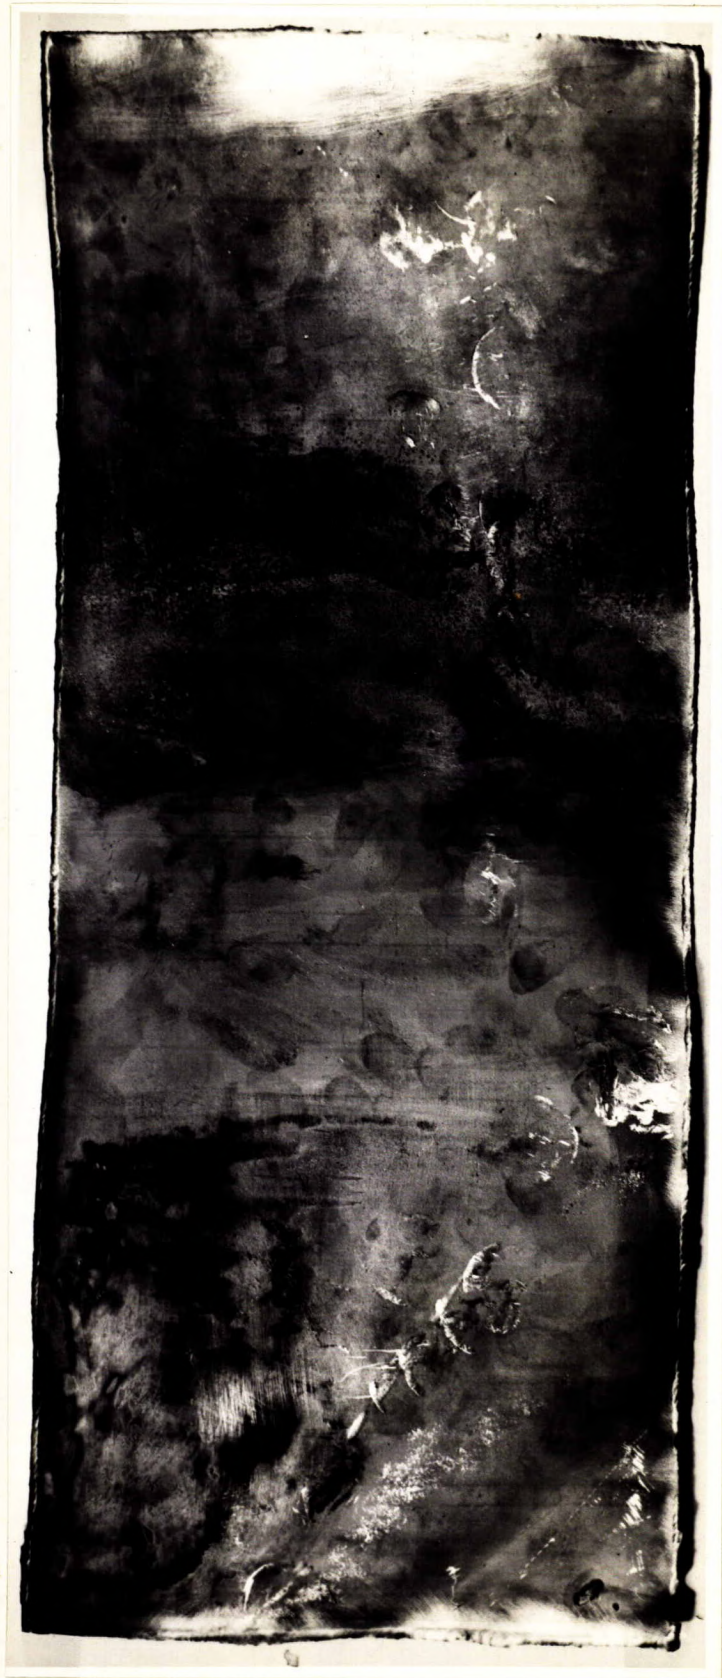
Figure 2.

A visual examination of the material as received reveals that a total of approximately 68 inches of weld failed by fracture through the centre of the weld. A 100 per cent weld failure is extremely rare and indicates weld strengths well below that ordinarily obtained in butt welds. It was also noted that failure is entirely confined to the centre of the weld and that the penetration secured was non-uniform.

SHEET FORMING BARREL OF CYLINDER, FLATTENED OUT.

Note that fracture is confined 100 per cent to the weld.

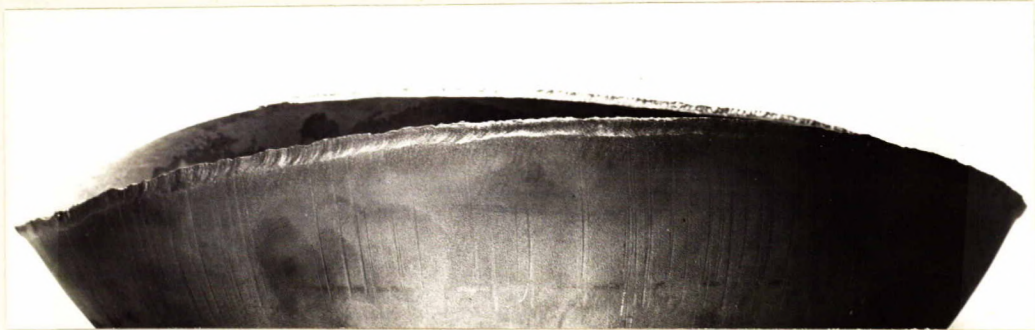
Figure 3.

CLOSE-UP OF EDGE OF DISHED END OF CYLINDER.

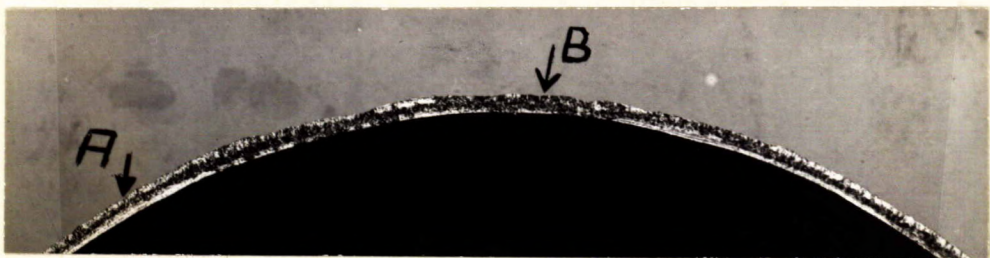
Figure 4.

(1) The material as received was subjected to a thorough visual examination. Figure 1 shows the material on arrival. Figure 2 shows the oblong sheet, flattened out, which forms the barrel of the cylinder. Note that the fracture is entirely confined to the weld. Figure 3 shows the fractured edge of one of the disc ends of the cylinder. Note that here also the fracture is through the centre of the weld. Figure 4 shows the fracture of one of the discs. This picture is typical of all fractured welds. Note the non-uniform penetration.

PHOTOGRAPH OF FRACTURED EDGE OF DISHED END OF CYLINDER.

This is typical of all fractured edges. Note incomplete penetration (A) and complete penetration (at B).

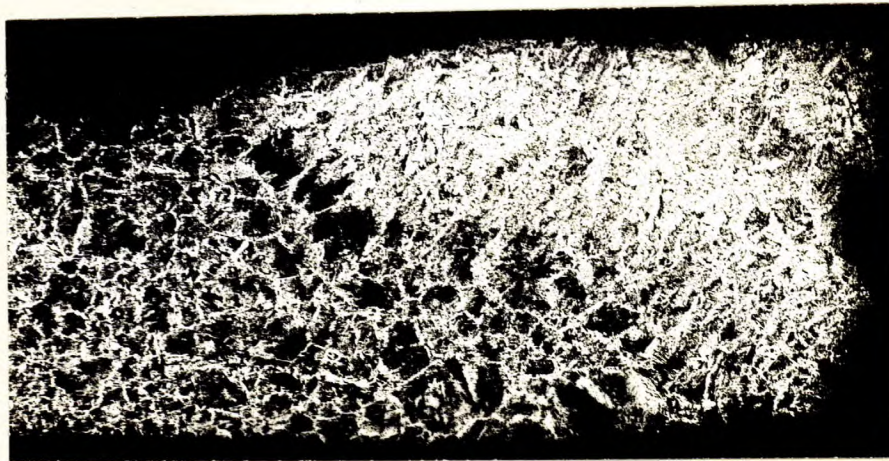
Figure 5.

(3) Samples were removed around the periphery of the welds where penetration had apparently varied and also from the centre of the large sheet. These samples were mounted, polished and subjected to microscopic examination. Figure 5 shows transverse section of a fractured weld where 100 per cent penetration

A microscopic examination of areas of complete and incomplete penetration confirms the visual examination. In some areas complete penetration to the root of the weld has been secured (see Figure 5). In other areas penetration may

TRANSVERSE SECTION OF WELD AT AREA OF COMPLETE PENETRATION.

Note that weld metal penetrated the full thickness of the sheet.

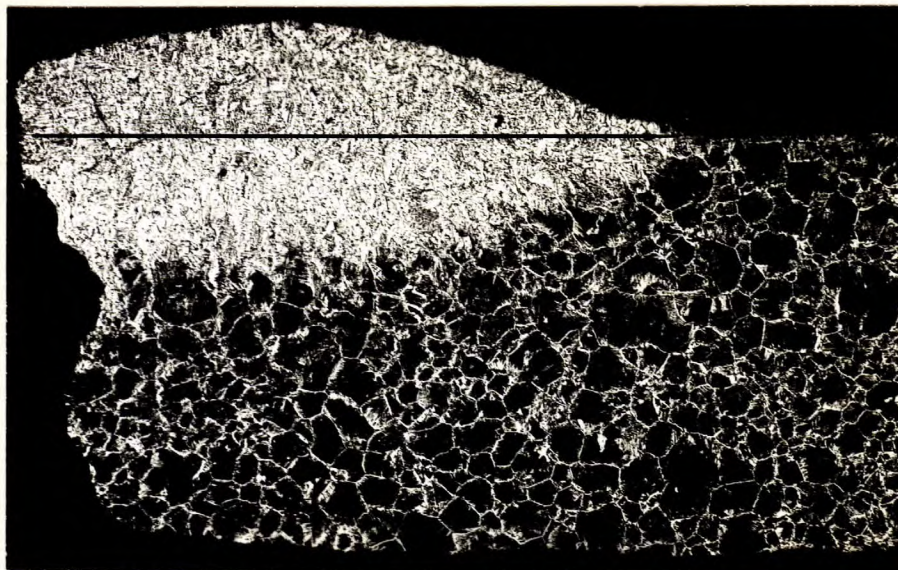
Figure 6.

has been secured. Figure 6 shows a similar section where penetration has been less than 50 per cent with a reinforcement of approximately 24 per cent of sheet thickness. These are typical of large areas of welds.

range as low as 35 per cent of the sheet thickness and this is accompanied by a reinforcement of approximately 24 per cent of the sheet thickness (see Figure 6). The microstructures of the weld indicate the use of a low carbon welding rod. The microstructure of the heat-affected zones of the welds indicates a normal response of the sheet material to the thermal cycle of welding. This normality is reflected in the hardness readings obtained. The microstructure of the sheet material remote from the welds is normal and no evidence was found of segregation of inclusions.

It is apparent that all welds are made in a single pass and without backing up. Poor or non-uniform penetration may be due to too close butting up of the edges to be welded, too high a welding speed or too low welding temperature. Ordinarily, welds of this type without back-up should be produced with 90 per cent penetration without difficulty. It is also quite noticeable that the normal reinforcing has not been allowed on these welds. By reinforcing is meant that amount of weld metal that projects above the surface of the sheet material. It cannot be over-emphasized that unfused roots of welds in an application such as this act as severe stress raisers and as such can easily cause service failures. Should the weld metal be of low strength the tearing action through the weld is made just that much easier.

1. Failure of the cylinder has been due to drastic overloading by accident. This failure has been facilitated by the notch effect at the unfused roots of welds due to irregular and incomplete penetration. However, the welding process is not primarily responsible for the failure.

TRANSVERSE SECTION OF WELD AT AREA OF ^{IN-}COMPLETE PENETRATION.

Note that fracture follows line of least thickness of metal -
through unfused root. Penetration - 35 per cent;
reinforcement - approximately 24 per cent.

2. The longitudinal barrel weld should be made by a pass inside and out.

3. On all welds tight butting up of edges to be welded should be avoided. Complete penetration is more easily secured with a 1/16-inch gap between edges.

4. Welding technique should be checked to ensure complete penetration. This investigation has shown widespread incomplete penetration which may result from any one of the following: too high welding speed, too low heat input or too tightly butting edges.

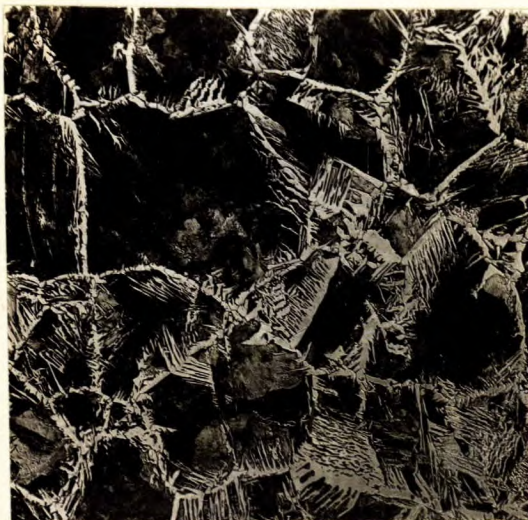
Figure 7.

Figure 7 shows the typical structure of the heat-affected zones of the welds and Figure 8 the structure of the sheet material remote from the welds. No evidence was found of segregation of inclusions.

3. The microstructure of the weld heat-affected zone and the parent material indicate a normal response of the material to the thermal cycle of welding. This normality is reflected in the hardness figures obtained.

TYPICAL STRUCTURE OF HEAT-AFFECTED ZONES.

Note tendency towards Widmanstätten type of structure.

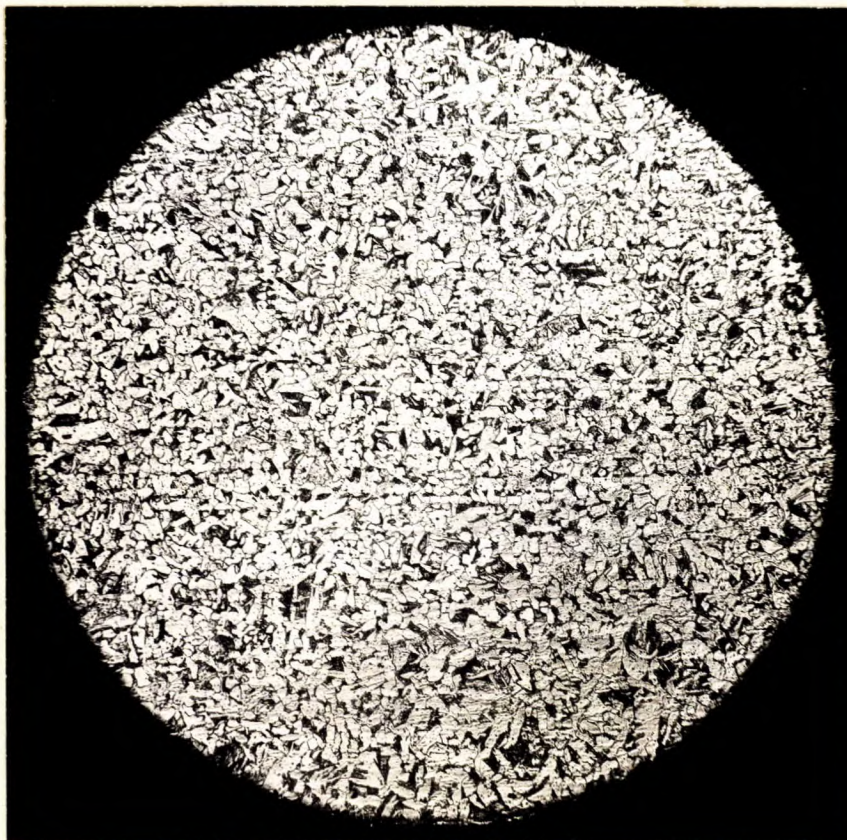
Figure 8.

NORMAL STRUCTURE OF SHEET MATERIAL.

Normalized after rolling to final size.
