R E P O R T  
of the  
ORE DRESSING AND METALLURGICAL LABORATORIES.

Investigation No. 1815.

Investigation of T-16 Carrier Track Pins  
from Somerville Testing Grounds.

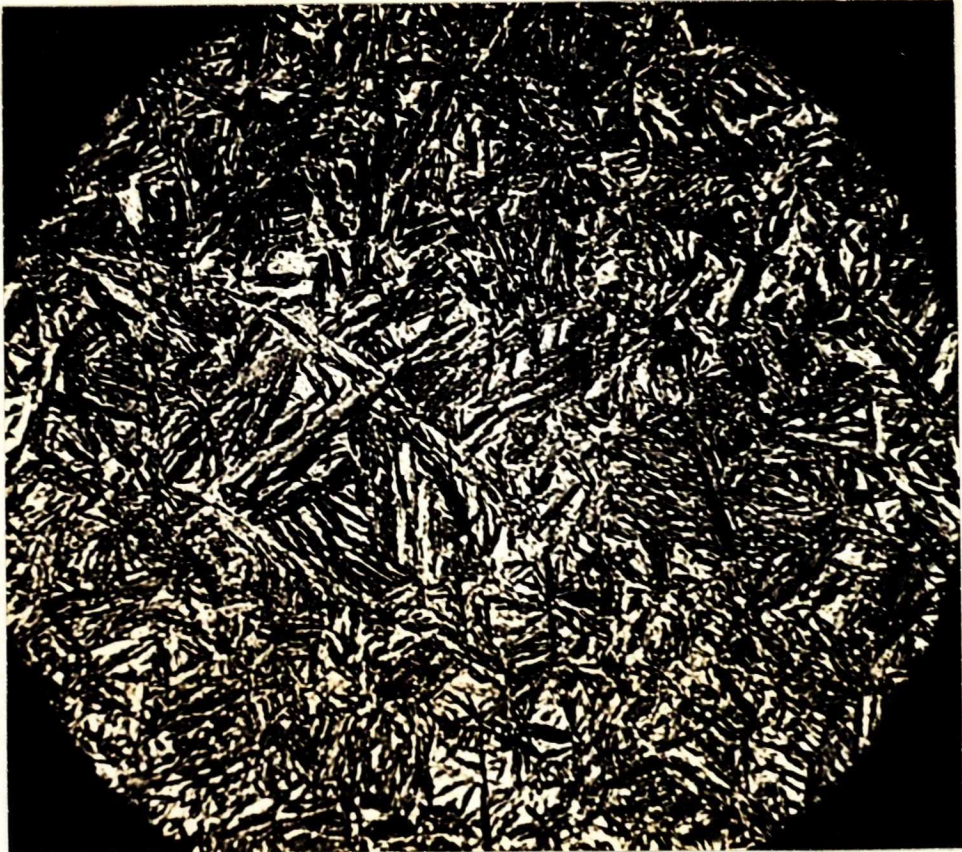
Figure 1.

Transverse microspecimens and longitudinal specimens were cut from the pins and examined under the microscope. In the unetched condition, the steel was found to be fairly clean. The specimens were etched in 2 per cent nital and re-examined. The longitudinal specimens gave no evidence of banding. Figure 1 (X1000) illustrates the acicular structure obtained in all specimens. Figure 2 (X1000) taken from a previous report (Investigation No. 1655, June 1, 1944) illustrates the finer more densely packed martensitic structure of a previously examined 0.46 carbon W.D. 8650 steel supposedly treated the same way as the pins here examined. Some carbide nodules are also present in the structure shown in Figure 2.

COARSE ACICULAR MARTENSITE (0.56 PER CENT CARBON).

The microstructure shows a coarser acicular structure than was obtained in the tests carried out in these Laboratories

on heat-treated pins, supplied by Commercial Heat Treating Co. in June 1944. This would indicate that a higher quench temperature was employed. This is also suggested by the almost complete absence of spheroidal carbides (provided that spheroidized steel is still being used). These are present in Figure 2. It would be interesting to check the structure of the bar stock to see whether the mills are consistently supplying a spheroidized material.

3. The microstructure shows coarse acicular martensite. Pins previously examined here were finer grain. A higher quenching temperature appears to have been used for these pins especially if a spheroidal bar stock was heat treated.

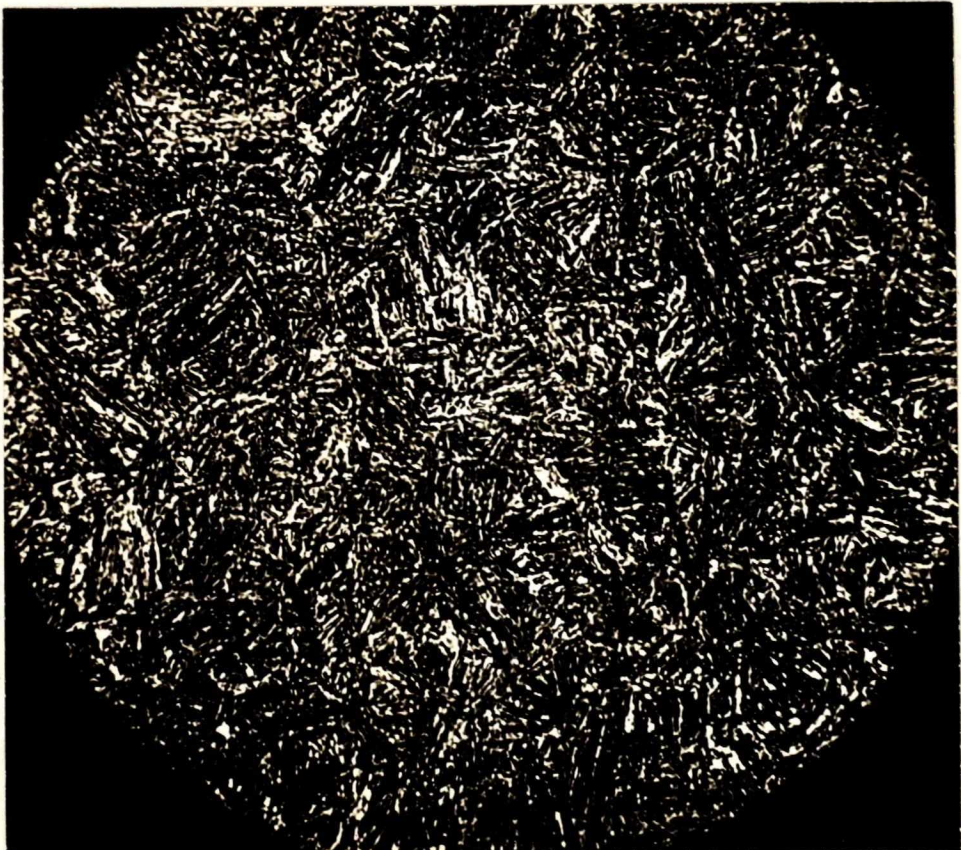
Figure 2.

TEMPERED MARTENSITE AND NODULES OF FREE CARBIDE  
(0.46 PER CENT CARBON).

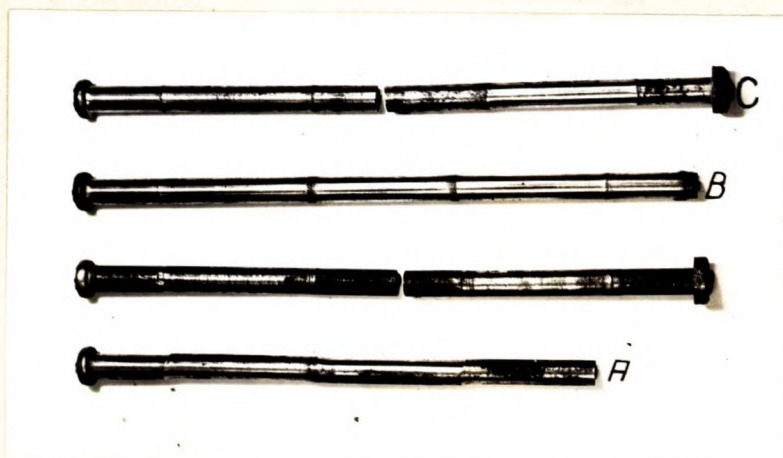
Failure of the cased universal carrier track pins occurred in one of three ways, as shown in Figure 3. Of the ten pins submitted, one broke close to the welded end, one pin was removed because the welded washer broke off and the remaining eight broke at approximately the centre of the pin.

- (A) One pin broke close to the riveted end.
- (B) One pin failed when the riveted washer came off.
- (C) Eight broke at approximately the centre of the pin.

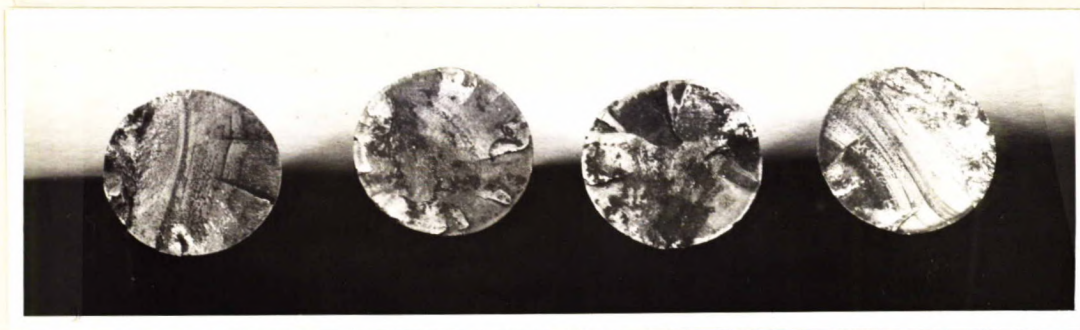
The fracture surfaces at the points of failure on all pins were characteristic in appearance of fractures resulting from fatigue type failures. Four such typical fractures are shown in Figure 4.

FRACTURE SURFACES TYPICAL OF FATIGUE FAILURES.

The appearance of the fracture surfaces at the points of failure indicates that failure was due to fatigue.

1. Macroscopic examination has shown that failure was of the fatigue type.

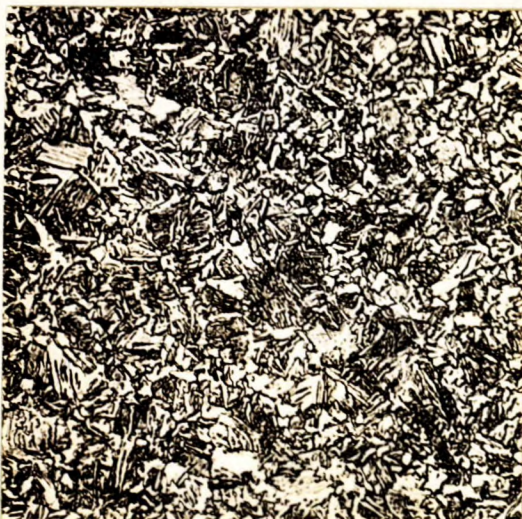
Figure 5.

As shown in Figure 5, the core structure consisted of ferrite and low carbon martensite. The higher carbon case was largely worn away in some spots (Table II) but the remaining portions had a fine martensitic microstructure (see Figure 6).

PIN NO. 5.

Core structure of ferrite and low carbon martensite.

Low core hardness is a likely cause of earlier failure, since it has been fairly well established that fatigue failure on the cased pin starts in the transition zone. Microscopic examination has substantiated this low core hardness in indicating that the pin structure is composed of a non-uniform ferrite-martensite aggregate.

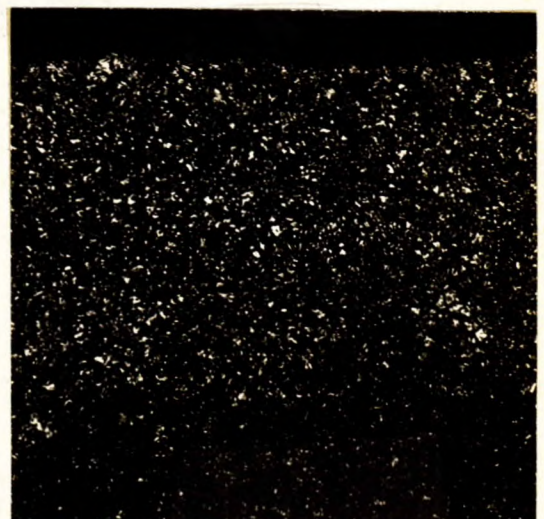
Figure 6.

PIN NO. 5.

Case structure of fine martensite.
