ORE DRESSING AND METALLURGICAL LABORATORIES.

Investigation No. 1817.

Metallurgical Examination of Pin from
Aircraft Aileron Control System.

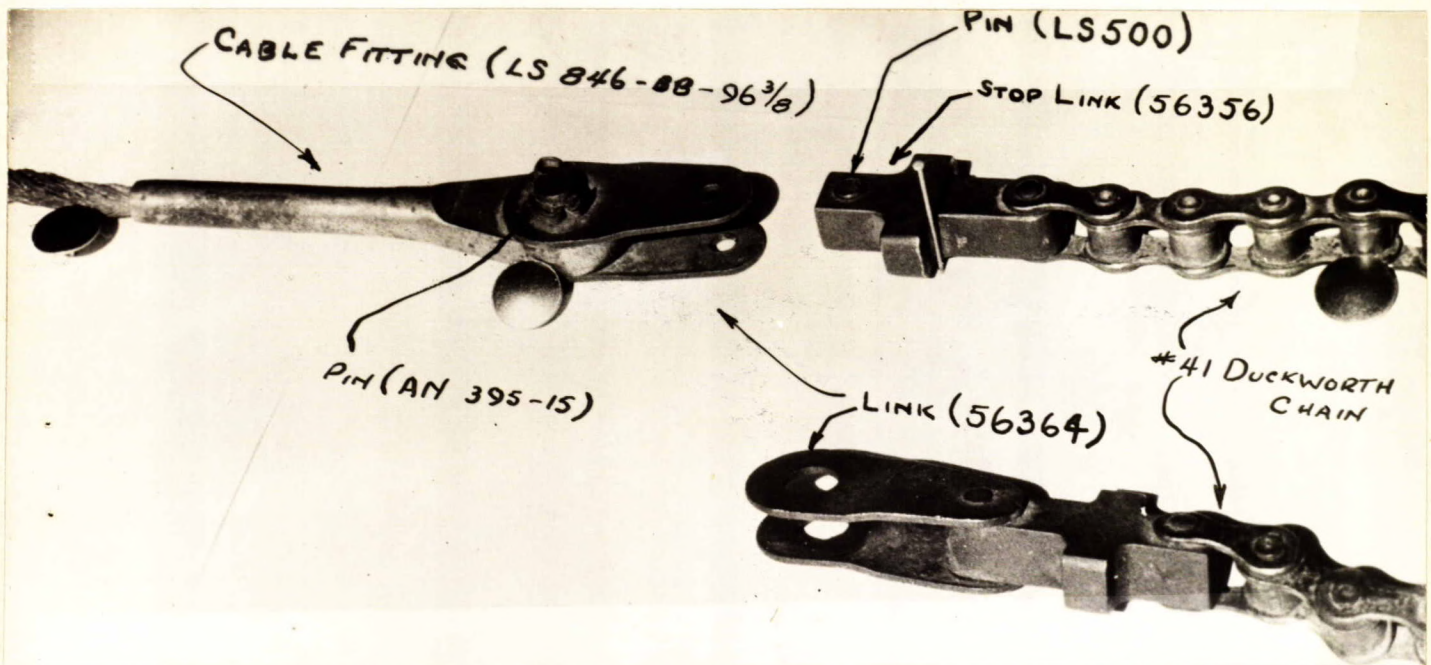
The pin (LS500) connecting the stop link (Lockheed Part 56356) and the links (Lockheed Part 56364) had failed in double shear, both heads being lost. These parts with their corresponding identification numbers are shown in Figure 1.

VIEW OF CONTROL COLUMN CHAIN
AS RECEIVED AT PMRL.

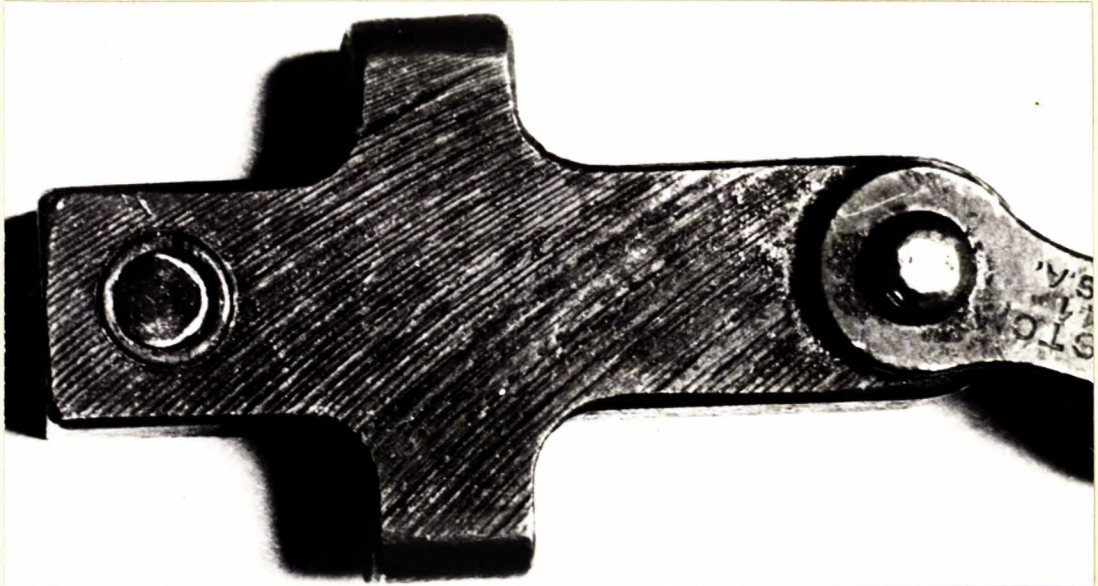
Figures 2 and 3 show both sides of the stop link
with the broken pin still in place.

STOP LINK WITH SHEARED PIN IN PLACE.
(Approximately 3 times full size).

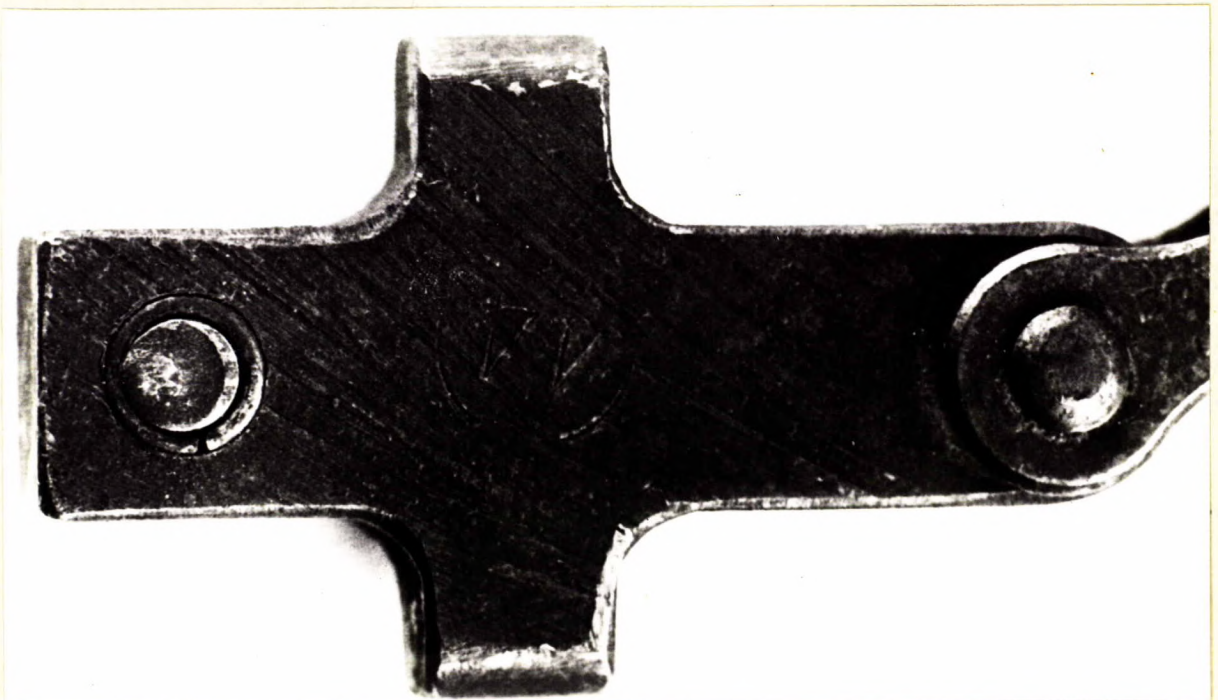
Figure 3.

OPPOSITE SIDE OF STOP LINK.
(Approximately 3 times full size).

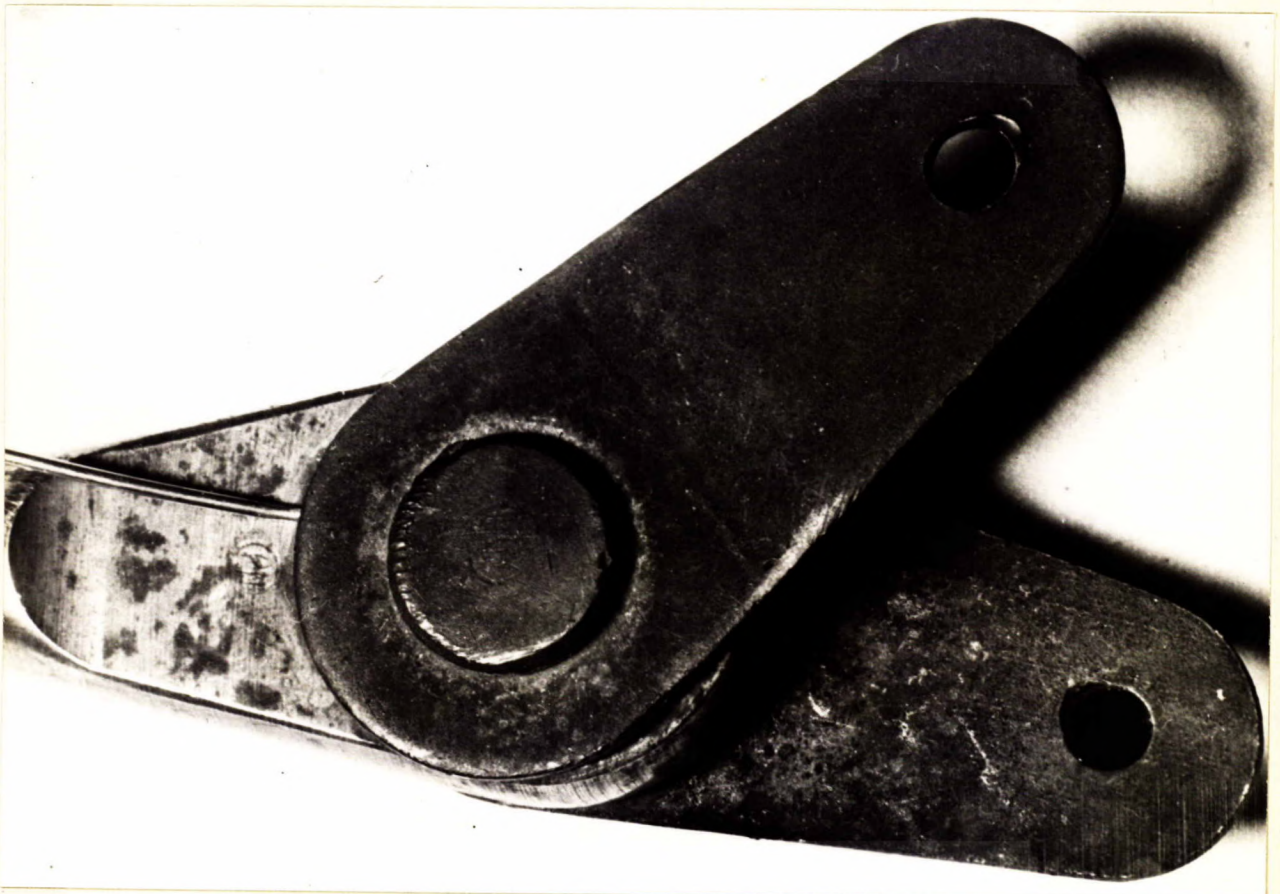
Figure 4.

Figure 4 is a view of the links which connected the stop link to the cable fitting. It will be noted that some distortion had taken place on the outside of one link and on the inside of the other.

LINKS (LOCKHEED PART 56364).

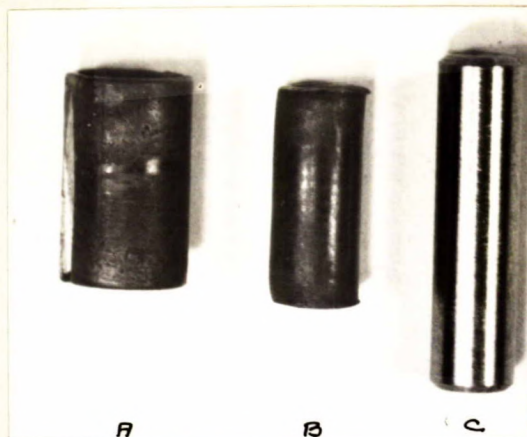
A view of the sheared pin is shown at B in Figure 5. A is the bushing removed from the broken pin while C is an unused pin.

- A. - Bushing from sheared pin.
- B. - Sheared pin.
- C. - New pin.

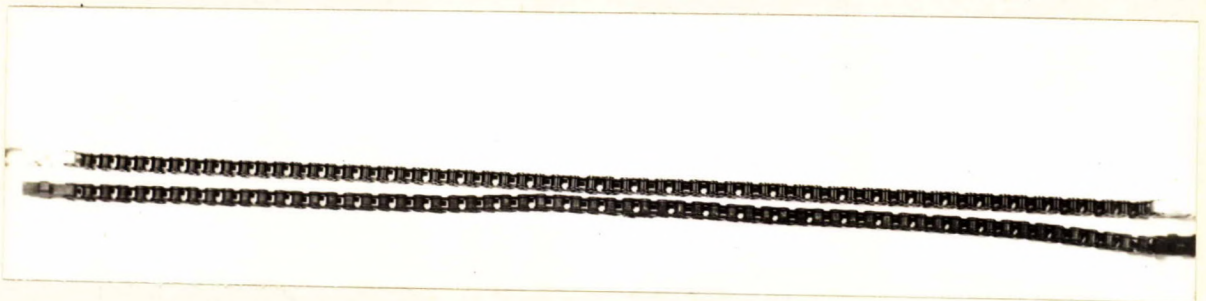
The chain (#41 Duckworth) also had been distorted. Maximum distortion in the links had occurred at a point 14 inches from the sheared LS500 pin. When placed against a full-scale drawing, this point was found to fall on the control wheel sprocket. A view of the chain alongside an unused chain is shown in Figure 6.

DISTORTION IN CHAIN.

Although no definite conclusions can be drawn as to why maximum distortion in the chain occurred at a point on the control wheel sprocket, it is likely that there was some violent wrenching action at this point.

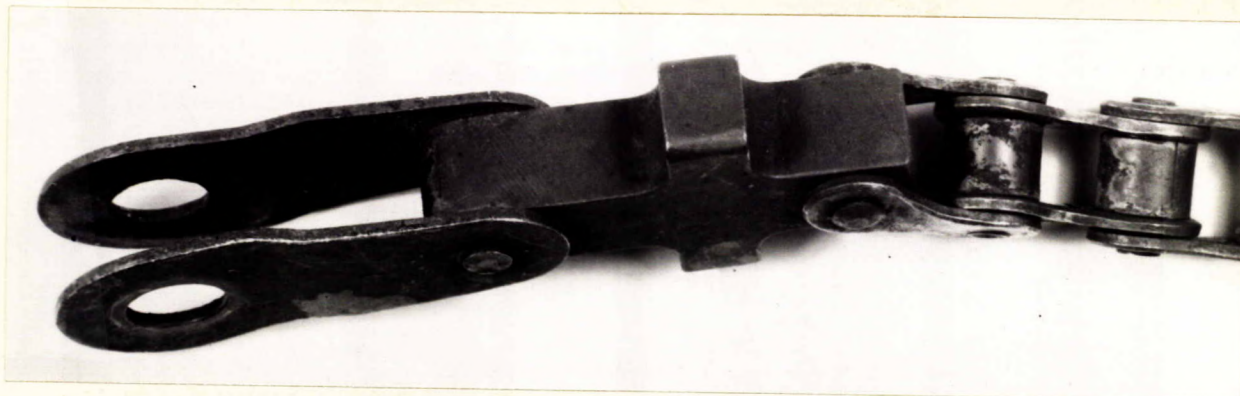
Figure 7.

A certain amount of twisting had also taken place. This was, for the most part, at the end of the chain furthest

TWIST IN LAST LINK OF CHAIN.
(Approximately twice full size).

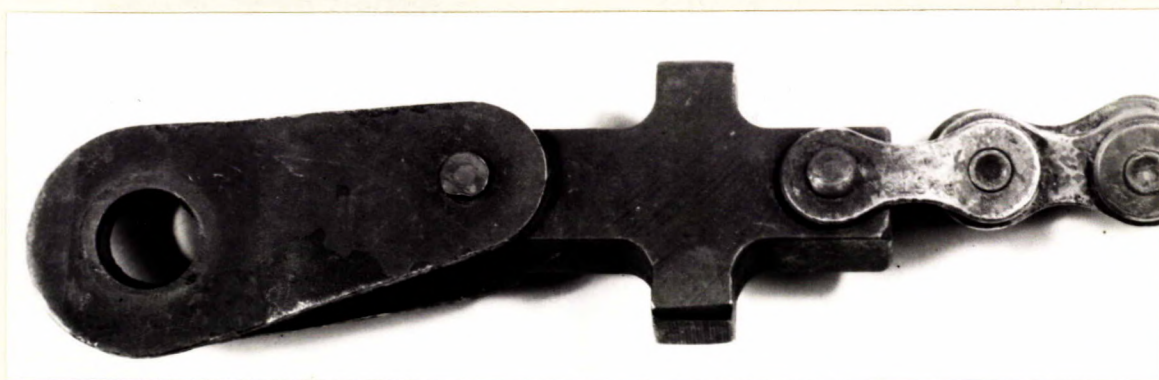
Figure 8.

SIDE VIEW OF CHAIN SHOWING TWIST.
(Approximately twice full size).

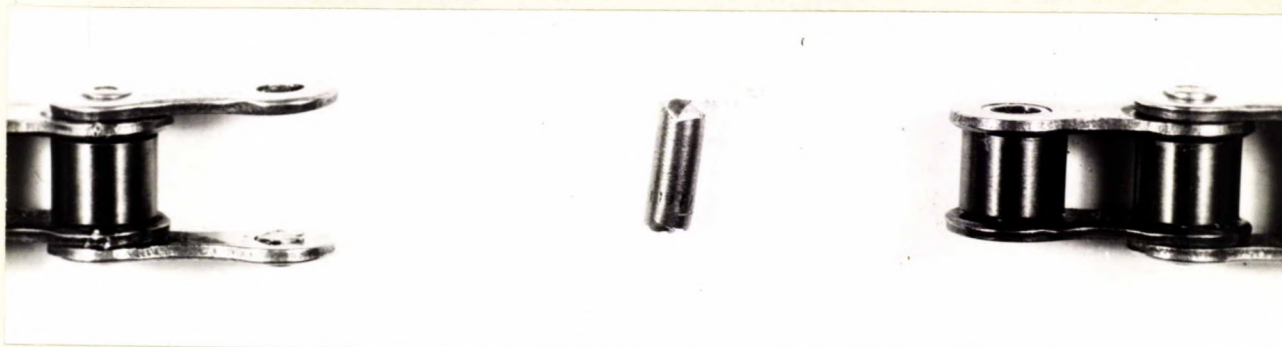
Figure 9.

A new control chain assembly which had been certified airworthy by Lockheed Aircraft Corporation, Burbank, California, was tested for strength. One-half of the chain was first pulled slowly. A Duckworth #41 pin in the chain failed under a load of 2,060 pounds.

FRACTURE IN CHAIN (Breaking load - 2,060 lb.)

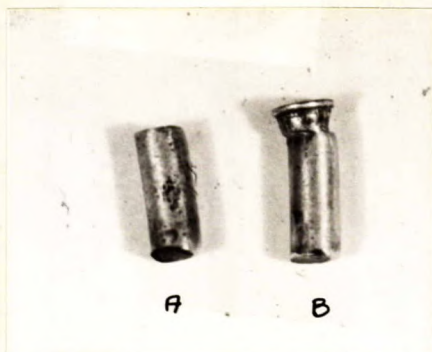
The remaining portion of this half was then retested and the LS500 pin failed at one end only under a load of 2,200 pounds (see B in Figure 10). The second half of the chain was then tested using a more rapid application of loading. In this test the LS500 pin broke in double shear under a load of 2,100 pounds. This pin is shown at A in Figure 10.

A. - Failed in double shear.

B. - Failed in single shear.

This latter pin failed in the same way as had the pin in the failed control assembly and the fractures presented the same appearance.

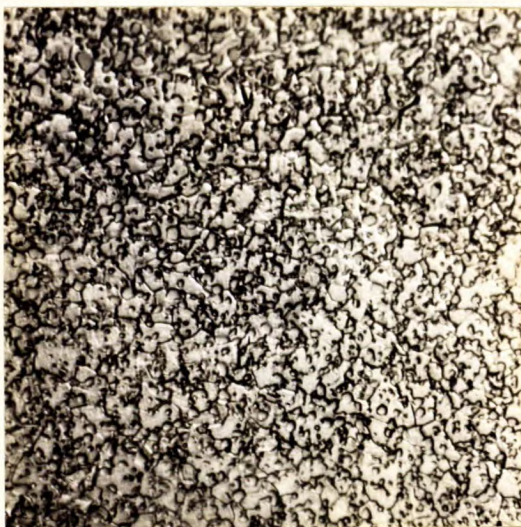
Figure 11.

The microstructures of the two samples were also compared. They proved to be practically identical, consisting of spheroidized carbides in a matrix of ferrite--the accepted structure of spheroidized carbon drill rod. The microstructures are shown in Figures 11 and 12.

MICROSTRUCTURE OF LS500
PIN FROM CRASHED AIRCRAFT.

From these two photomicrographs it can be seen that the spheroidized structure of the pin which failed under test was finer than that of the pin taken from the crashed aircraft. This agrees with the hardness results which showed the tested pin to be slightly harder.

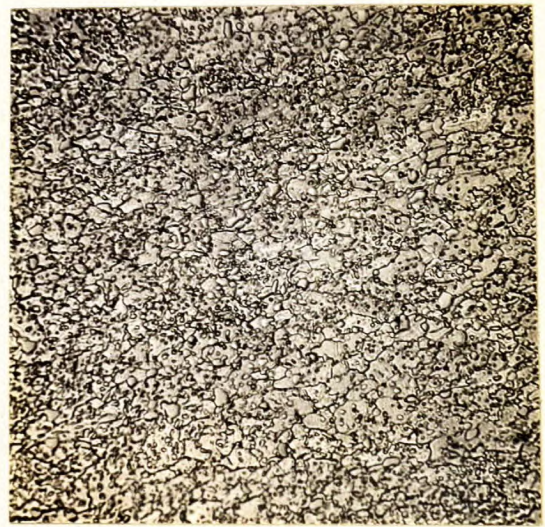
Figure 12.

MICROSTRUCTURE OF LS500
PIN BROKEN IN TEST.
