R E P O R T  
of the  
ORE DRESSING AND METALLURGICAL LABORATORIES.

Investigation No. 1819.

Metallurgical Examination of Broken Section  
of 4-Wheel Drive Rear Axle Shaft.

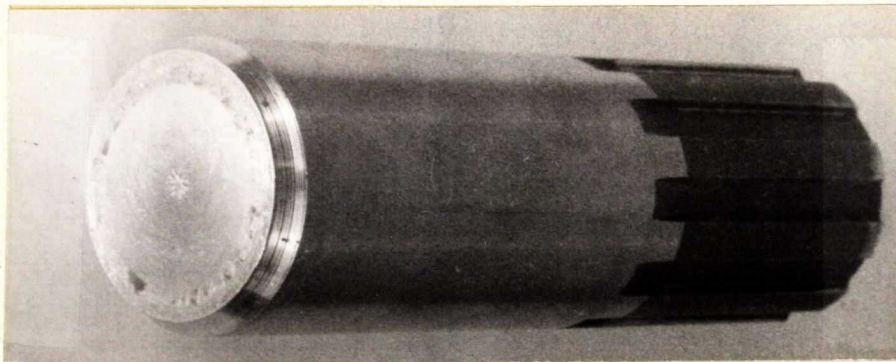
BROKEN SECTION OF 4-WHEEL DRIVE REAR AXLE SHAFT.

Note coarse machining of fillet and  
lack of deformation at fracture.

Visual examination revealed that very little deformation accompanied the fracture which occurred at the fillet. It was also noted that the fillet had been machined very poorly. The grooves resulting from this rough machining can be seen in Figure 1.

It is thought that the condition of the fillet was at least a contributing cause of failure, since the roughness of the surface would materially lower the fatigue strength.

1. The axle was found to be metallurgically sound.
2. Failure can be attributed to overstressing. This may well have been local, due to the faulty machining of the fillet.
3. Failure of the type encountered in this investigation may be minimized by (a) careful machining, and (b) employment of a large radius fillet.

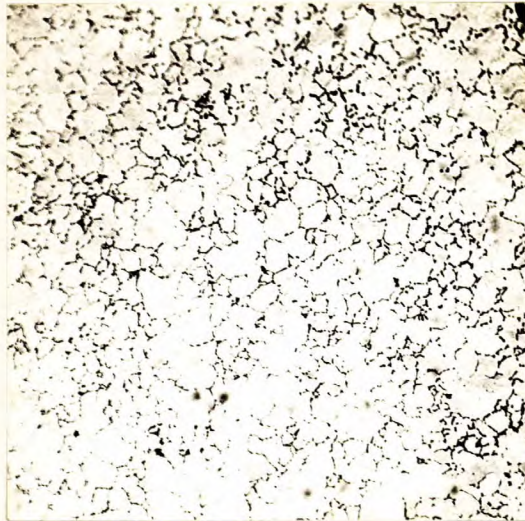
Figure 2.

The McQuaid-Ehn grain size was found to be 6 to 7, as shown in Figure 2 (etchant, boiling sodium picrate).

The grain size of 6 to 7, as revealed by the McQuaid-Ehn test, satisfactorily complies with the specifications.

McQUAID-EHN TEST

Grain size - 6 to 7.

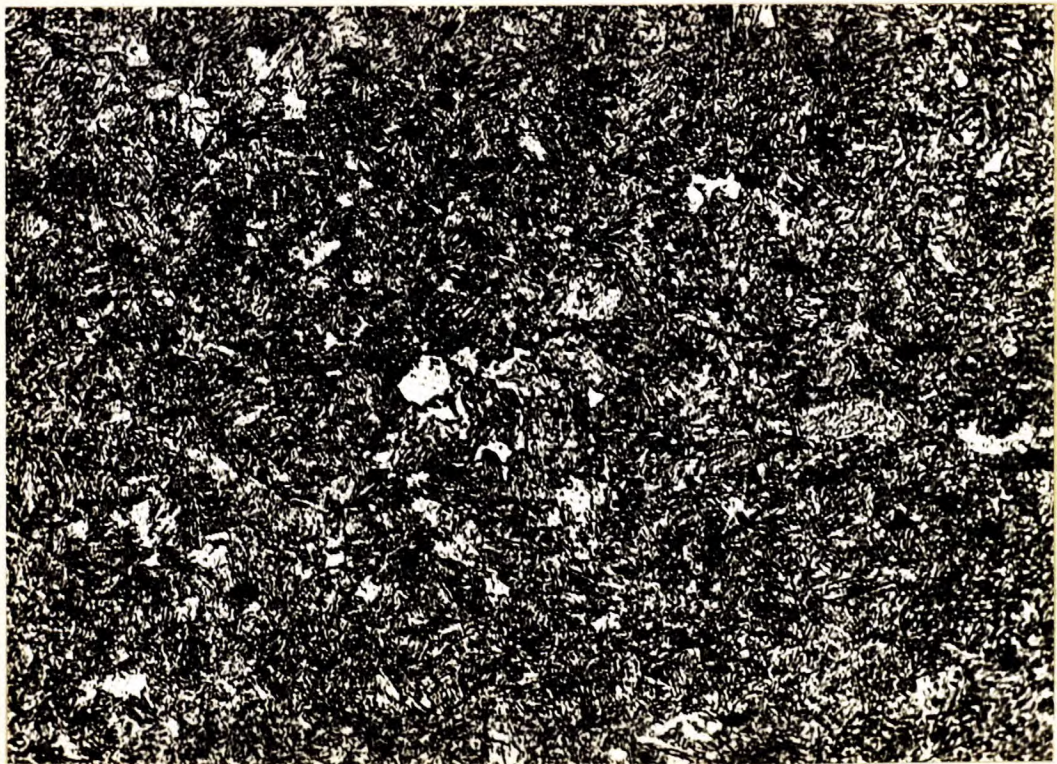
Figure 3.

Figure 3, taken at X750 magnification, shows the microstructure of the steel to be tempered martensite.

Microscopic examination indicated a structure which is normal for quenched and drawn SAE 4340 steel. Very little distortion of the metal at the fracture was evident, thus indicating failure in either fatigue or impact. The nature of the fractured surface strongly indicates the former. The normal quantity and distribution of inclusions was noted.

MICROSTRUCTURE OF AXLE AS RECEIVED.

Tempered martensite.
