R E P O R T
of the
ORE DRESSING AND METALLURGICAL LABORATORIES.

Investigation No. 1821.

Corrosion Resistance of Electroplated Steel Parts.

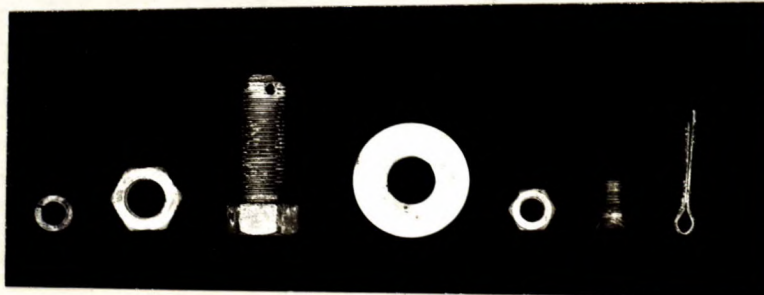
Figure 1.

The condition of the parts at the end of the test is shown in Figures 1 and 2. Those in Figure 1 had little or no iron rust on them while those in Figure 2 had considerable iron rust.

CADMIUM-PLATED STEEL PARTS WHICH WITHSTOOD THE ACTION OF THE SALT SPRAY FOR 230 HOURS.

Little or no rust is evident on these parts although, of course, there is a certain amount of cadmium corrosion product.

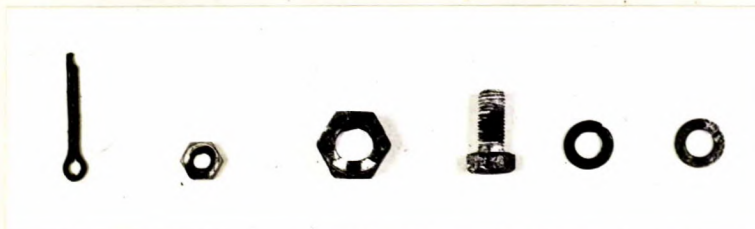
Figure 2.

a b c d e f
CADMIUM-PLATED STEEL PARTS WHICH RUSTED DURING THE 230 HOURS IN THE SALT SPRAY.

- After 15 hours - Cotter pin (a in Figure 2) began to rust.
- After 90 hours - Washer (e in Figure 2) began to rust.
- After 160 hours - Large nut (c in Figure 2) began to rust on all sides.
- After approximately 200 hours - The parts marked b, d and f began to rust.

It will be noted that one cotter pin failed and one remained good; also, that two small washers failed and one remained good.

It is presumed that all of these parts were plated in the plating barrel. If they were all plated in the same batch it would appear that there was not sufficient movement of the parts during the operation. If they were plated in different batches the conclusion is that all batches did not have the same treatment. Some of the batches may have been faulty with regard to time of plating, current density, cadmium content of plating bath, size of batch, amount of movement of the parts being plated, etc.
