ORE DRESSING AND METALLURGICAL LABORATORIES.

Investigation No. 1829.

Metallurgical Examination of Two Broken Steel Studs
from a Snowmobile Rebound Chain Assembly.

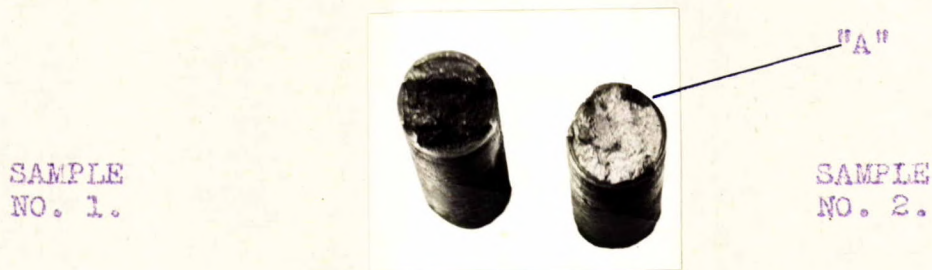
Figure 1.

Figure 1 is a photograph showing the fractured surface of the two steel studs. The surface of Sample No. 1 was rusted, so that no special significance could be attached to the fracture. Sample No. 2 had a duplex fracture, and the failure appeared to have originated at the base of the thread (at "A" in Figure 1).

The use of free-cutting steels for the manufacture of parts subject to high impact stresses is not recommended, on account of their low impact properties. The poor impact strength of Sample No. 1, therefore, would account for its premature failure in service. The duplex nature of the fracture of Sample No. 2 indicates that it failed by fatigue. The use of higher strength steel and a reduction of the amount of thread to just enough to take the threaded bushing and two lock nuts would probably overcome similar failures.

A nickel steel of SAE 2320 composition, quenched in oil from 1450° F. to 1500° F. and tempered at 1100° F., or a chromium-molybdenum steel of SAE 4130 composition, quenched in water from 1575° F. to 1625° F. and tempered at 1100° F., is recommended and should give improved service. The lower-carbon steel would be preferable as it is more easily welded. Both steels have high impact properties at room and sub-zero

temperatures and can be readily welded. If the alloy steels are unavailable it is thought that a normalized SAE 1020 steel should prove satisfactory for these studs, provided the steel is properly made and the thread on the steel is reduced to the minimum requirements as suggested above.

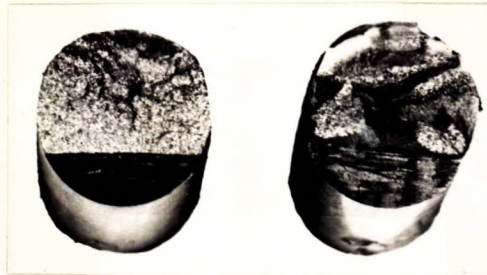
Figure 2.

Figure 2 is a photograph showing the fracture of the Izod specimens. The fracture of Sample No. 1 was fairly coarse. However, Sample No. 2 appeared to be fine-grained at the outer surface and coarse-grained towards the centre. A seam was observed in the centre of Sample No. 2.

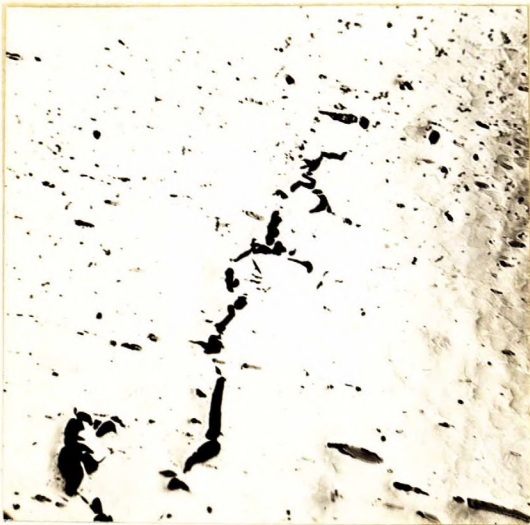
Figure 3.

SHRINKAGE CAVITIES,
SAMPLE NO. 1.

The photomicrographs show that steel Sample No. 1 had a high sulphide inclusion content, as would be expected in a high-sulphur, free-cutting steel. In addition, Sample No. 1 was found to contain shrinkage cavities. Sample No. 2 was made from seamy stock in which slag inclusions have been entrapped in the rolling operation.

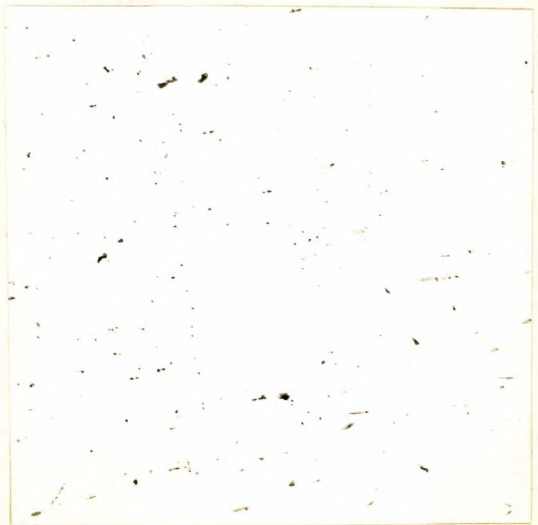
Figure 4.

SULPHIDE INCLUSION,
SAMPLE NO. 1.

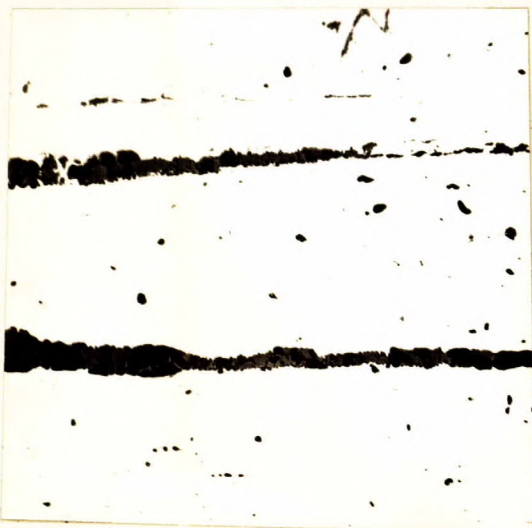
Figure 5.

SLAG INCLUSION,
SAMPLE NO. 2.

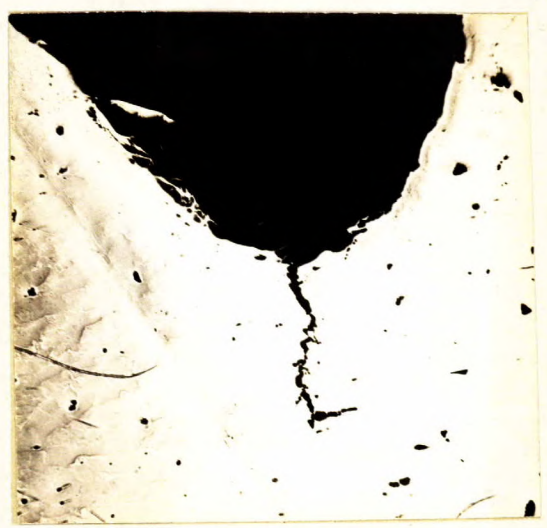
Figure 6.

Specimens of the steels adjacent to the fracture were mounted in bakelite, polished, and examined under the microscope in the unetched condition. The inclusion content of these steels was quite high. Sample No. 1 was found to contain shrinkage cavities, while slag was observed in Sample No. 2. These defects are illustrated in Figures 3, 4 and 5. Figure 6 illustrates a crack typical of several found at the base of the thread in Sample No. 2.

CRACK AT BASE OF THREAD,
SAMPLE NO. 3.

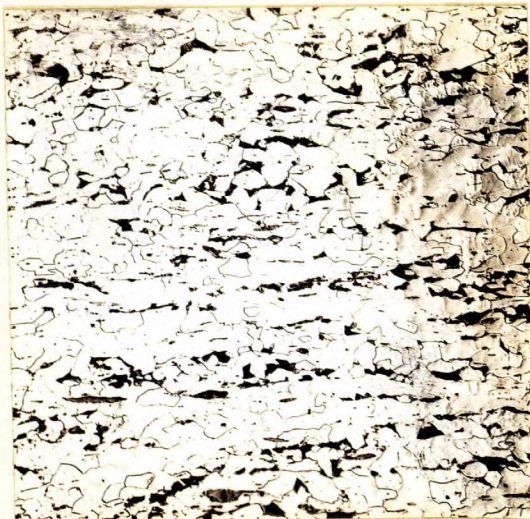
Figure 7.

The nital-etched structures of Samples Nos. 1 and 2 are shown in Figures 7 and 8 respectively. The steels are fine grained. The structure consists of pearlite, the iron-iron carbide constituent (the dark etching material), and ferrite, the iron constituent (the light etching material).
