April 9th, 1945.

ORE DRESSING AND METALLURGICAL LABORATORIES

Investigation No. 1834.

Examination of Rivetted C.D.P. Track Pins
and Washers.

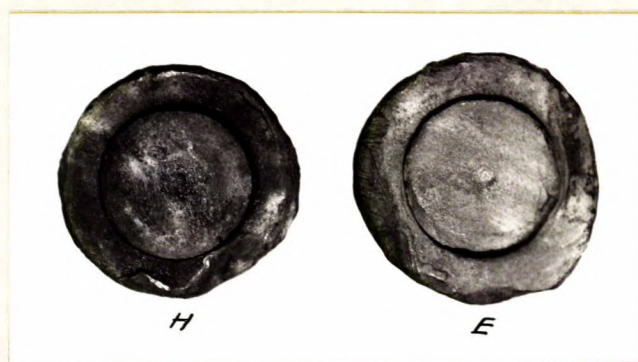
Figure 1.

Every washer and pin submitted was given a close visual examination. The most notable fact brought out by this examination was that all washers on the pins which had been in service and had gone 749 miles were severely deformed (see Figure 1). Several of the peened ends had pieces of metal chipped away. All of the washers were very loose on the pins.

PHOTOGRAPH OF HULL IRON AND STEEL
AND ELECTRIC STEELS PINS AND WASHERS
WHICH HAD BEEN IN SERVICE FOR 749 MILES.

Note deformation of washers.

3. In view of the fact that washers from both firms show severe deformation during service, it is suggested that although overpeening may be a contributing cause of failure the main cause is lack of protection of the washers during service. A peened end may have been satisfactory for lighter vehicles of this type but with a heavier vehicle it appears that some other design is indicated. Perhaps a harder (say, 30 Rockwell "C") and wider washer would be sufficient.
