ORE DRESSING AND METALLURGICAL LABORATORIES.

Investigation No. 1837.

Metallurgical Examination of Broken Bogie
Pin from 20-Ton Transporter.

April 16, 1945.

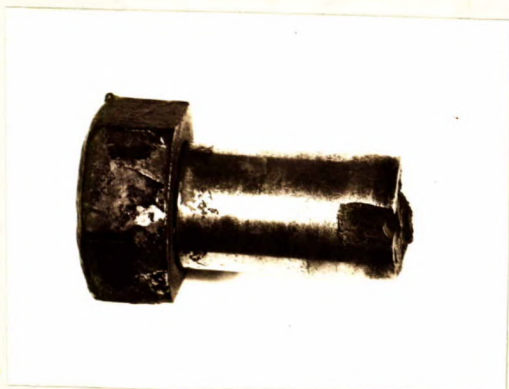
Figure 1.

BROKEN BOGIE PIN FROM 20-TON TRANSPORTER.

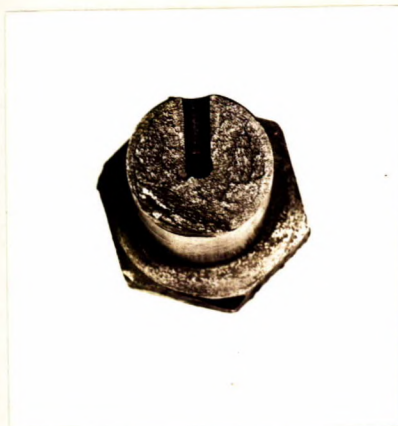
Figure 2.

Note fracture
at oil hole.

Visual examination revealed that the fracture had occurred at right angles to the longitudinal axis at the horizontal portion of the oil hole. (See Figure 2).

The position of the fracture at the horizontal case-hardened oil hole lends itself to the opinion that failure has occurred because of faulty design, since a hole drilled at right angles to the body of the pin and then carburized would act as a source of very high stress concentration and would render the part extremely susceptible to fatigue failure.

1. It is recommended that a solid pin be made of the same material (SAE 1030) but be correctly case-hardened, to 60 Rockwell " C", so as to prevent decarburization.
2. An alternative to the above case-hardened pin would be a homogeneous pin made of either SAE 9255 or NE 8650 steel, hardened throughout to a hardness of approximately 445 Brinell.

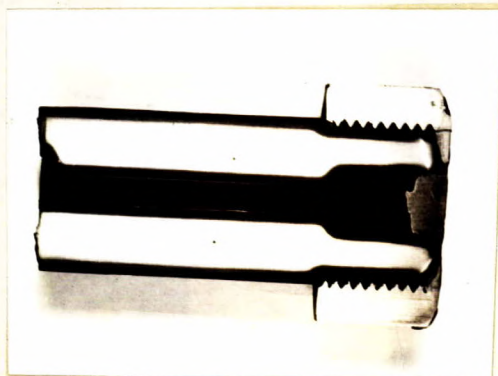
Figure 3.

A longitudinal section was made of the pin (see Figure 3), consisting of a nut threaded on to a bolt. An oil hole, which was subsequently plugged, was drilled axially through the centre of the bolt and out at one side, at right angles to the axis.

On etching the section in 2 per cent nital, a very thick case (approximately 50 thousandths of an inch) was revealed, extending along both the inner and outer walls of the bolt.

LONGITUDINAL SECTION (Nital Etch).

Note decarburization adjacent to oil hole.

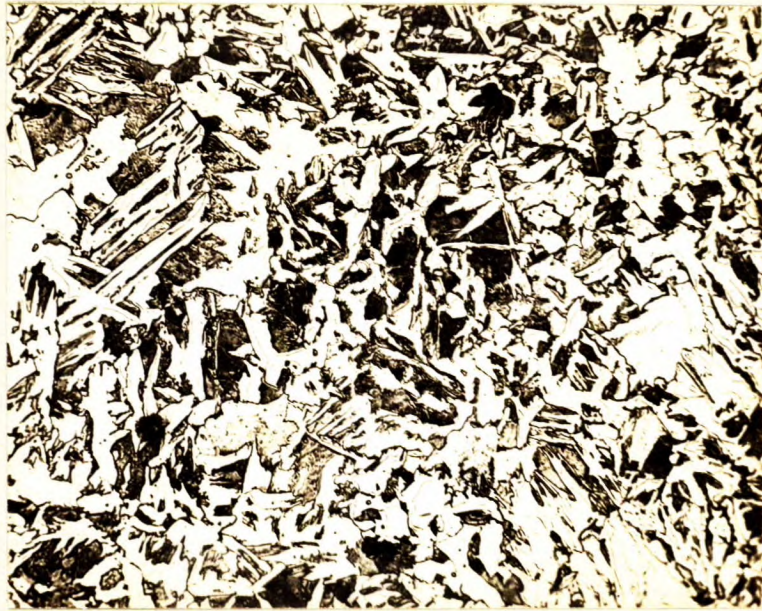
Figure 4.

Figure 4 is a photomicrograph, taken at X500 magnification, showing the structure of the core, consisting of fine pearlite and ferrite.

MICROSTRUCTURE OF CORE.

Fine pearlite and ferrite.

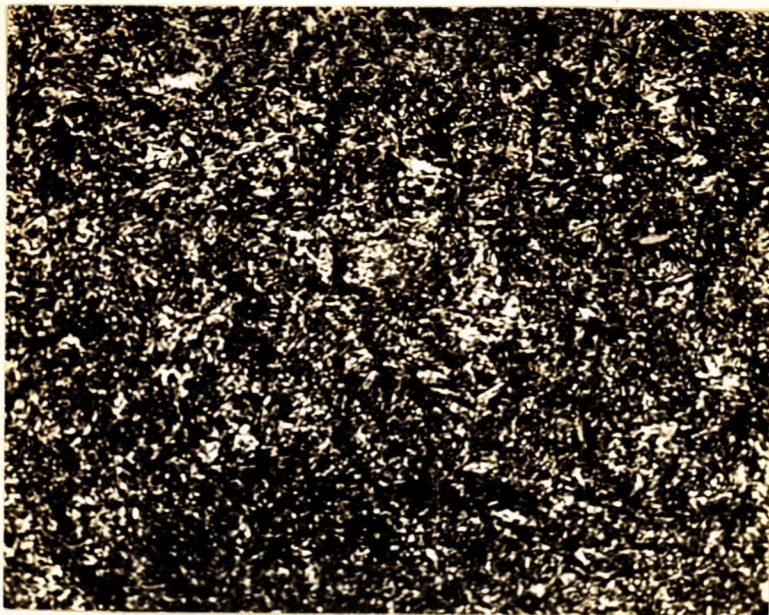
Figure 5.

Figure 5 shows the microstructure of the case, at X1000 magnification, consisting of fine martensite and carbides.

MICROSTRUCTURE OF CASE.

Fine martensite and carbides.

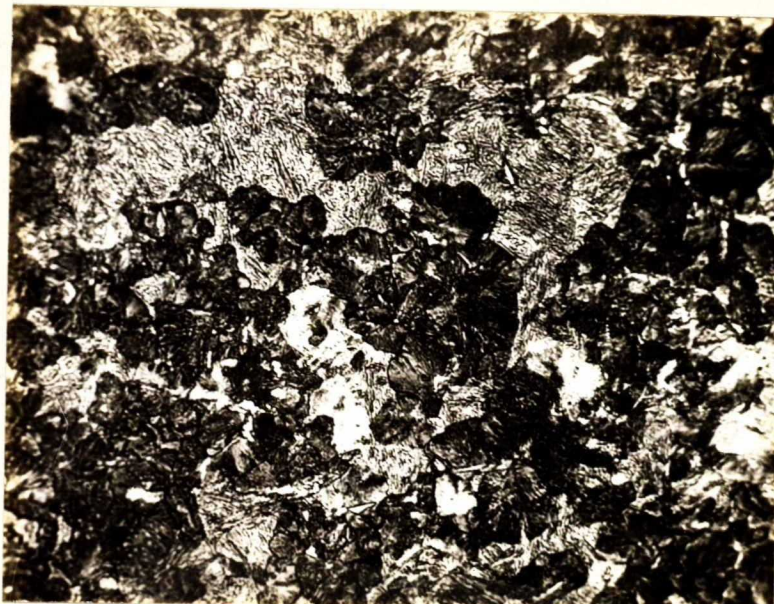
Figure 6.

Figure 6, taken at X500 magnification, shows the typical microstructure of the zone intermediate between the case and the core. The structure consists of ferrite, martensite and troostite.

INTERMEDIATE ZONE.

Martensite, troostite, and ferrite.

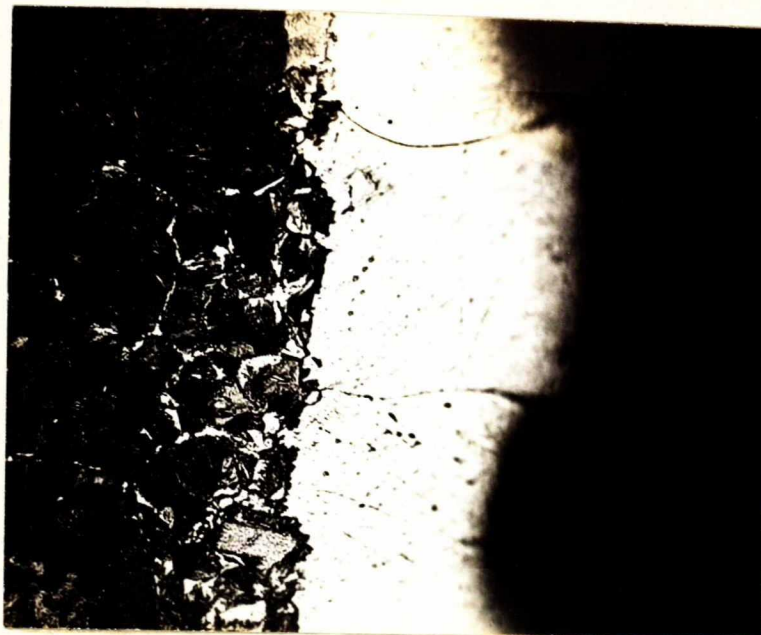
Figure 7.

Figure 7 (X500 magnification) shows the extent of decarburization of the case adjacent to the oil hole. The thickness of the decarburized area is approximately 2/1000 inch.

The decarburized surface extending along the oil hole, shown in Figure 7 and also evident in the macrophotograph in Figure 3, was probably caused by faulty carburizing

procedure. Such a condition is most undesirable, since the fatigue property of the steel is seriously reduced.

DECARBURIZED CASE ADJACENT TO OIL HOLE.

The white constituent is ferrite.
