April 24, 1945.

ORE DRESSING AND METALLURGICAL LABORATORIES.

Investigation No. 1849.

Metallurgical Examination of Induction-Hardened
Snowmobile Sprockets.

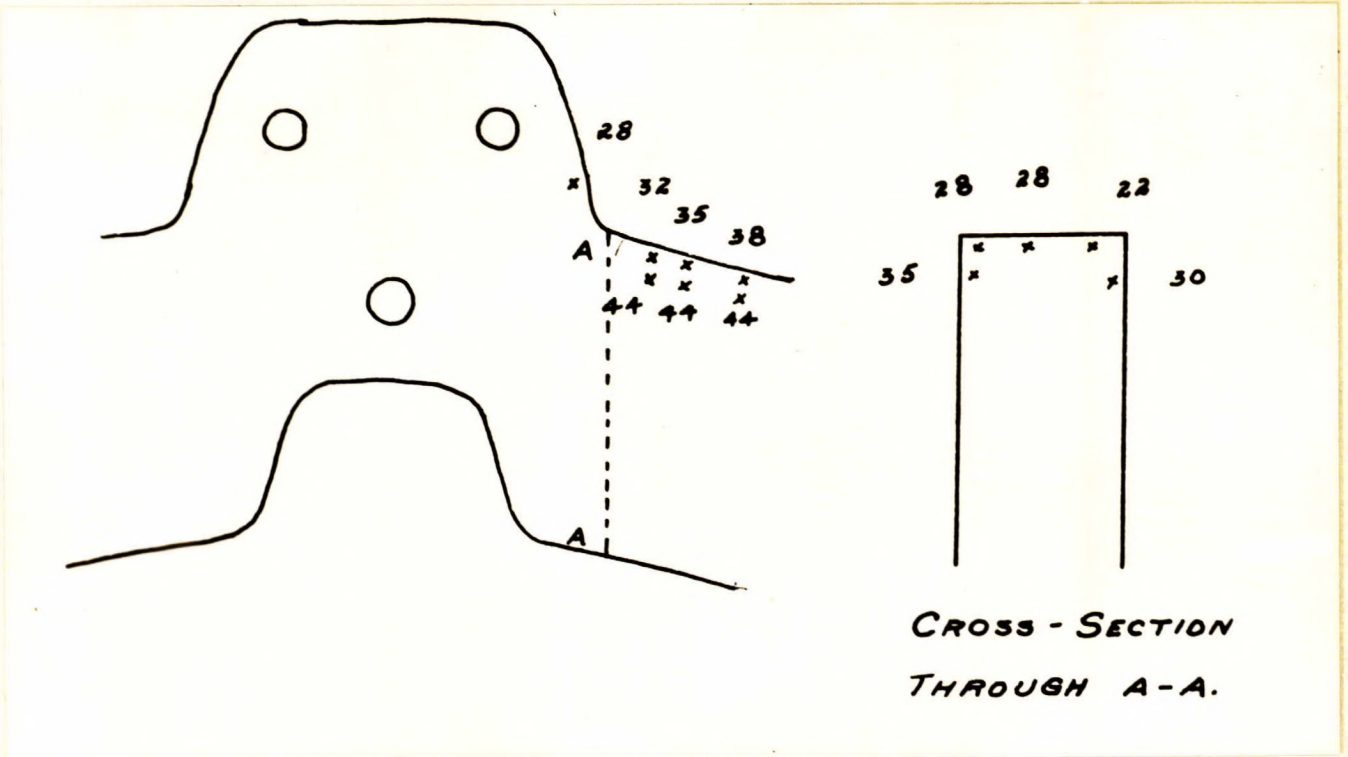
Figure 1.

As shown in Figures 1 and 1a, there is a zone of low and variable hardness at the bearing surface. Readings taken 1/16 inch from this surface ranged from 28 to 44 Rockwell "C". About 1/10 inch from the bearing surface, the hardness is more uniform.

Readings in the cross-section (Figure 1a) were taken with a Vickers machine and converted to Rockwell "C". The low values (22 to 28) were taken approximately 0.040 inch from the bearing surface.

ROCKWELL "C" HARDNESS SURVEY ON SPROCKET "AS RECEIVED".

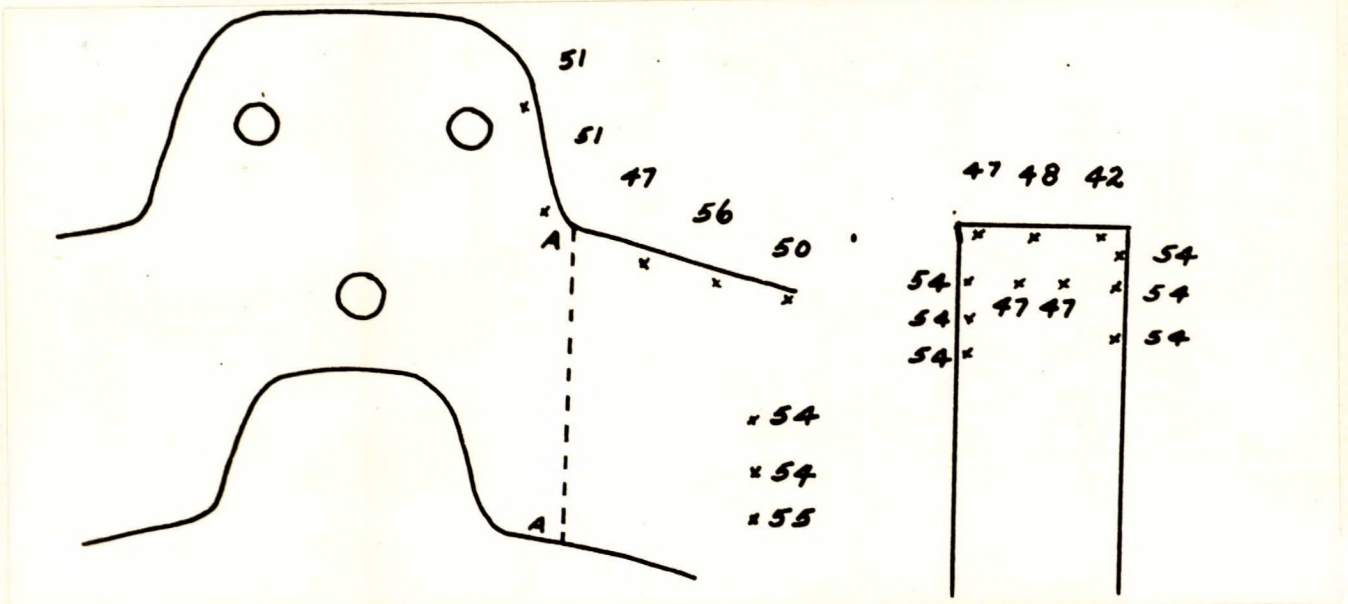
Figure 2.

Hardness surveys on completely hardened sprocket sections substantiate the evidence of lower hardness, in what appears to be a partially decarburized zone at the bearing surface. The location of readings and the hardness values obtained on the reheat treated sample are shown in Figures 2 and 2a.

ROCKWELL "C" HARDNESS SURVEY ON SPROCKET AFTER REHEAT TREATMENT.

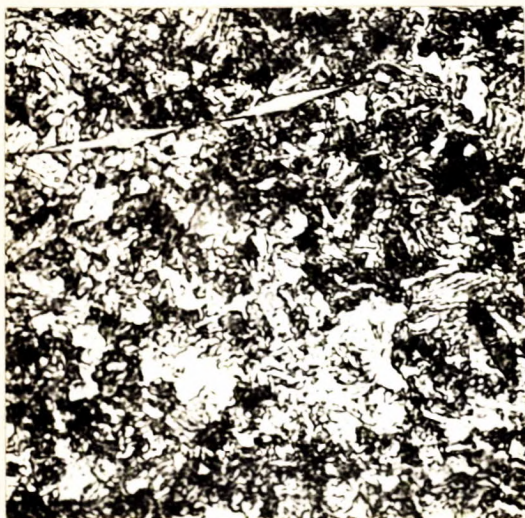
Figure 3.

X1000, etched in
2 per cent nital.

INDUCTION HARDENED ZONE
OF SPROCKET AS RECEIVED.

Ferrite, troostite, and martensite.

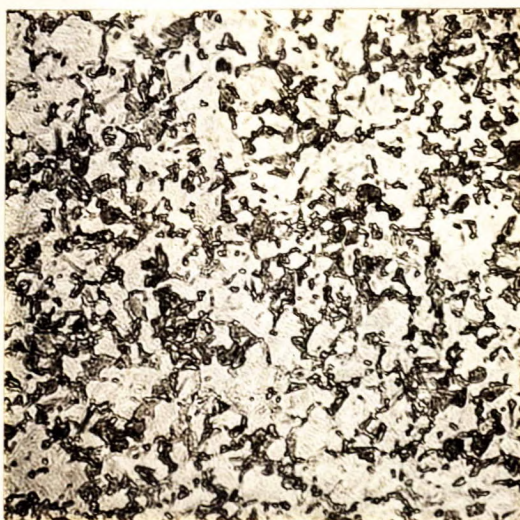
Figure 4.

X500, etched in
2 per cent nital.

SAME ZONE AFTER REHEAT TREATMENT.

Contains more martensite.

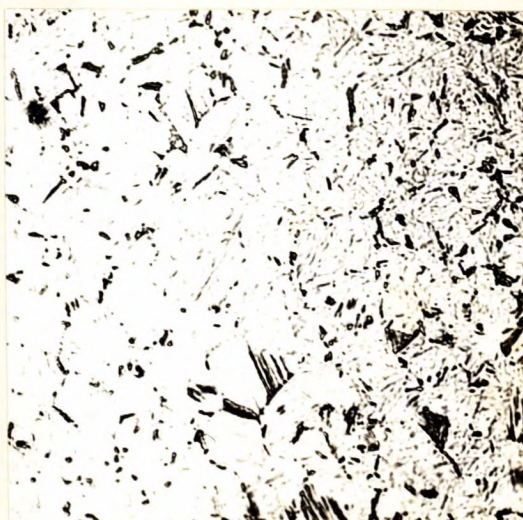
Figure 5.

X500, etched in
2 per cent nital.

REHEAT TREATED SURFACE
FREE FROM DECARBURIZATION.

Largely martensitic.
