Investigation No. 1853.

Examination of Extruded Magnesium Alloy Channel
Section Assembly with Steel Locking Device.

R E P O R T
of the
ORE DRESSING AND METALLURGICAL LABORATORIES.

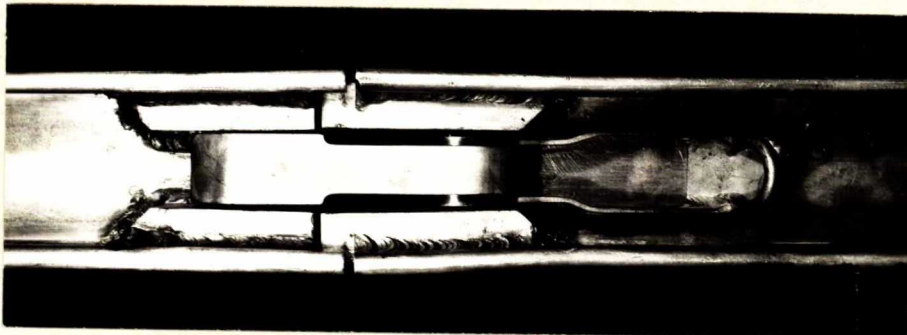
On April 17, 1945, Col. E. C. Thorne, of the Directorate of Engineering Development, Department of National Defence (Army), Ottawa, Ontario, submitted two extruded magnesium alloy channel section assemblies similar to those used in an assault bridge. The channels, reported to be of magnesium alloy A.S.T.M. 8X (nominal composition 6.5 per cent aluminium, 0.7 per cent zinc, 0.2 per cent manganese, balance magnesium), were joined together by a locking device of SAE 4130 steel, as shown in Figure 1.

The locking device consists of a steel hook which works on two steel pins attached to the flanges of the channels. As may be seen from Figure 1, magnesium alloy blocks are welded to the channel flanges to lessen the danger of tearing the material about the steel pin when the assembly is under tension. To reduce the tendency of the

MAGNESIUM ALLOY CHANNEL ASSEMBLY SHOWING STEEL LOCKING DEVICE.

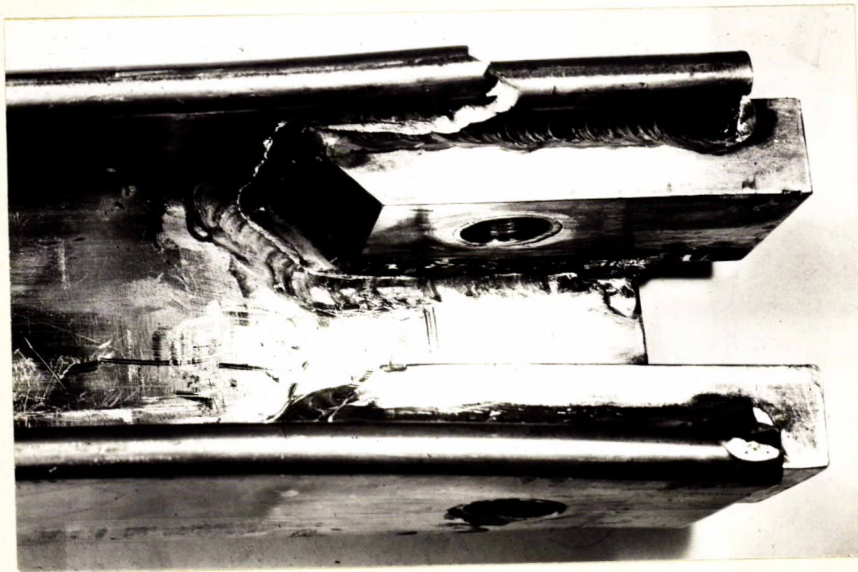
Figure 2.

TOP VIEW OF MAGNESIUM ALLOY CHANNEL
AFTER TESTING.

Note how fracture follows weld.

It will be seen, from Figures 2 and 3, that the fracture followed the weld around to a point on the flange

near the hole for the 5/8-inch pin and its bushing and here the flange failed.

Examination of the fracture through the weld (Figures 2 and 3) showed that there was some lack of penetration at the root of the weld (see Figures 5 and 6). This should be eliminated by improving the welding technique. The stress-raising effect of the hole in the channel flange accommodating the pin may have had some part in causing the failure, but it is felt that improving the weld would increase the strength of the assembly.

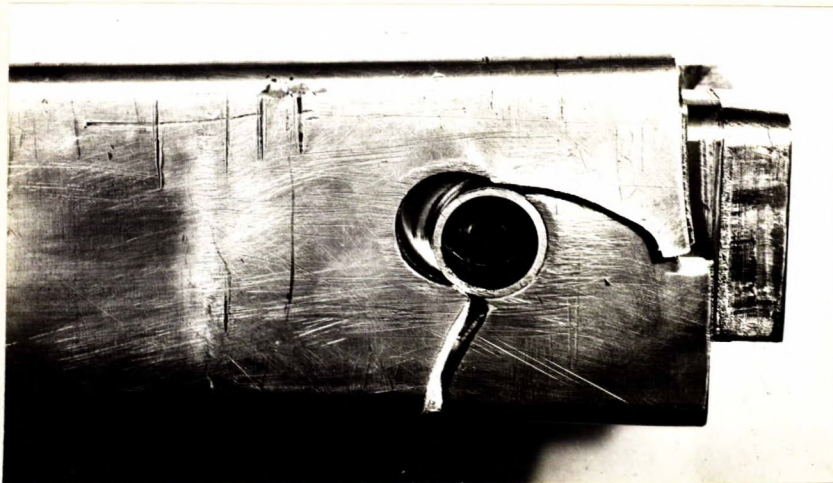
Figure 3.

SIDE VIEW OF FRACTURE IN MAGNESIUM CHANNEL.
(Approximately 2/3 size).

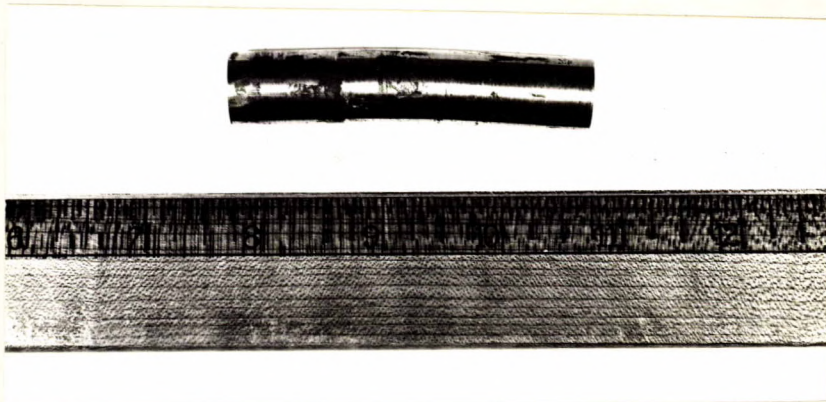
Figure 4.

5/8-INCH DIAMETER STEEL PIN AFTER TESTING.

Note slight bend in pin.

at 900° F. After such a treatment the steel would be expected to have an Izod impact strength of 40 foot-pounds. It is felt that no attempt should be made to increase the properties by lowering the draw temperature, as the Izod would be decreased. Increasing the diameter of the pin is a more satisfactory way to raise the strength. The bend angle of the 5/8-inch diameter pin removed from the assembly after testing does not seem excessive (see Figure 4).

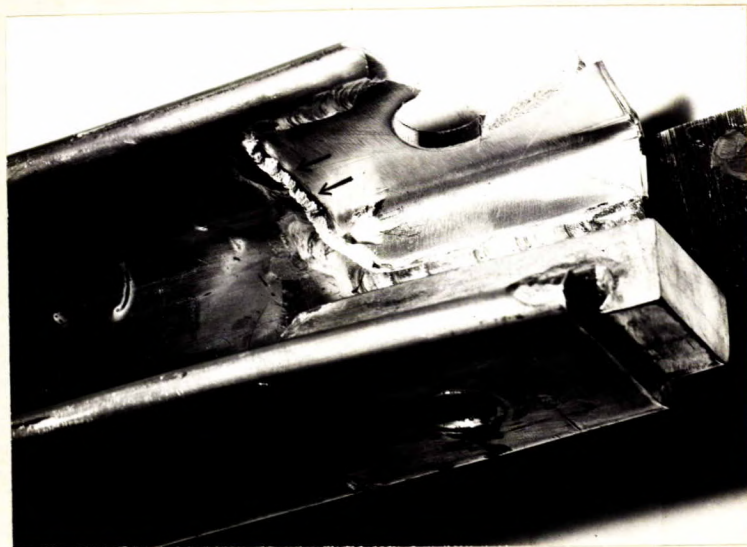
Figure 5.

Examination of the weld fracture showed lack of penetration of the weld metal at the root of the weld. This may be seen in Figures 5 and 6. Figure 5 shows the lack of penetration at the root of the vertical weld on the flange of the channel. Figure 6, a photomicrograph at 30 magnifications, shows a cross-section of the weld at the root, showing the lack of penetration.

FIGURE SHOWING LACK OF PENETRATION AT ROOT OF WELD.

Dark area (arrow) at root of vertical weld indicates lack of penetration.

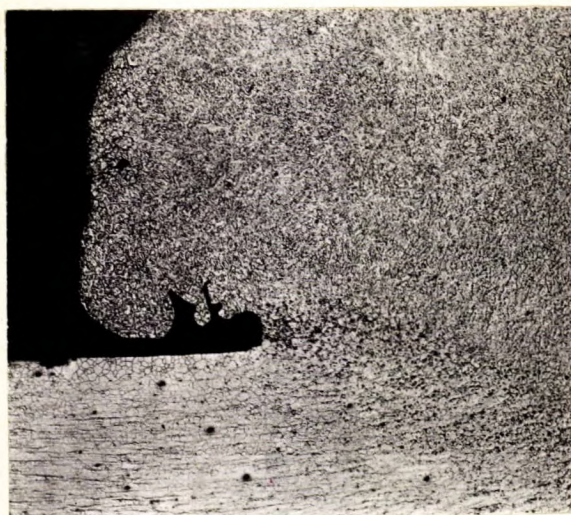
Figure 6.

X30, etched in 2 per cent nital.

PHOTOMICROGRAPH SHOWING LACK OF PENETRATION
AT ROOT OF WELD.

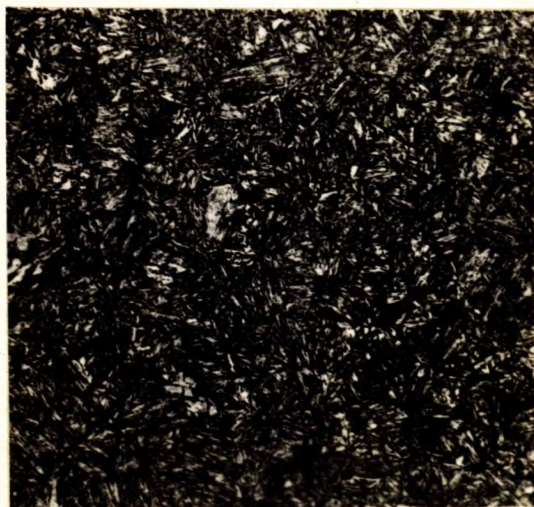
Figure 7.

The steel hook was macro-etched in 50 per cent hydrochloric acid and found to have been machined from a solid block of forged steel. Its hardness was found to be 302 Brinell. Figure 7, a photomicrograph at X500 magnification, shows its structure to consist of tempered martensite. No decarburization was observed at the surface.

STRUCTURE OF STEEL HOOK.

Tempered martensite.

Macro-etching the steel hook showed that it had been machined from a solid rolled or forged block. Its microstructure, consisting of tempered martensite (see Figure 7), shows that its heat treatment has been satisfactory.
