April 26, 1945.

ORE DRESSING AND METALLURGICAL LABORATORIES.

Investigation No. 1854.

Metallurgical Examination of Flame-Hardened  
Cast Iron Cylinder Blocks.

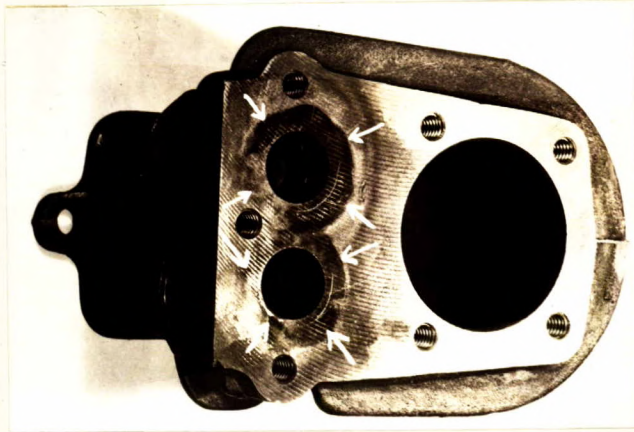
Figure 1.

FLAME-HARDENED CAST IRON CYLINDER BLOCK.

Note flame-hardened valve seats.

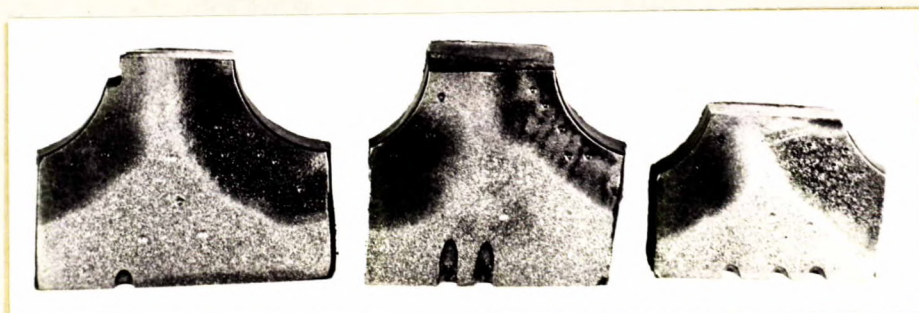
Figure 2.

SECTIONS CUT FROM BLOCKS (NITAL ETCH), SHOWING EXTENT OF HARDENED ZONE ON THE SURFACE ALONG VALVE SEATS.

The macro-examination reveals that the valve seats were hardened at the surface for a distance of approximately 5/16 inch around the valve holes. The depth of hardening varied to a maximum of 1/20 inch. Cylinder Block No. 2 appeared to have a more shallow hardened layer than did Blocks Nos. 1 and 3.

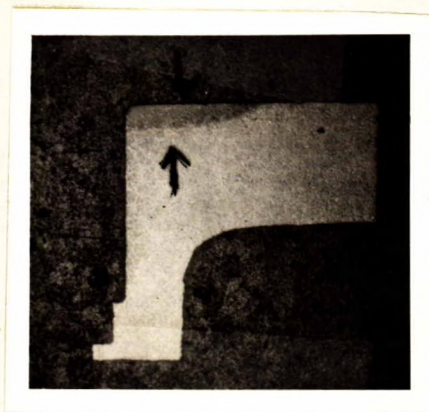
Figure 3.

SECTION FROM CYLINDER BLOCK No. 1 (NITAL ETCH), SHOWING DEPTH OF HARDENED ZONE ( $1/20$  INCH).

The shallow depth of hardness (less than 1/20 inch) would be considered inadequate. The depth of the hardened layer is generally controlled by using a constant intensity of the oxy-acetylene flame and varying the speed of the flame travel. The slower the speed the more heat is developed at the skin and the greater the penetration. A depth beyond 5/16 inch would result in the burning of the surface metal and the presence of excessive quenching stresses with a consequent distortion. The deleterious conditions can be minimized by the use of alloying elements.

2. The depth of the hardened layer was also inadequate (1/20 inch maximum).

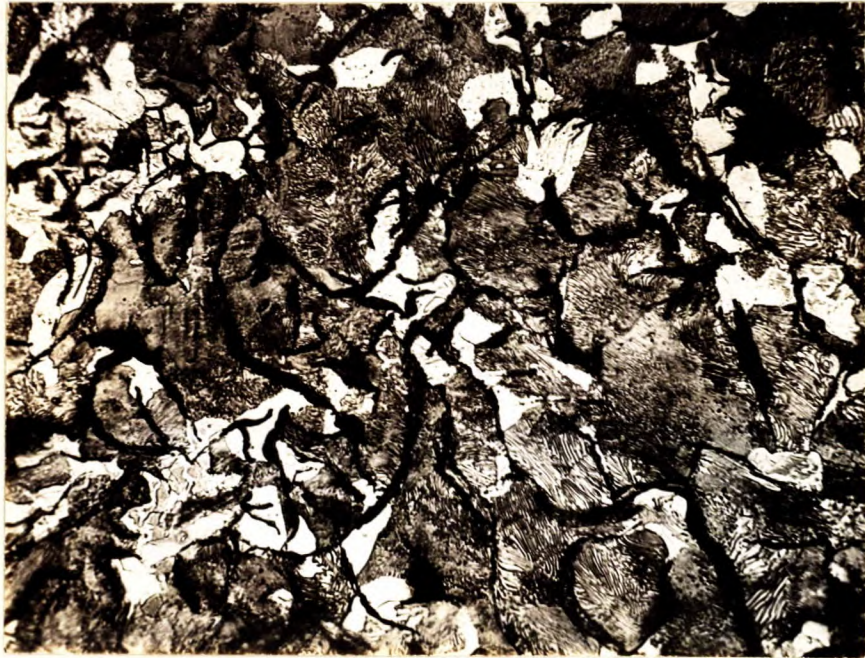
Figure 4.

CYLINDER BLOCK NO. 1.

Unhardened zone showing pearlite, ferrite, and graphite.

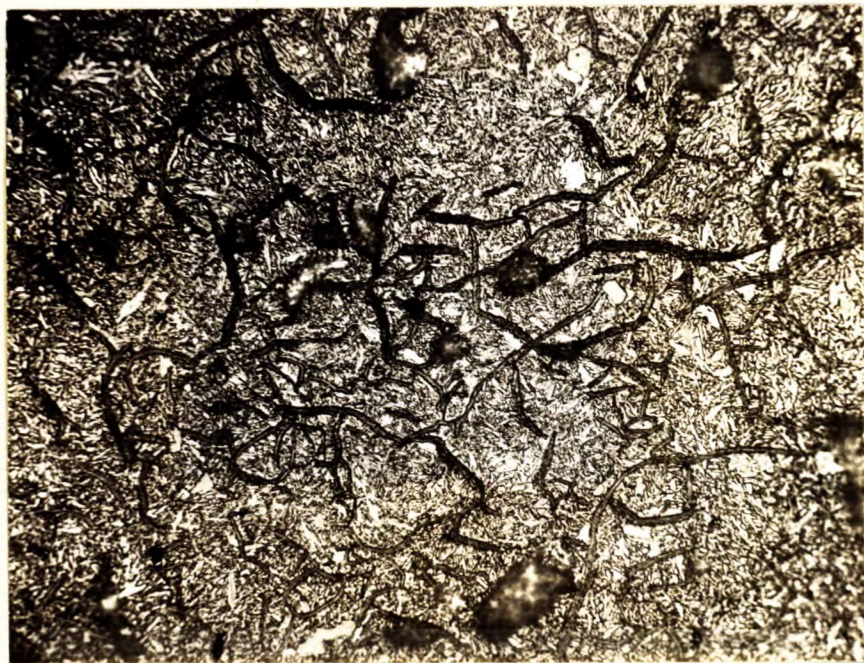
Figure 5.

CYLINDER BLOCK NO. 1.

Hardened zone showing martensite and graphite.

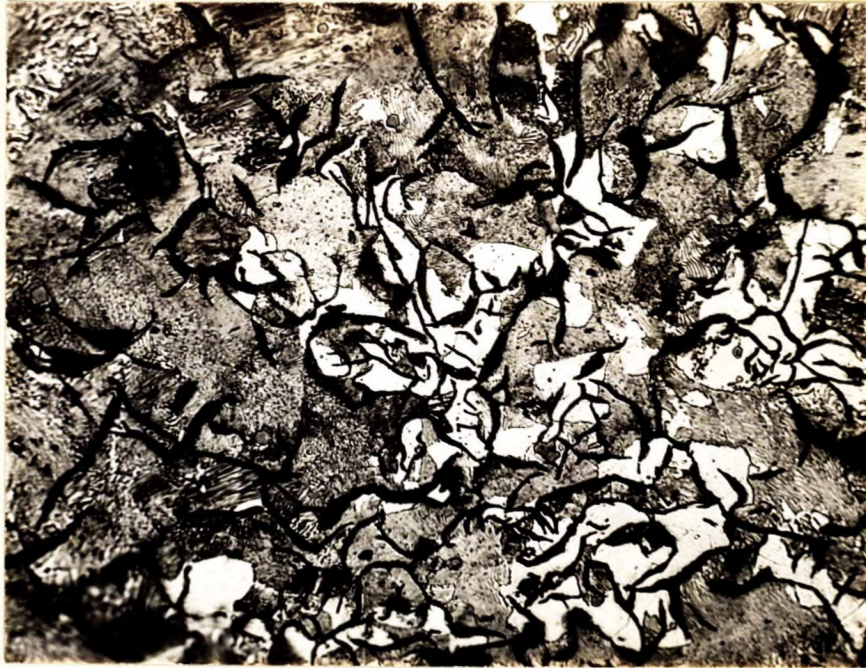
Figure 6.

CYLINDER BLOCK NO. 2.

Unhardened zone showing pearlite, ferrite, and graphite.

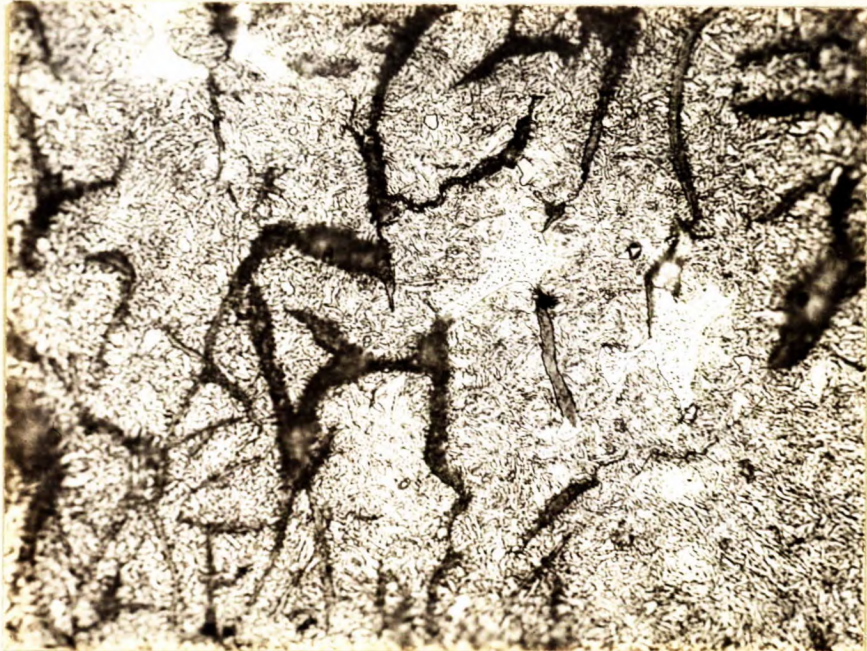
Figure 7.

CYLINDER BLOCK NO. 2.

Hardened zone showing martensite and graphite.  
Phosphide eutectic also evident.

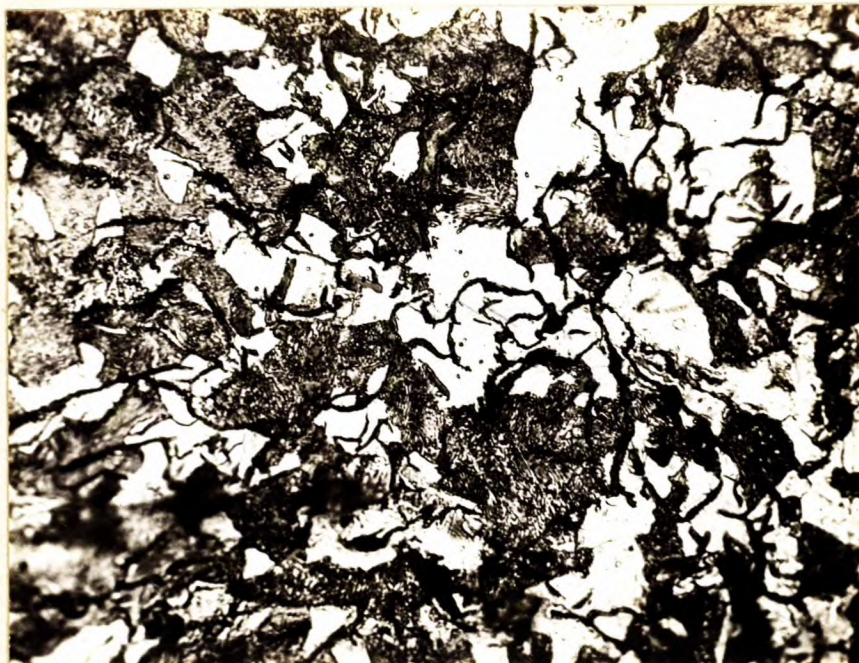
Figure 8.

CYLINDER BLOCK NO. 3.

Unhardened zone showing ferrite, pearlite, and graphite.

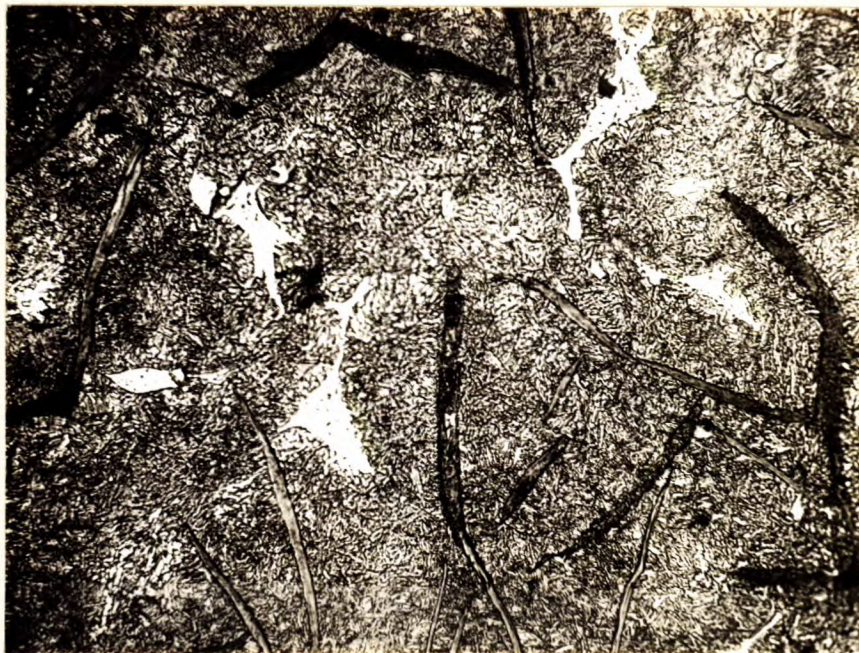
Figure 9.

CYLINDER BLOCK NO. 3.

Hardened zone showing martensite and graphite.  
Phosphide eutectic also evident.
