April 30, 1945.

ORE DRESSING AND METALLURGICAL LABORATORIES.

Investigation No. 1855.

Metallurgical Examination of a Welded Steel
Enemy Incendiary Container.

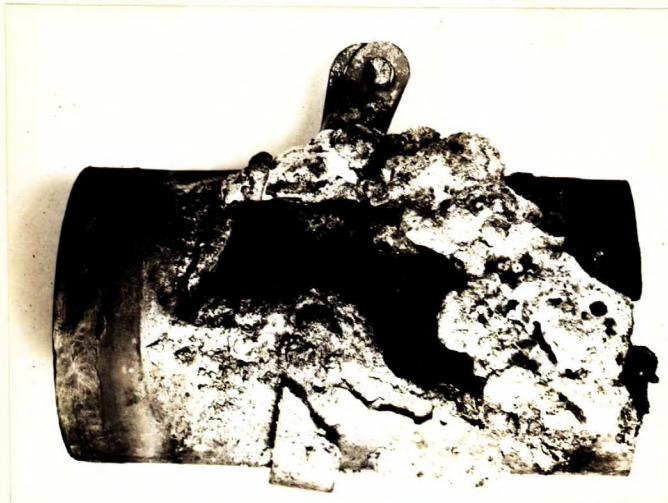
Figure 1.

WELDED STEEL
CONTAINER RECEIVED.
(Approximately 2/5
actual size).

The welded steel container consisted of a cylinder, approximately 10 inches high by 3-3/4 inches in diameter, made by welding a wall 1/16-inch thick onto a base 11/16 inch in thickness (see Figure 2). The heat resulting from the burning of the incendiary materials had burnt a large hole through the wall of the container (see Figure 1). Some of the molten metal, subsequently solidified, was found adhering to the wall of the container.

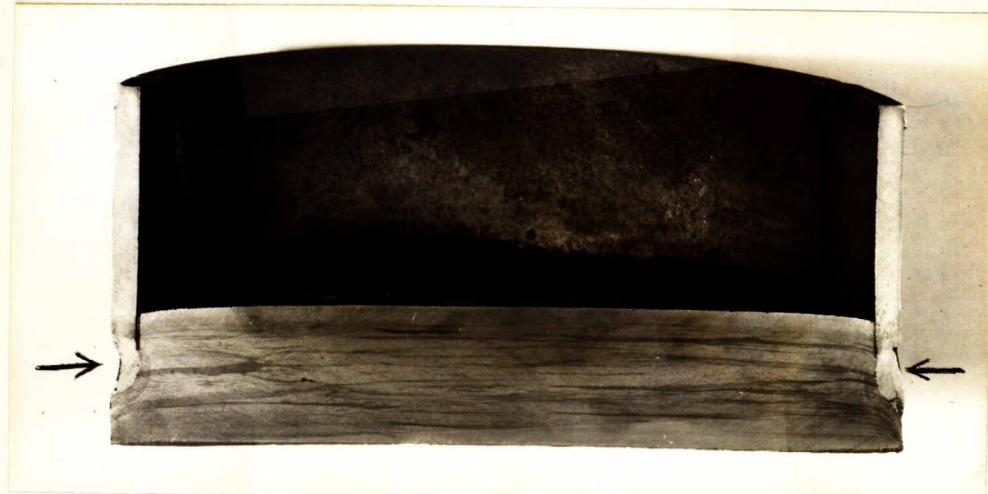
Figure 2.

A section was cut vertically through the cylinder, in order to show the method of welding the wall onto the base plate (see Figure 2). A close-up of this weld is seen in Figure 3. The narrow heat-affected zone is characteristic of arc welding.

METHOD OF ARC-WELDING WALL ONTO BASE.

Note low centre of weld.

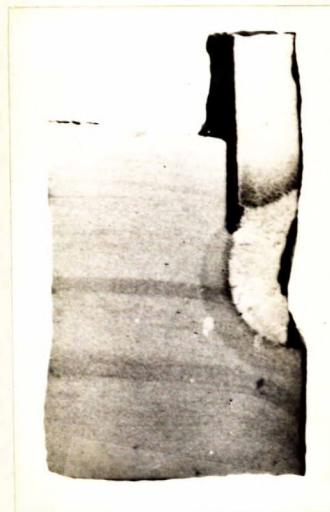
Figure 3.

ONE OF THE WELDS IN FIGURE 2.

Note narrow heat-affected zone
characteristic of arc welding.

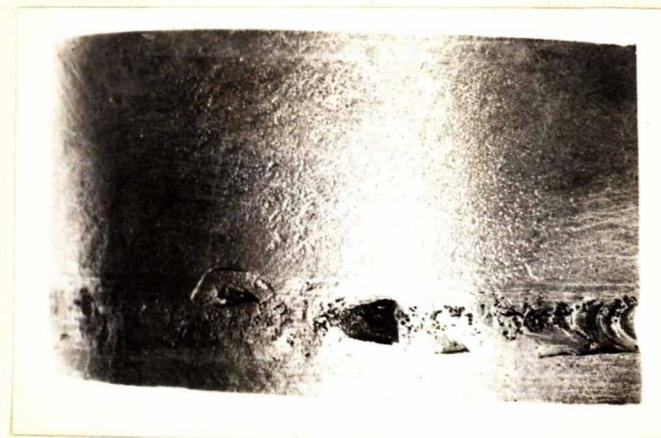
Figure 4.

The weld joining the cylinder wall to the base plate shows severe arc craters and undercutting (Figure 4). These defects are caused by:

- (1) Too high welding speeds,
- (2) Use of bare electrodes, which are difficult to control accurately.

That bare electrodes were used appears to be confirmed by the porous surfaces of all the welds. It should also be recognized that porosity can be the result of welding over rusty or dirty material.

ARC CRATERS IN WELD JOINING
WALL TO BASE PLATE.

Probably resulting from either

- (1) too high a welding speed, or
- (2) use of bare electrodes, which are difficult to control accurately.

Note undercutting at right.

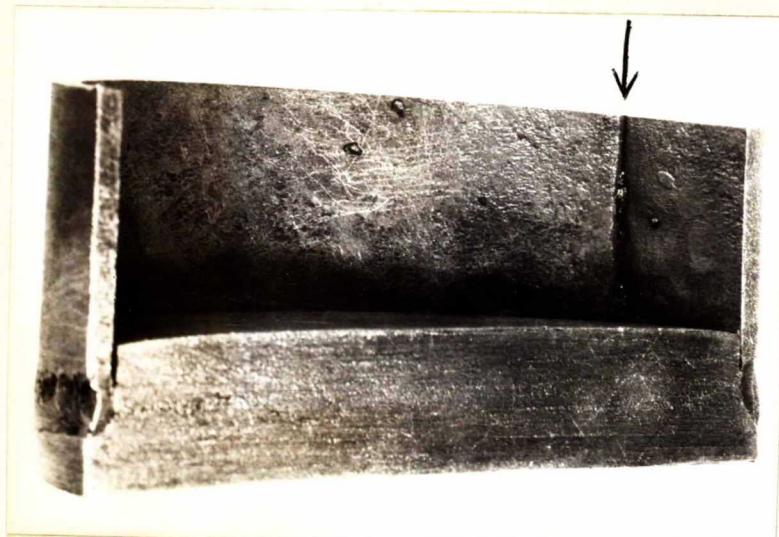
Figure 5.

same types of defects. In addition, it is apparent that the material was either improperly bent to shape, or insufficiently jigged to ensure proper alignment of the edges. No back-up has been used on this weld and, as a result, incomplete penetration has occurred (see Figure 5). These two factors have resulted in a severe notch at the root of the weld (see Figure 6).

INSIDE OF VERTICAL WELD OF CYLINDER WALL.

Note severe notch at root of weld.

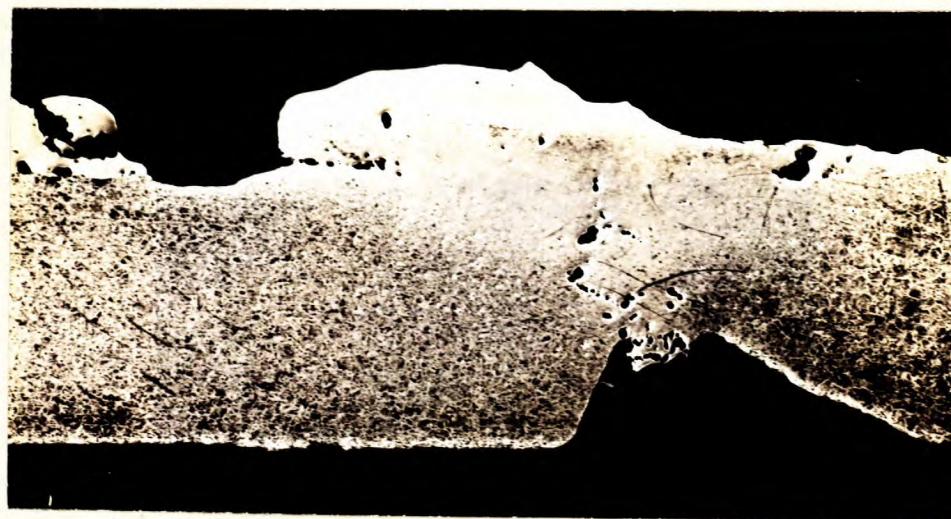
Figure 6.

POOR WELD IN WALL OF CYLINDER.

- Note:
- (1) Porosity along fusion line, possibly resulting from improper joint cleaning prior to welding.
 - (2) Misalignment of edges to be welded, resulting in pronounced root notch.
 - (3) White upper portion is metal from thermite reaction.
-

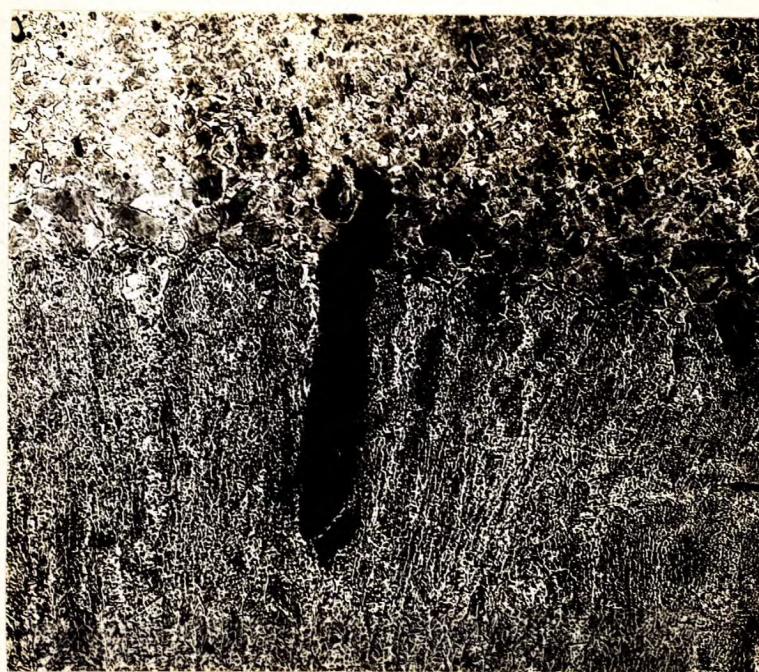
Figure 7.

Figures 7, 8, 9 and 10 are photomicrographs, all taken at X100 magnification. Figure 7 shows the porosity occurring at the junction of the weld joining the base plate to the cylinder wall. The small cracks along the fusion line probably resulted from inclusions.

POROSITY AT JUNCTION OF WELD JOINING
BASE PLATE TO CYLINDER WALL.

Note small cracks along fusion line,
resulting from inclusions.

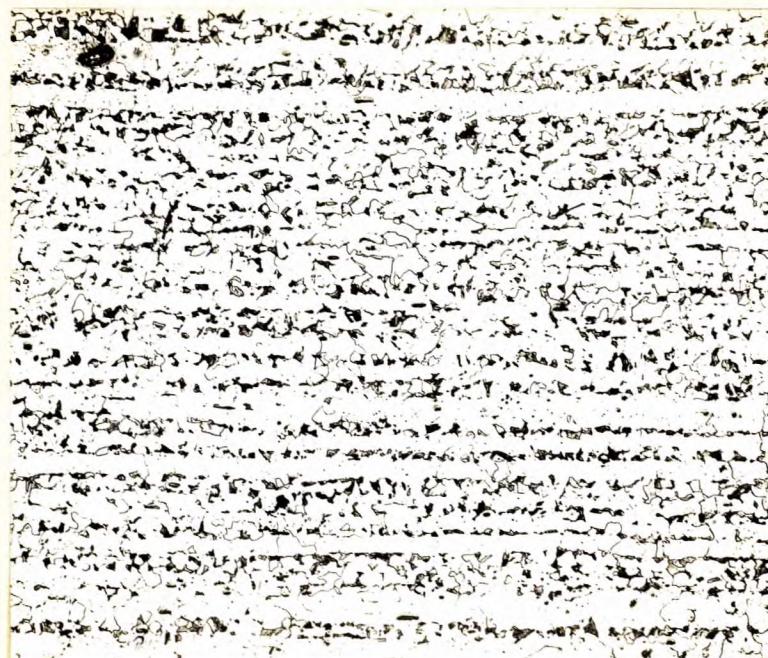
Figure 8.

Figures 8 and 9 indicate the microstructure of the base plate and wall respectively, consisting of ferrite and pearlite, typical of hot-rolled low-carbon steel.

MICROSTRUCTURE OF CYLINDER BASE PLATE.

Ferrite and pearlite.

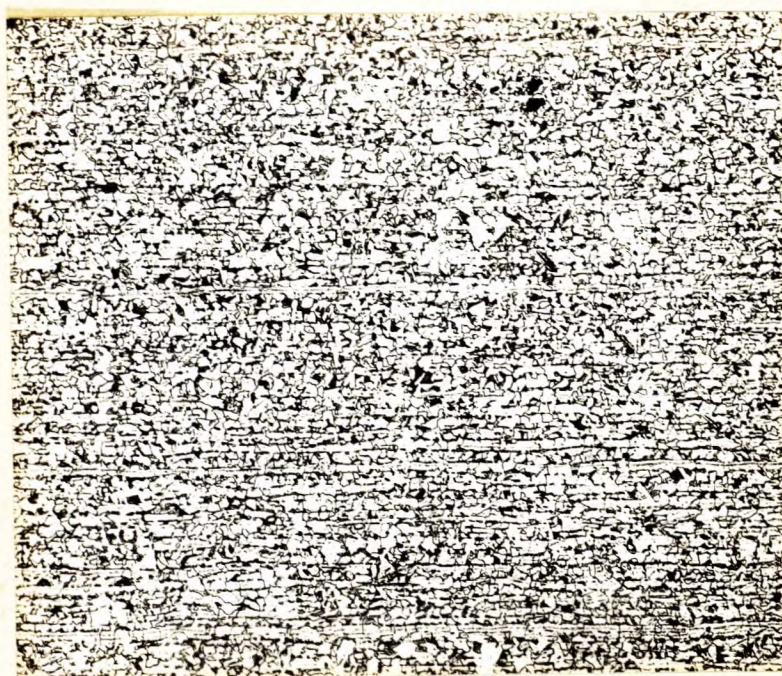
Figure 9.

MICROSTRUCTURE OF CYLINDER WALL.

Ferrite and pearlite.

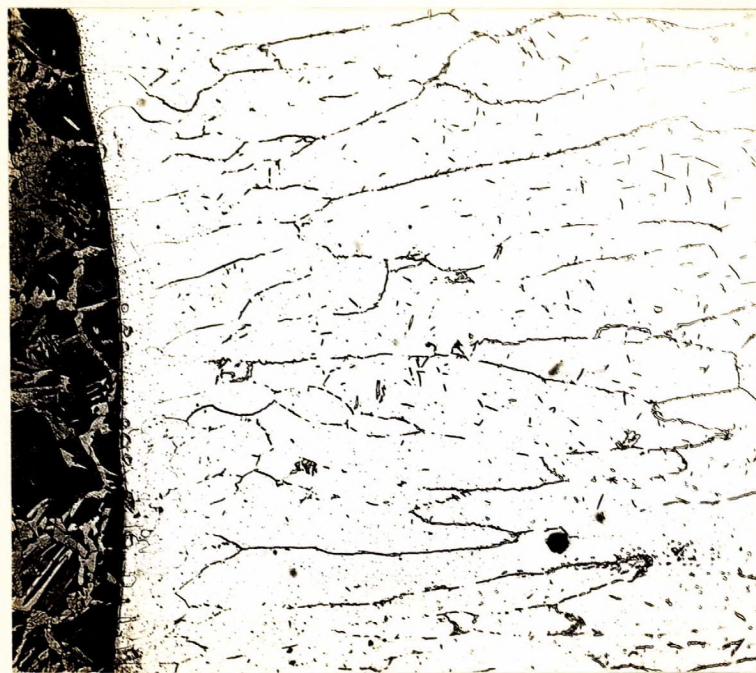
Figure 10.

Figure 10 shows the microstructure, at X100 magnification, of the metal adhering to the wall of the cylinder. This metal probably resulted from the thermite reaction.

The spectroscopic examination of the metal adhering to the wall of the cylinder (see Figure 10), which shows a preponderance of iron, silicon and aluminium, lends support to the opinion that this metal is a ferrous alloy resulting from the thermite reaction. The comparatively high hardness (337 to 347 Vickers) also proves that it is a ferrous alloy.

MICROSTRUCTURE OF THERMITE METAL
ADHERING TO WALL OF CYLINDER.
