ORE DRESSING AND METALLURGICAL LABORATORIES.

Investigation No. 1856.

Corrosion Resistance of Painted and Electroplated Steel Nuts, Bolts and Washers.

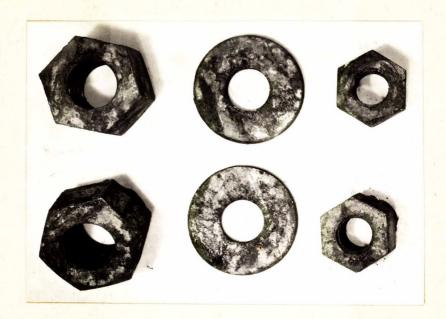
(a)

The painted samples were removed from the salt spray cabinet at the end of 40 hours. Without exception they were badly corroded, as shown in Figures la and 1b. General break-down took place both on threaded and on flat surfaces.

PAINTED STEEL SAMPLES AFTER 40 HOURS IN THE SALT SPRAY CORROSION CABINET.

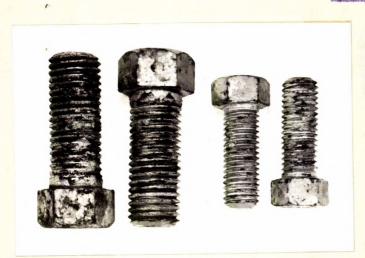
Figure 3.

The coated steel samples, both painted and electroplated, were removed from the Weather-Ometer at the end of
70 hours. All of the painted samples showed considerable evidence of corrosion, as shown in Figures 3a and 3b. Breakdown

took place both on threaded and on flat surfaces.

PAINTED STEEL SAMPLES AFTER 70 HOURS IN THE WEATHER-OMETER CORROSION TEST.
