ORE DRESSING AND METALLURGICAL LABORATORIES.

Investigation No. 1863.

Metallurgical Examination of a Pitman
Shaft Gear, Twisted in Service.

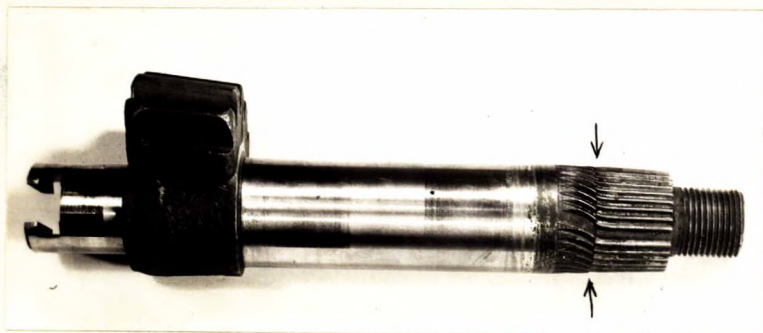
Figure 1.

On March 20, 1945, one Pitman shaft gear which had twisted in service (see Figure 1) was submitted by the Controller General, Inspection Board of United Kingdom and Canada, Ottawa, Ontario, under Analysis Requisition No. O.T. 4341. A drawing, No. 269177, covering the details of the component, was also submitted.

PITMAN SHAFT GEAR TWISTED IN SERVICE.

Summarizing, it is thought that the failure had occurred in torsion because of the low strength of the steel, resulting from improper quenching.

It is recommended that the spline shafts be heat-treated as follows, in order that a hardness range of 32 to 36 Rockwell "C" be achieved throughout the section:

1. Heat at 1575° F. for 1 hour.
2. Quench in oil.
3. Temper at 300° F. for 1 hour.

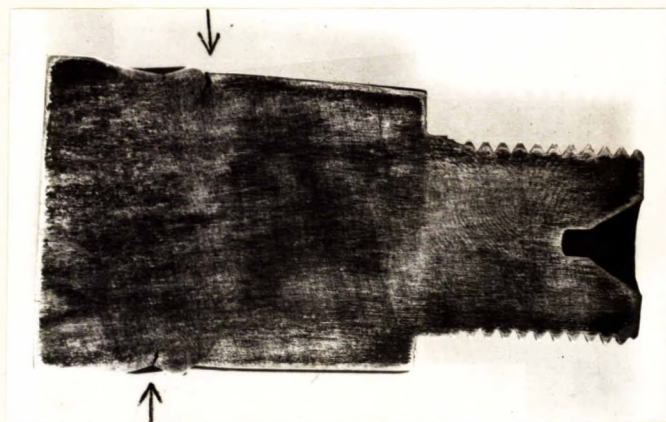
Figure 2.

Macroscopic examination made on a longitudinal section out through the shaft revealed cracks extending inward from the surface at the location where twisting had occurred (see Figure 2). These cracks had formed as a result of the twisting of the metal.

MACRO-EXAMINATION SHOWING CRACKS NEAR
SURFACE AT TWISTED AREA.

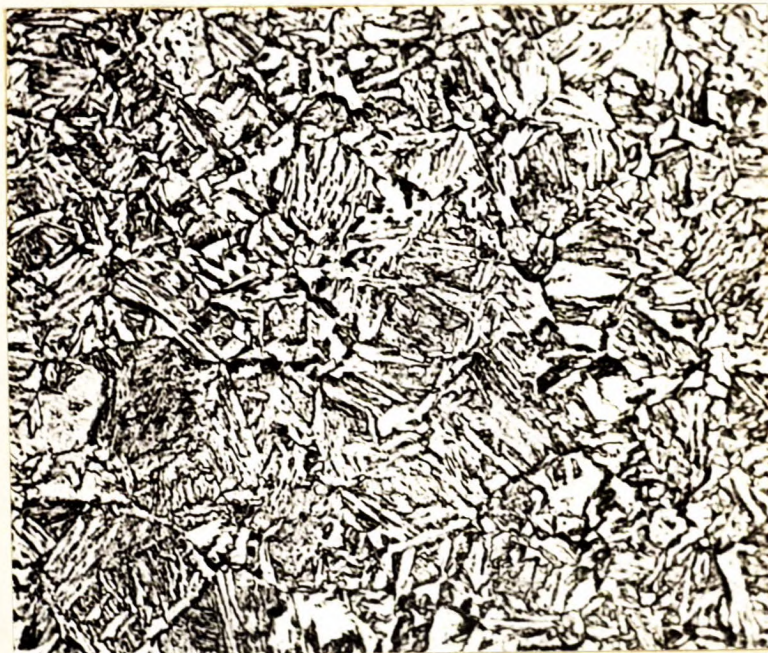
Figure 3.

MICROSTRUCTURE AT CENTRE.

Note large quantities of ferrite.

The photomicrograph in Figure 3, which shows the presence of excessive ferrite, would point to improper quenching. It is evident from this photomicrograph that the cooling rate had not been rapid enough to miss the nose of the S-curve, thus resulting in the precipitation of much ferrite.

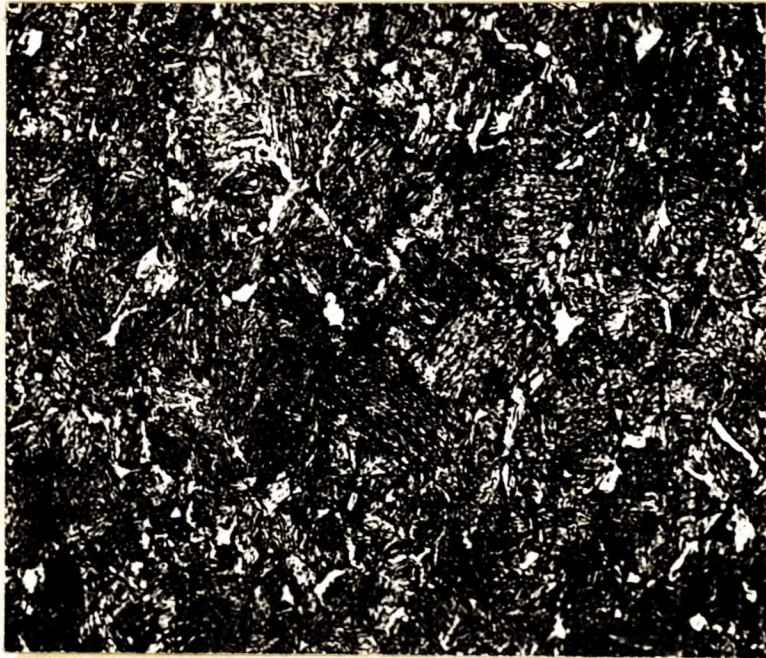
Figure 4.

MICROSTRUCTURE NEAR SURFACE.

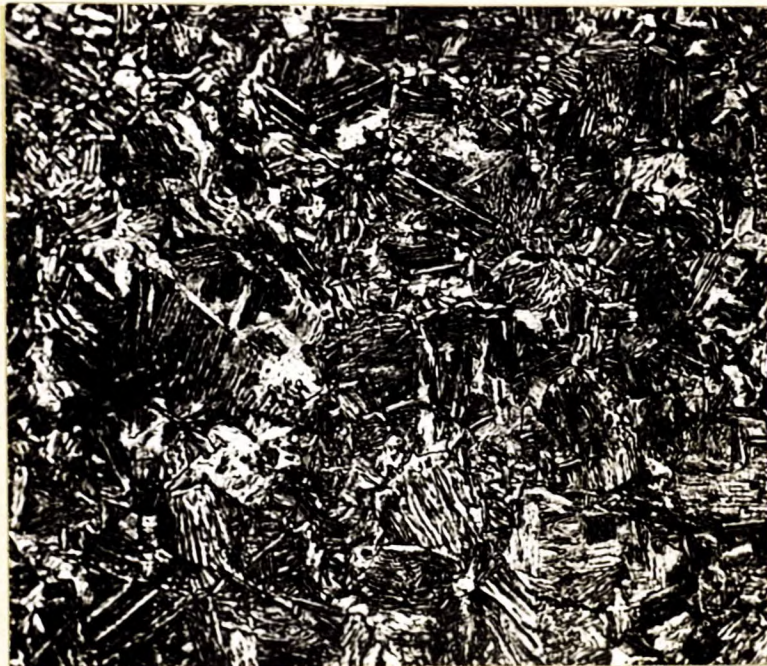
Figure 5.

MICROSTRUCTURE AFTER HEAT TREATMENT (OIL-
QUENCHED FROM 1575° F., AND DRAWN AT 300° F.).

It was found that oil-quenching from 1575° F., followed by drawing at 300° F., resulted in a hardness varying from 32½ to 36 Rockwell "C", which appears to answer the requirements.
