Investigation No. 1867.

Nature of Corrosion on Under Surfaces of Wings,  
Fuselages and Tail Units of Lockheed Model  
12A Aircraft CF-BZM and CF-BZN.

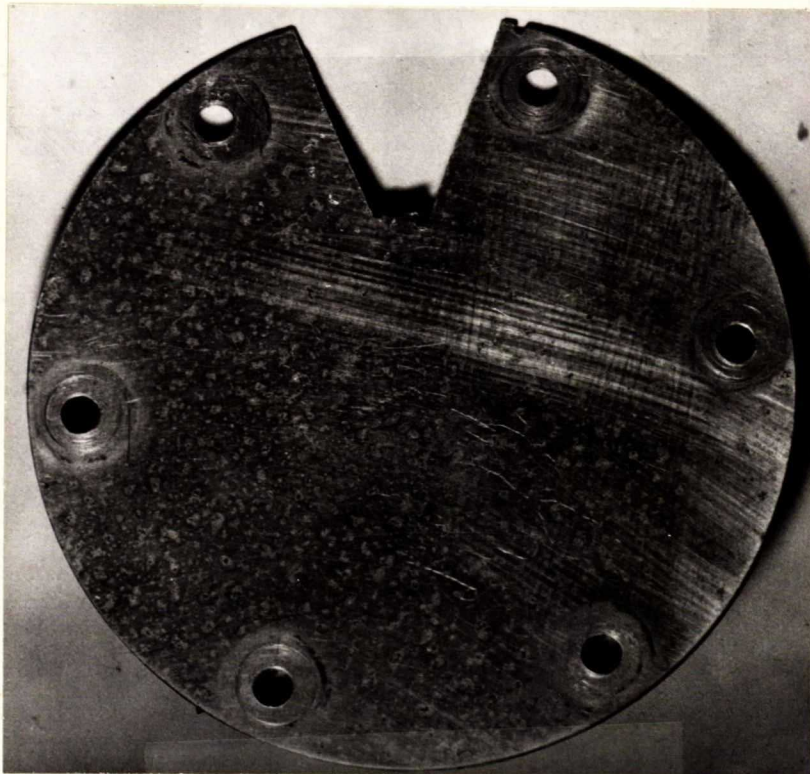
(a)

A typical piece was cut from the sample, for microscopic examination. The remainder was photographed in order to obtain a permanent record of the appearance of the corrosion (see Figures 1a and 1b).

1. The shallow pits which did not penetrate through the aluminium layer on the surface of the alclad appeared to be of little importance.
2. Pits which penetrated the aluminium layer and entered the duralumin underneath were much more serious, because corrosion might continue at these points until serious damage has been produced.
3. This continuation of corrosion would be much slower if the aircraft is operated inland where it will not come in contact with salt solution and salt spray such as are encountered in the vicinity of the ocean.
4. It is possible, as suggested, that the corrosion on the bottom of the aircraft was due to the improper use of cleaning materials.

CORRODED SAMPLE OF ALGLAD TAKEN FROM THE LOWER  
WING SURFACE OF LOCKHEED AIRCRAFT CF-BZM.

1. In order to remove any traces of cleaning material which might still be present in the pits, it is recommended that the surface of the metal be thoroughly scrubbed and rinsed with hot water. No chemicals should be added to the water.

2. Should these aircraft be used, it is recommended that they should be watched closely to determine the rate at which the corrosion is progressing.

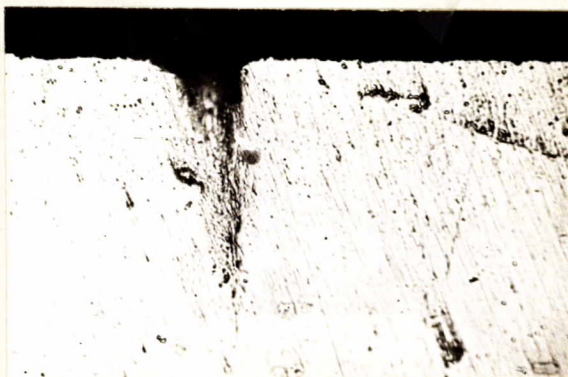
Figure 2.

The cut piece was mounted and polished, and the pits on the surface were examined under the microscope. Most of the pits observed were quite shallow and seemed to be of little importance. A very few of them were comparatively deep. The depth of the deepest one was found to be 0.003 inch. This pit was photographed (see Figure 2).

DEEPEST PIT FOUND ON MICROSCOPIC EXAMINATION  
OF THE CORRODED SURFACE OF THE ALGLAD.
