ORE DRESSING AND METALLURGICAL LABORATORIES.

Investigation No. 1868.

Metallurgical Examination of Snowmobile Sprocket
and Cross Link after Field Test.

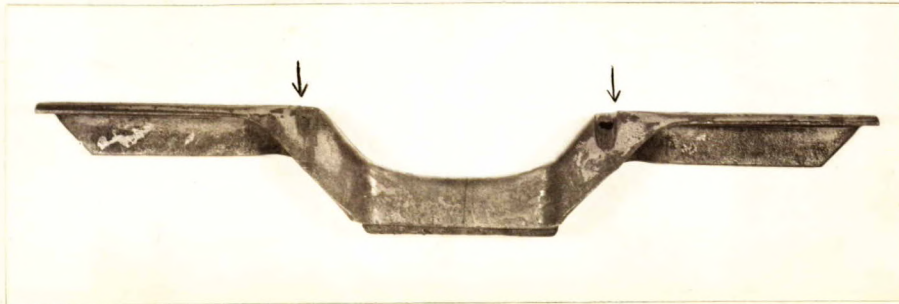
Figure 1.

SNOWMOBILE CROSS LINK.

Arrows indicate bearing surfaces,
points of excessive wear.

The chemical analysis of the snowmobile cross link is in agreement with the specification for SAE 4340 steel, with the exception of the carbon and manganese contents which are slightly higher. Hardness determinations and microscopic examination have shown that the link has been properly quenched and drawn to the specified hardness of 42-47 Rockwell "C".

1. The Snowmobile cross link has been homogeneously hardened to the specified 42-47 Rockwell "C" without decarburization at any of the surfaces.
2. If excessive wear should continue to be a problem with these cross links, the resistance may be improved by the use of a somewhat higher carbon content. Past experience with wear problems has shown that better wear resistance, for the same hardness, is obtained with carbon contents above 0.50 per cent.

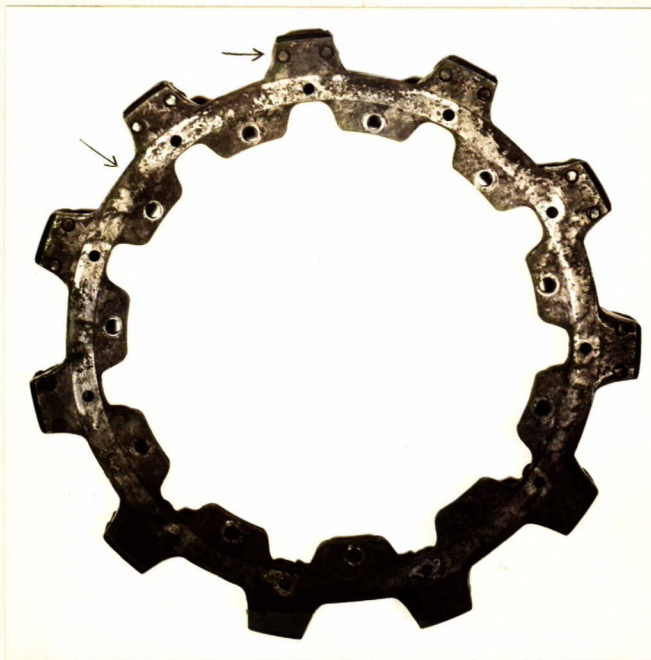
Figure 2.

SNOWMOBILE SPROCKET.

Arrows indicate bearing
surfaces, badly worn.

Specifications required that the sprocket bearing surfaces be induction-hardened to Rockwell "C" 57 ± 3 to a depth of $5/32 \pm 1/32$ inches, but this original surface has worn away and it is not possible to arrive at any definite conclusion regarding its hardness or microstructure. Comparison of the

worn sprocket with others which had not been in service showed that there has been as much wear on the side of the tooth as on the bay of the sprocket. Therefore, the hardness variations shown in Figure 3 are the result of non-uniform depth of hardening on the original bearing surface.

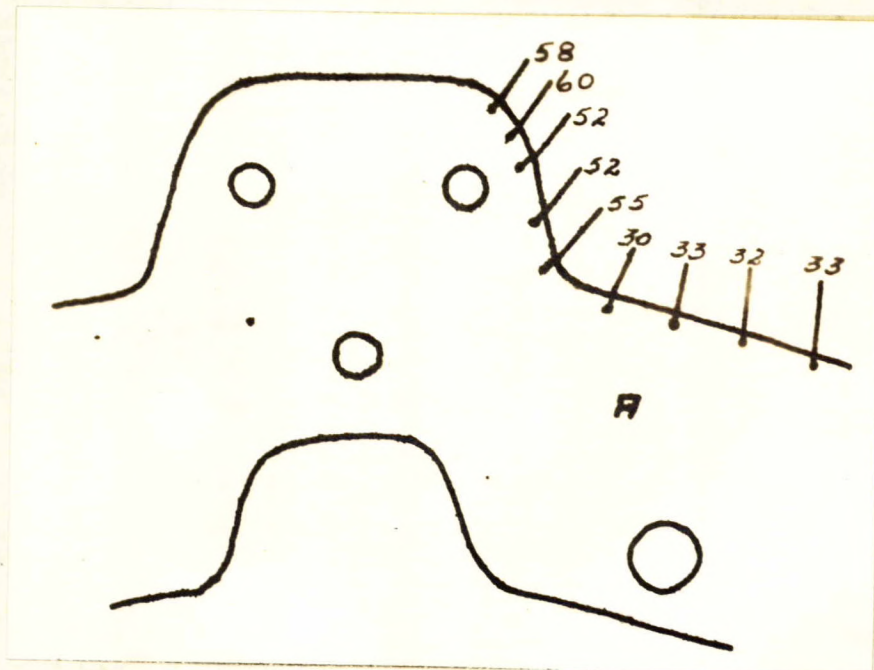
Hardness readings were taken on the sprocket about 1/16 inch from the bearing surface, as shown in Figure 3. Readings were taken with a Vickers machine (using a 10-kilogram load) and converted to Rockwell "C".

HARDNESS SURVEY.

Hardness values varied from 30 to 58 Rockwell "C", highest results being obtained on the tooth.

1. The Snowmobile sprocket has a chemical analysis corresponding to SAE 1050 specifications.
2. The hardness 1/16 inch from the bearing surface varied from 30 to 60 Rockwell "C". The higher values were obtained on the tooth of the sprocket. This variation in hardness indicates non-uniform depth of hardening on the original bearing surface, either because of faulty heat treatment or partial

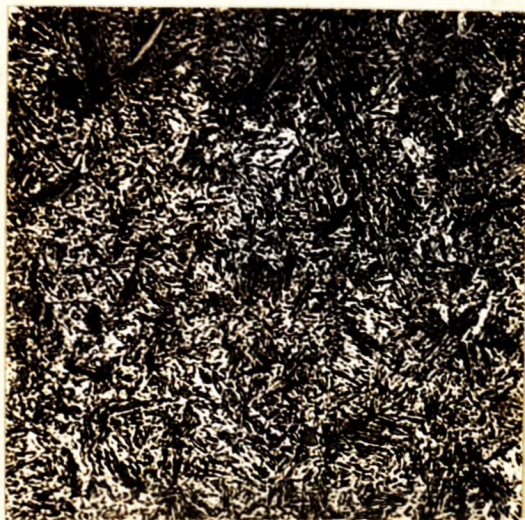
Figure 4.

was completely martensitic (see Figure 4). At points of lower hardness the microstructure consisted of troostite as well as martensite (see Figure 5).

SNOWMOBILE SPROCKET.

Martensitic structure.

Hardness, 55 to 58
Rockwell "C".

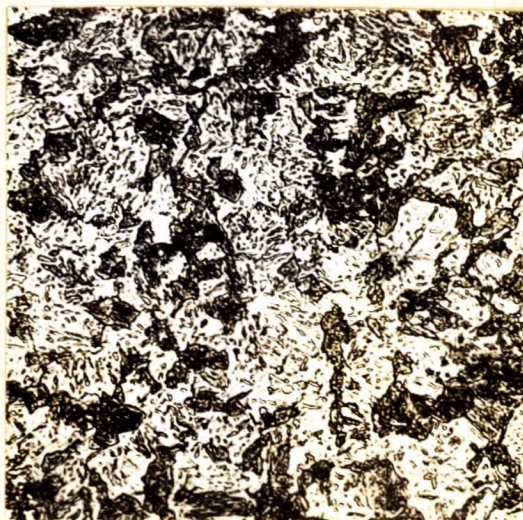
Figure 5.

SNOWMOBILE SPROCKET.

Tempered martensite
and troostite.

Hardness, 30 to 33
Rockwell "C".

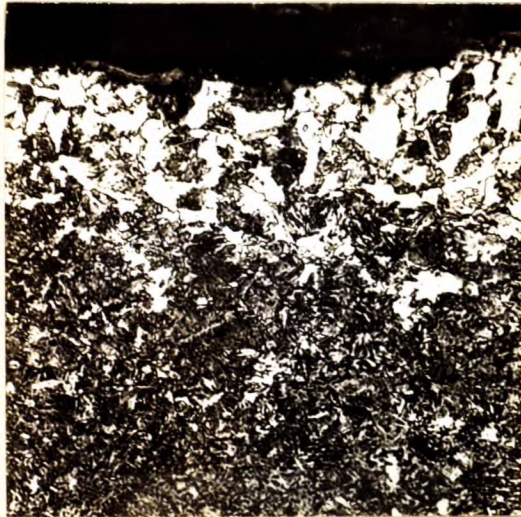
Figure 6.

Surfaces of the sprocket which had not been exposed to wear (e.g., point A in Figure 3) were partially decarburized to a depth of 0.008-0.010 inch (see Figure 6).

SNOWMOBILE SPROCKET.

Ferrite, troostite and
tempered martensite.

Partial decarburization on
sprocket surface which had
not been exposed to wearing
conditions.

The partial decarburization observed on the unworn parts, if present on the bearing surfaces before field test, would have been the cause of very rapid wear down to a depth of 0.010 inch.

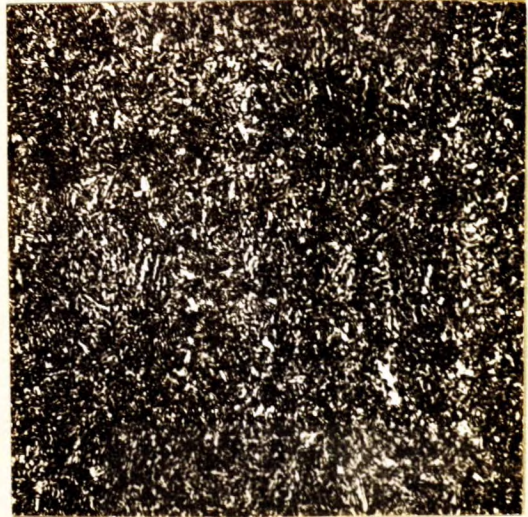
Figure 7.

The microstructure of sections cut from the cross link was uniformly tempered martensite without any partial decarburization at the surface (see Figure 7).

SNOWMOBILE CROSS LINK.

Tempered martensite.
