May 17, 1945.

ORE DRESSING AND METALLURGICAL LABORATORIES.

Investigation No. 1869.

Examination of a Fractured Cast Iron Generator
Crankshaft from H.M.C.S. "Lachine".

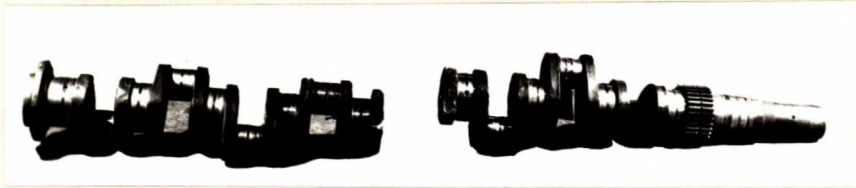
Figure 1.

Figure 1 is a photograph of the broken crankshaft "as received" and shows the break between the fourth journal from the driving gear and web. The web fracture is shown in Figure 2. A section cut through the journal at the point of fracture is shown in Figure 3. It will be noted that the metal is quite sound.

CRANKSHAFT AS RECEIVED.
(Approximately 1/24 actual size).

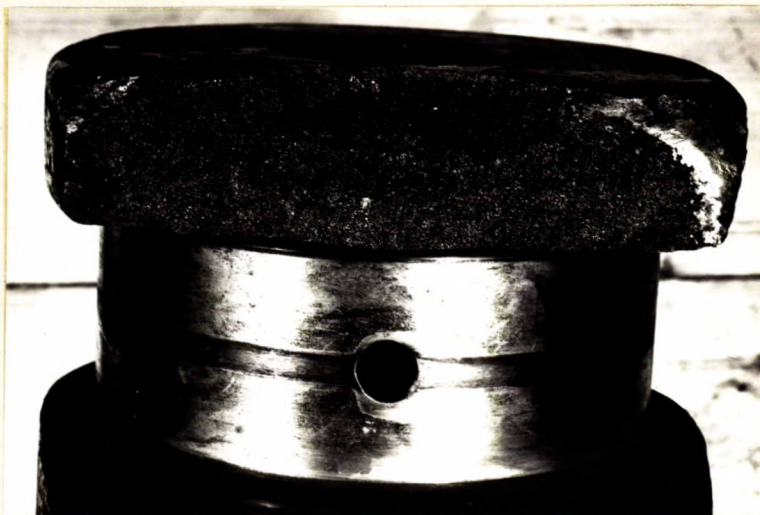
Figure 2.

SHOWING FRACTURE OF CRANKSHAFT WEB.
(Approximately to size).

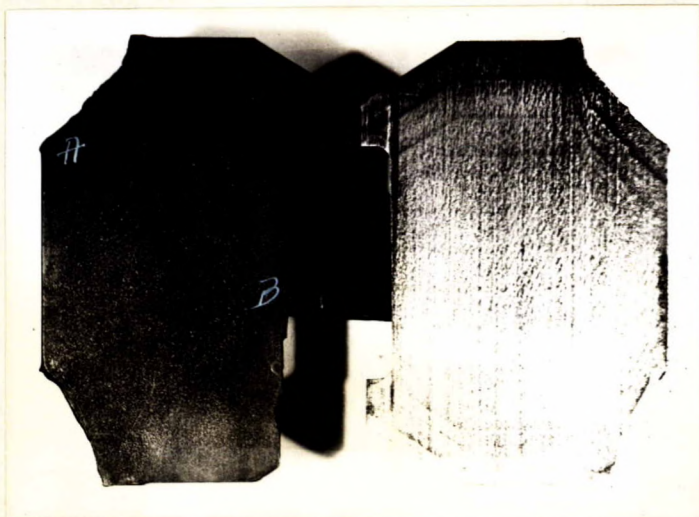
Figure 3.

SECTION THROUGH JOURNAL.
(Approximately 1/5 size).

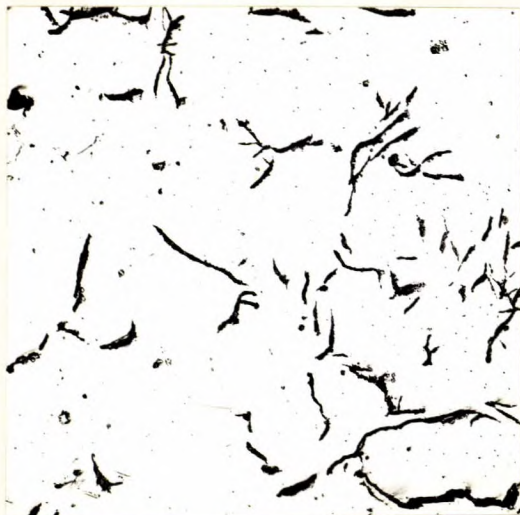
Figure 4.

Figure 4 is a photograph, at X100 magnification, showing the size and distribution of the graphite flakes in the unetched iron. Figure 5 is a photomicrograph, at X100 magnification, showing the nital-etched structure of the iron. The graphite flakes are normal and the matrix is pearlitic, with some quite small areas of ferrite.

X100, unetched.

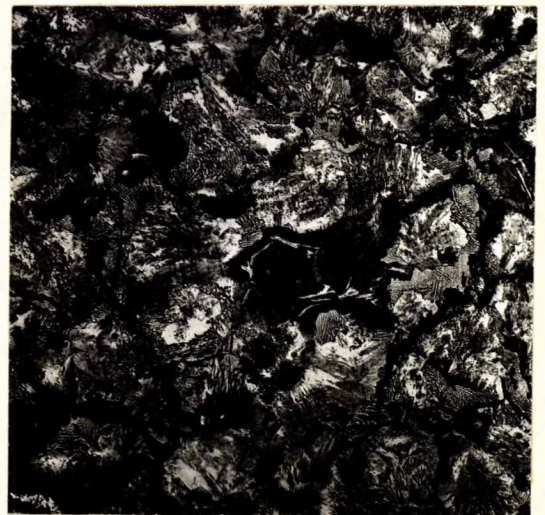
Figure 5.

X100, etched in 2 per cent nital.
