ORE DRESSING AND METALLURGICAL LABORATORIES.

Investigation No. 1870.

Metallurgical Examination of
2-Inch Mortar Signal Bombs.

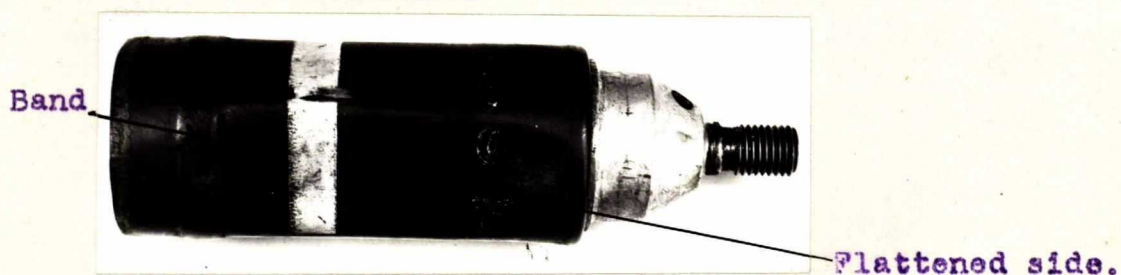
Figure 1.

Figure 1 is a photograph showing the failed steel bomb as submitted.

The metal tube appeared to have collapsed in the proof firing test. However, no breaks were observed in the tubing body of the bomb. The tube was found to be 0.037 inch thick.

The results of this investigation would indicate that the failure of the tube was due to its low yield strength. The low mechanical properties of the failed tubing are probably due to drawing the material at too high a temperature

or to full annealing rather than tempering. It is recommended that the temperature of the draw should not exceed 1000° F. and that the annealing be carried out in a controlled atmosphere to prevent decarburization.

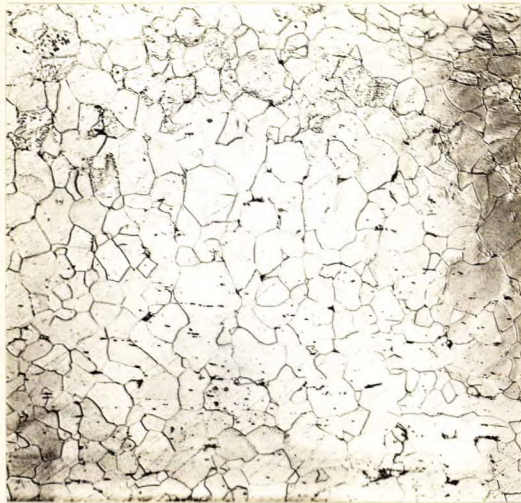
Figure 2.

LONGITUDINAL SECTION, SIGNAL
BOMB SAMPLED FROM STOCK WHICH
PASSED PROOF FIRING TEST.

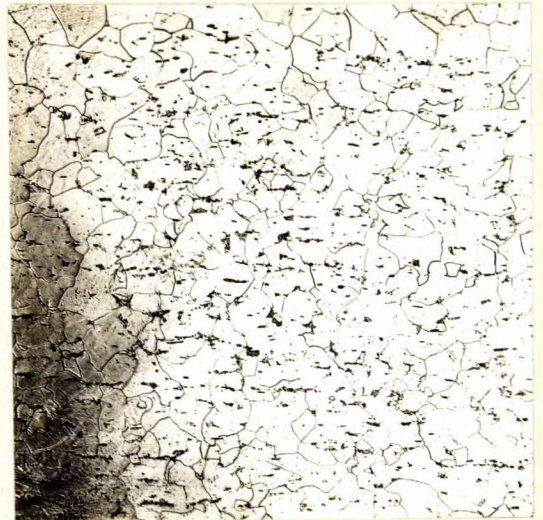
Figure 3.

LONGITUDINAL SECTION, SIGNAL
BOMB FAILED IN PROOF FIRING.

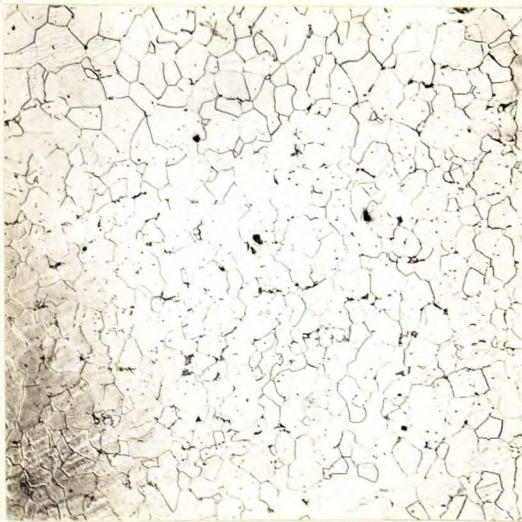
Figure 4.

TRANSVERSE SECTION, SIGNAL
BOMB SAMPLED FROM STOCK
WHICH PASSED PROOF FIRING TEST.

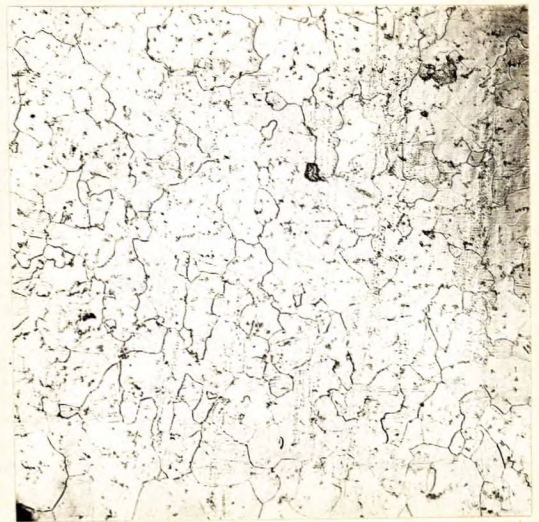
Figure 5.

TRANSVERSE SECTION, SIGNAL
BOMB FAILED IN PROOF FIRING.

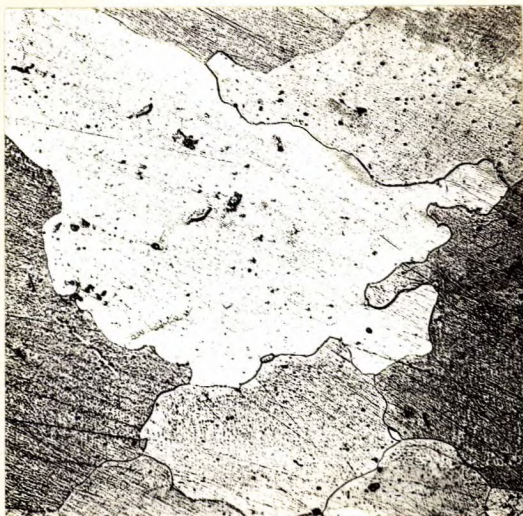
steels were fairly fine-grained. However, some grain growth was observed in the heavily worked sections of the tubes. This condition is illustrated in Figure 6. The structure of the steel before and after annealing is shown in Figures 7 and 8. It will be observed that the steel was heavily decarburized in the annealing operation.

SHOWING LARGE GRAIN STRUCTURE AT BENT SECTION
OF TUBING AFTER 2ND DRAW.

Specimen No. 4. Carbon, 0.04 per cent.

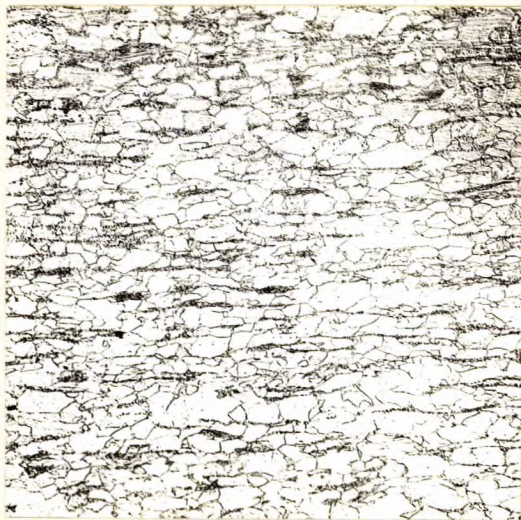
Figure 7.

BEFORE ANNEAL.

Showing structure after 1st draw.

Carbon, 0.08 per cent.

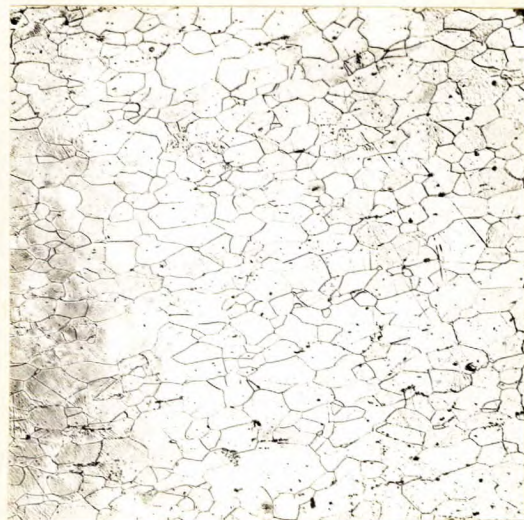
Figure 8.

AFTER ANNEAL.

Showing structure after 1st
anneal and 2nd draw.

Carbon, 0.04 per cent.

The chemical composition of the steel used in the manufacture of the signal bombs submitted was similar to that of an SAE 1010 steel. Although there were two high carbon content values reported for two tubes in Operations Nos. 6 and 7, the average values after the annealing operation definitely indicate a marked drop in carbon. This was confirmed in the microscopic examination. Decarburization can be prevented by annealing in a controlled atmosphere.
