ORE DRESSING AND METALLURGICAL LABORATORIES.

Investigation No. 1871.

Metallurgical Examination of Steering  
End Ball Sockets from Armoured Truck.

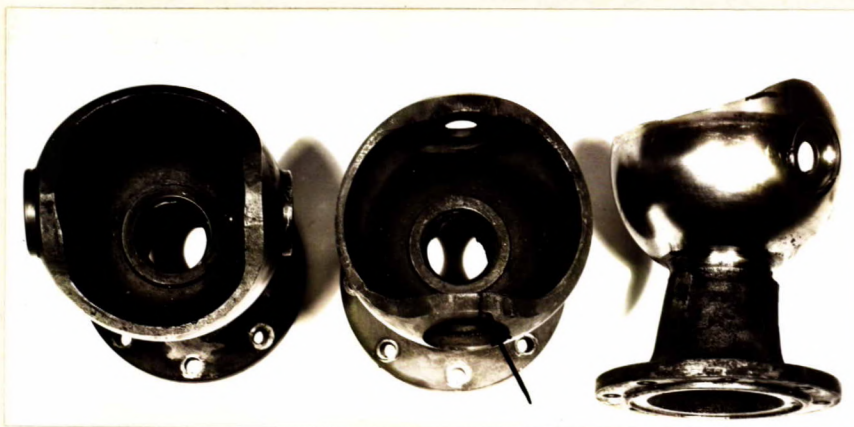
Figure 1.

THE THREE FAILED STEERING END BALL SOCKETS  
AS RECEIVED.

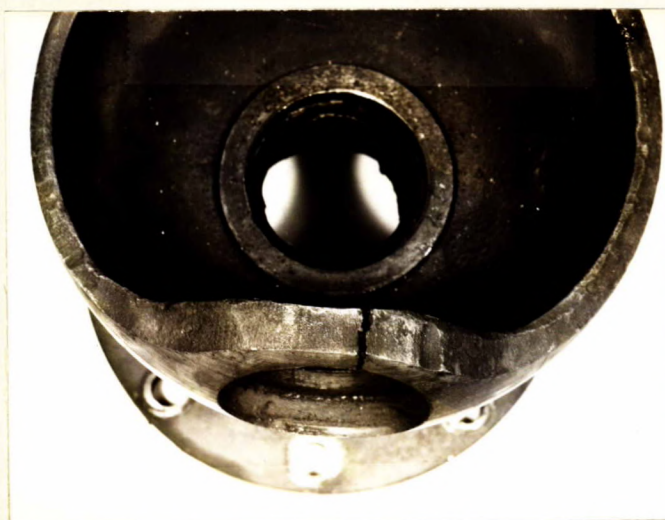
Figure 2.

CRACK IN BALL SOCKET NO. 2 (see  
arrow, Figure 1), ENLARGED.

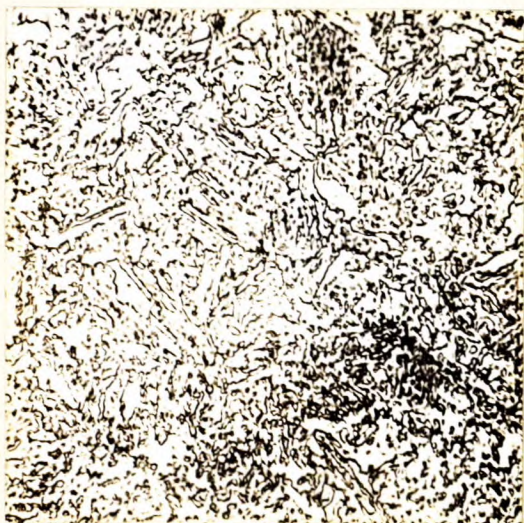
Figure 3.

Microscopic examination of specimens cut from each ball socket disclosed that the three castings submitted because of failure had a similar microstructure, consisting of spheroidized carbides in a spheroidized matrix, produced, no doubt, by drawing at a temperature just under the lower critical. These microstructures are illustrated in Figures 3 and 4, photomicrographs at 1000 and 1500 diameters of Sockets Nos. 2 and 3 respectively.

Ball Socket No. 2.

Drawn martensite and  
spheroidized carbides.

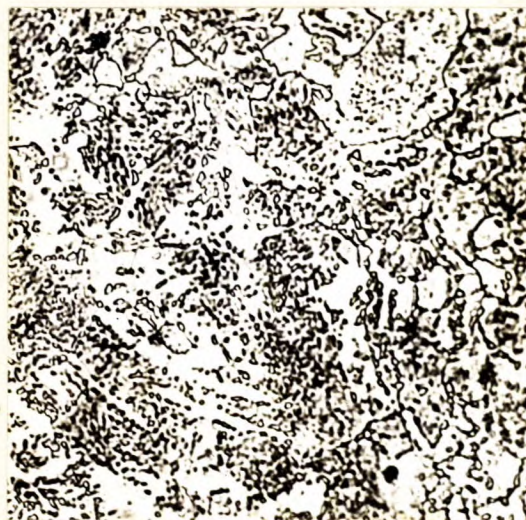
Figure 4.

Ball Socket No. 3.

Note spheroidized  
carbides.

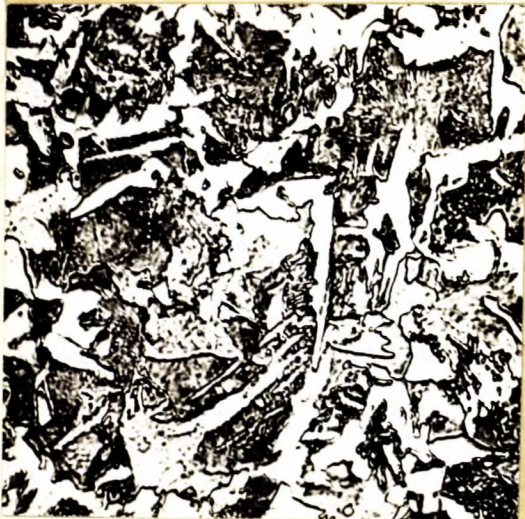
Figure 5.

The microstructures of the satisfactory sockets (Nos. 4 and 5) were different in two respects: (a) they consisted of ferrite and tempered martensite, as shown in Figure 5 (a photomicrograph, at X1000, of Socket No. 4); and (b) both sockets were decarburized to a depth of 0.040 inch.

Ball Socket No. 4.

Ferrite and drawn  
martensite.

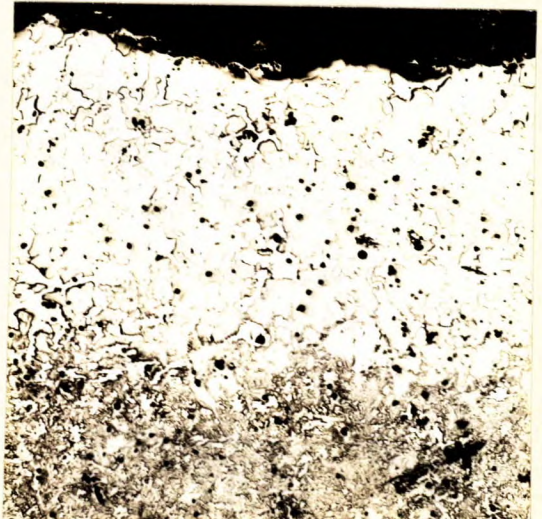
Figure 6.

Surface of Ball Socket No. 5.

Partial decarburization,  
to depth of 0.040 inch.

Surface decarburization is responsible for the differences in the hardnesses reported for Sockets Nos. 4 and 5 in Tables I and III respectively as the 0.040 partial decarburization shown in Figure 6 had not been completely removed before hardness testing. Brinell surface hardness tests taken on the neck of the sockets (Table I) have been recorded in this report as this is the mode of inspection testing. This surface decarburization would lower the fatigue strength of the casting but in this particular case this is not of importance as failure is not produced by the action of alternating stress.
