REPORT
of the
ORE DRESSING AND METALLURGICAL LABORATORIES.

Investigation No. 1874.

Metallurgical Examination of Broken Bolt
from Type C-4 Liberator Gas Filter.

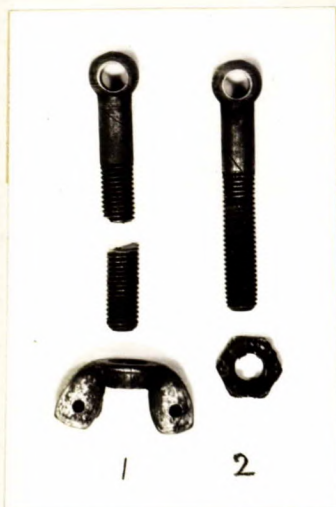
Figure 1.

For purposes of identification, the two bolts removed from the crashed plane are designated as Nos. 1 and 2, and the bolts on the unit supplied, said to have withstood 400 hours of service, *are* designated as Nos. 3 and 4.

BOLTS REMOVED FROM FILTER
UNIT OF CRASHED LIBERATOR
AIRCRAFT.

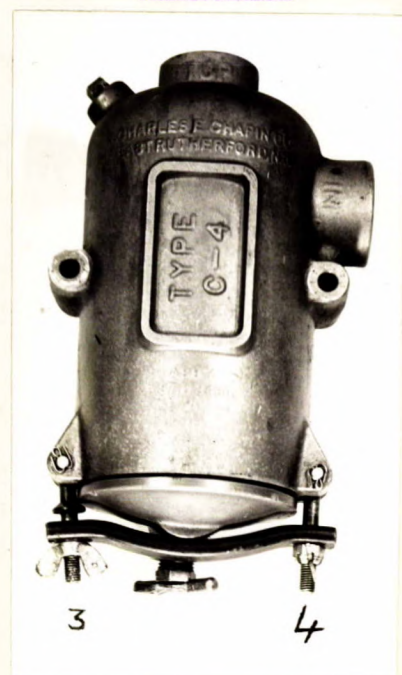
Figure 2.

TYPE C-4 LIBERATOR
GAS FILTER UNIT.

Examination of the assembled filter unit (in Figure 2) indicates that vibration of the wing nut and bolt assembly is unavoidable since the nut is tightened against the resistance of the steel bar, which has a certain amount of flexibility. In this connection it should be noted that the bolt with the shoulder (No. 3, shown in Figure 2) would be superior to the bolt which failed, since a rigid member

could be obtained by tightening the bar up against the shoulder of the bolt. The cross-bar should, of course, be designed so that the lid will be held tightly enough to maintain a proper seal.

3. The design of the bolt assembly should be such as to ensure as great a rigidity as possible.

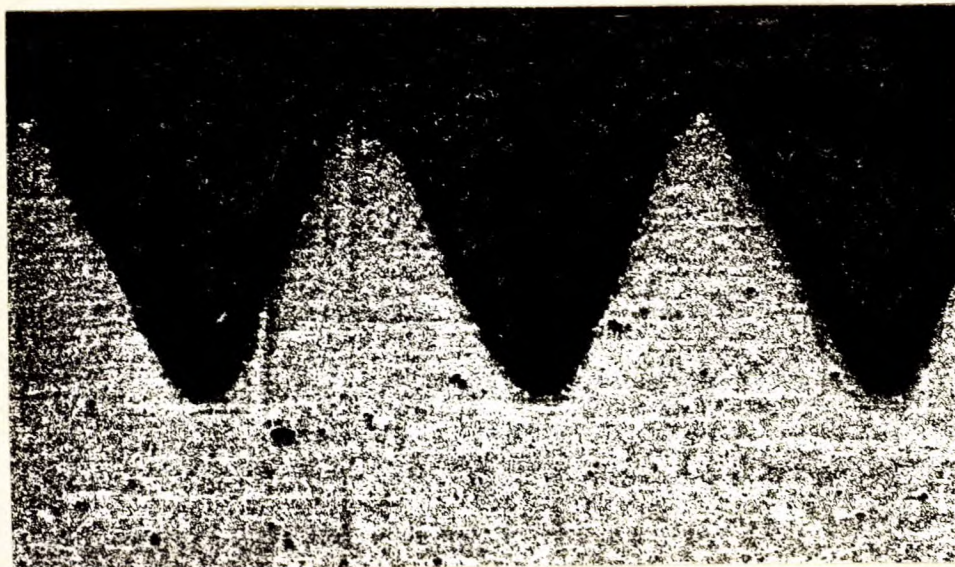
Figure 3.

The deep and often sharp notches formed by the threads act as very severe stress raisers. Figures 3 and 4 show (because of lack of distortion at the roots) that the threads in both broken and good bolts were cut and had been heat-treated after cutting. It should be noted, however, that the root radius of the broken bolt is less than that of the good one, thus resulting in increased stress concentration at the thread roots. Hence, the thread design of the broken bolt is definitely inferior to that of the good bolt.

BROKEN BOLT (NO. 1).

Threads cut from blank.
Note rather small root radius.

4. The employment of bolts containing rolled rather than cut threads; or the use of cut threads subsequently given a superficial rolling after heat treating.

- (a) A large root thread radius.
- (b) A shoulder on the shank to give greater rigidity.
- (c) A reduced diameter of the shank up to the threaded section, in order to increase the elasticity of the bolt.

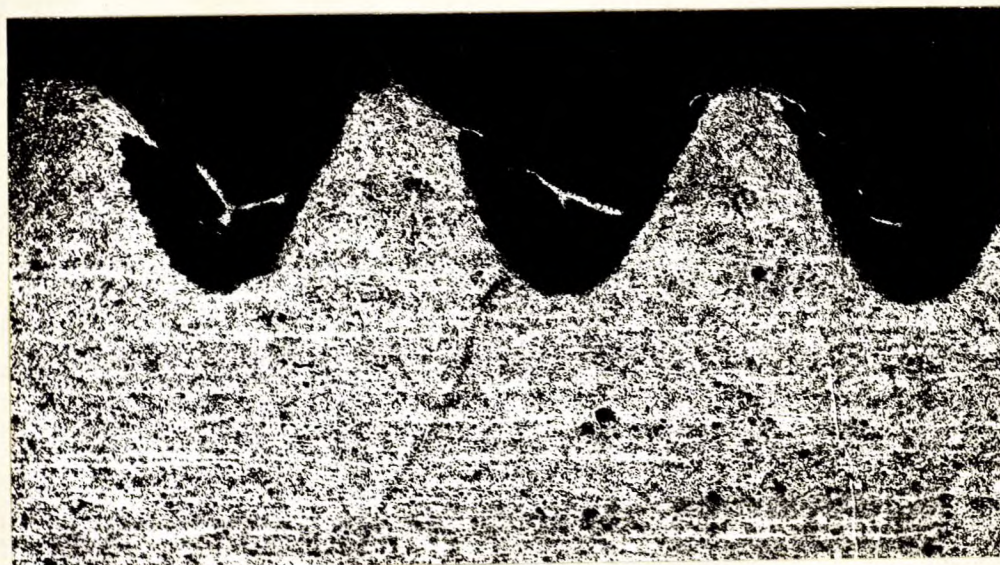
Figure 4.

GOOD BOLT (NO. 3).

Threads cut from blank.
Note greater radius of root as compared
with Figure 3, resulting in decreased notch
sensitivity.

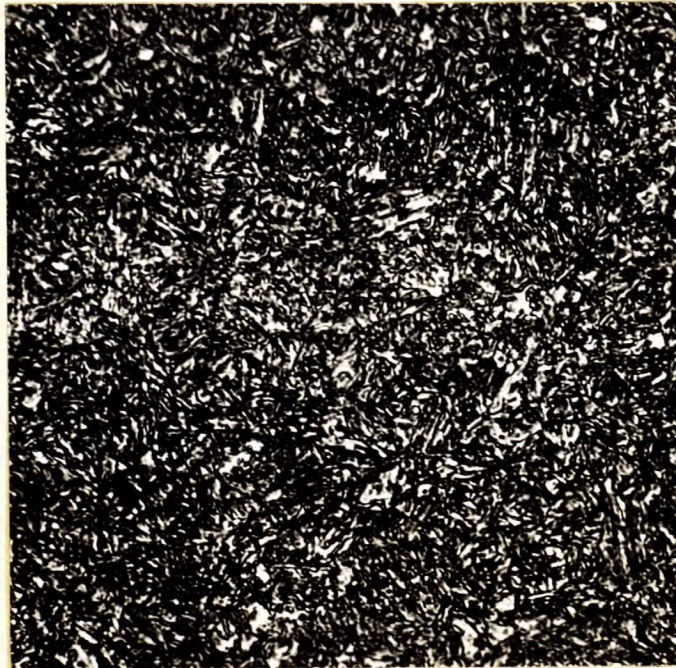
Figure 5.

Figures 5 and 6, taken at X1000 magnification, show the microstructures of the broken bolt and good bolt respectively. The microstructures are similar, consisting of tempered martensite. The structure in Figure 6 is coarser than that in Figure 5, indicating a higher heating temperature before quenching.

The microstructure of the broken bolt (see Figure 5) is normal for a quenched and drawn steel.

X1000, nital etch.
BROKEN BOLT (NO. 1).
Tempered martensite.

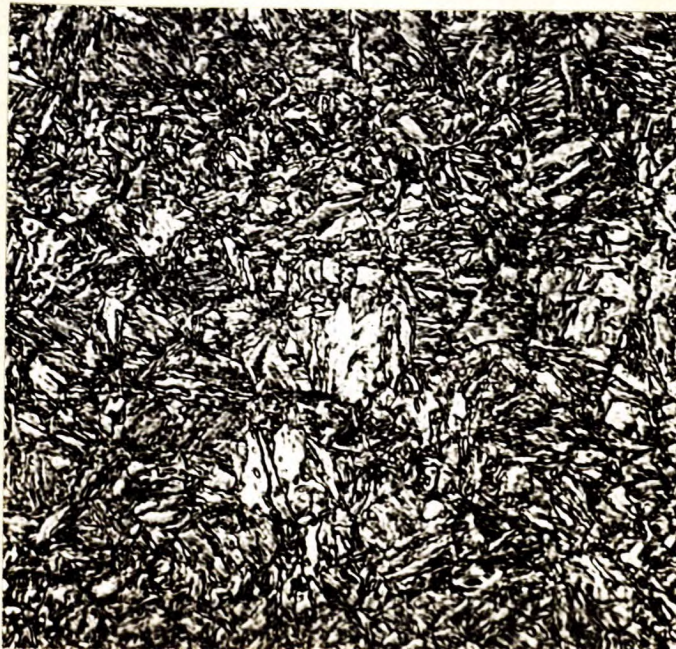
Figure 6.

X1000, nital etch.
GOOD BOLT (NO. 3).
Tempered martensite.

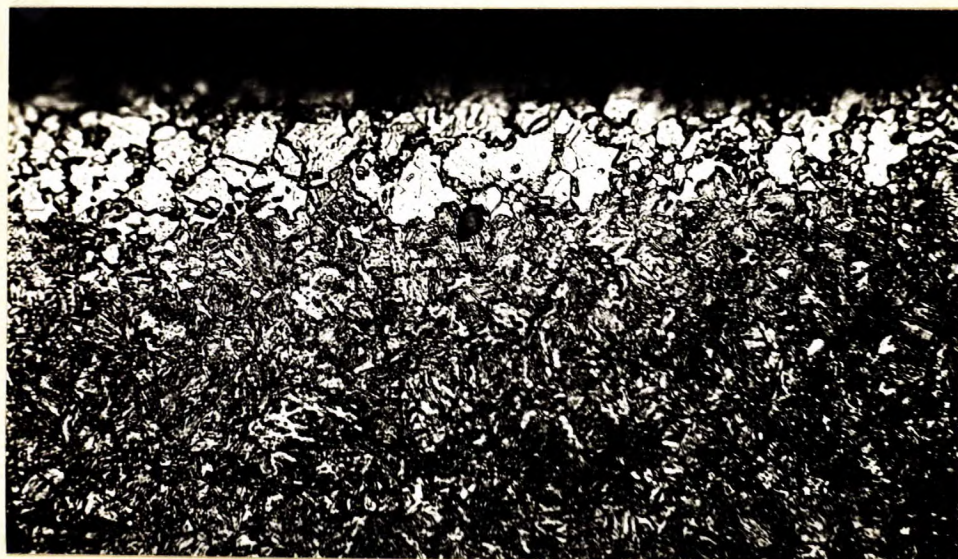
Figure 7.

Figure 7 shows decarburization to a depth of approximately 1/1000 inch at the threads of the broken bolt, incurred during the heat treatment. The decarburization did not result from the fire that consumed the aircraft, since the microstructure and hardness of the bolt indicate that the bolt had not been heated to a temperature high enough to cause decarburization. The presence of decarburization is significant in that it results in a considerable decrease in fatigue strength. However, it should be noted that some decarburization was also evident in the good bolt (see Figure 8) which had withstood 400 hours of service before removal, although the extent of the decarburization is not as great.

Decarburization very seriously decreases the fatigue strength of a metal and should be avoided.

BROKEN BOLT (NO. 1).

Showing decarburization on threads
(approximately 0.001 inch).

1. Stringent measures should be taken to prevent the employment in service of decarburized bolts.

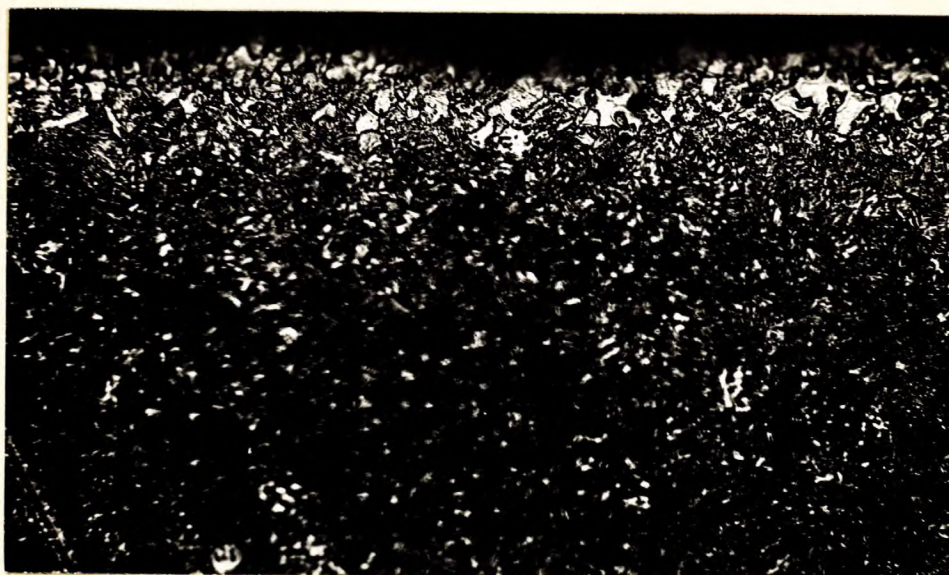
Figure 8.

GOOD BOLT (NO. 3).

Showing very slight decarburization.
