Investigation No. 1875.

Metallurgical Examination of a Broken  
Camshaft from a 3-Ton Dodge Truck.

On May 7, 1945, the Division of Metallurgy, Army Engineering Design Branch, Department of Munitions and Supply, Ottawa, Ontario, submitted two broken camshafts for metallurgical examination. The request for this work was covered by Requisition No. 698, A.E.D.B. Lot No. 591, Report No. 13, Test No. 75. This requisition contained the following information:

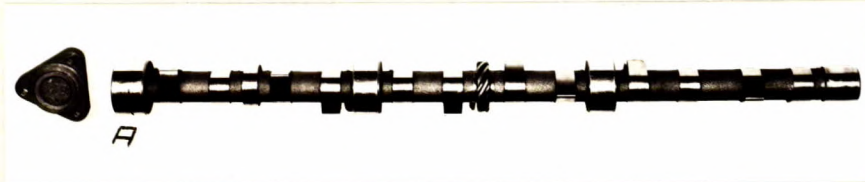
Figure 1.

Figure 1 is a photograph illustrating the location  
of the failure of these camshafts.

(Approximately 1/8 actual size).

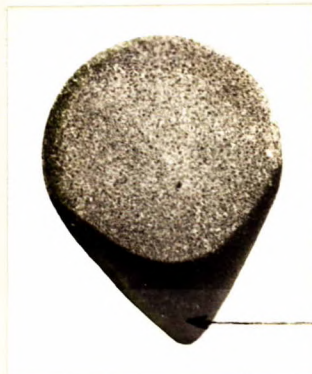
Figure 2.

Figures 2 and 3 are photographs of cross-sections of the cam and bearing respectively. A slight shrinkage cavity was observed in the centre of the bearing section, (at A in Figure 1) of the shaft. This is shown at B in Figure 3. No defects were noted in the cam section, and the hardened portion appeared uniform.

Scleroscope hardness  
of cam, 66.

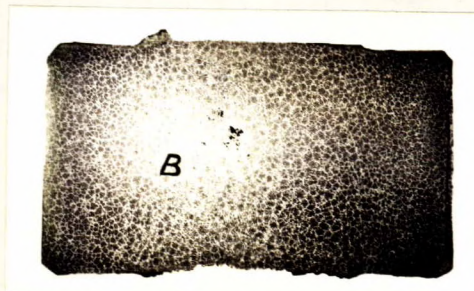
Figure 3.

Brinell hardness  
of bearing surface  
(3,000-kilogram load),  
255.

The chemical composition of the camshaft examined is within the range generally used by C.W.C. Crankshaft Co., Muskegon, Michigan, for this application. The several small centre-line shrinkage cavities shown to be present by macro and X-ray examinations are not considered to be serious defects. The tensile and fatigue properties of the iron are regarded as satisfactory. The Brinell hardness of the bearing surface of the camshaft was slightly less than the value specified. However, the scleroscope hardness of the chilled portion of the cam met the requirements specified by Chrysler. A microscopic examination showed massive carbides to be present in the chilled and unchilled portions of the shaft. These carbides can be reduced by increasing the silicon and nickel additions. An increase in the nickel content would probably be preferred as it would improve the chilling and tensile properties of the iron. The presence of these carbides would probably lower the impact strength of the iron. The martensitic structure observed in the chilled section of the camshaft indicates that the cams were hardened by a water quench in the flame-hardening operation.

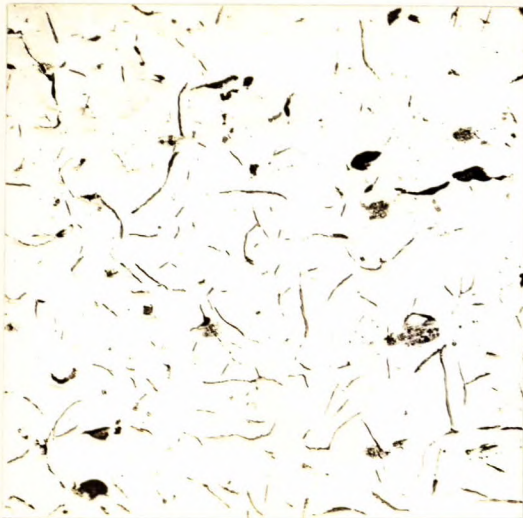
Figure 4.

Figures 4 and 5 are photomicrographs, at X100 magnification, showing the unetched and nital-etched structures, respectively, of the iron. The graphite flakes are quite fine and uniformly distributed throughout the pearlitic matrix. Considerable free cementite, however, was found to be present throughout the iron. One of these areas, in which Tukon hardness readings were taken of the cementite and the pearlite, is shown in Figure 6, a photomicrograph at X500 magnification. The matrix material is fine pearlite. Figure 7 is a photomicrograph, at X500 magnification, showing the martensitic background structure of the chilled section of the cam. Massive carbides are also present.

X100, unetched.

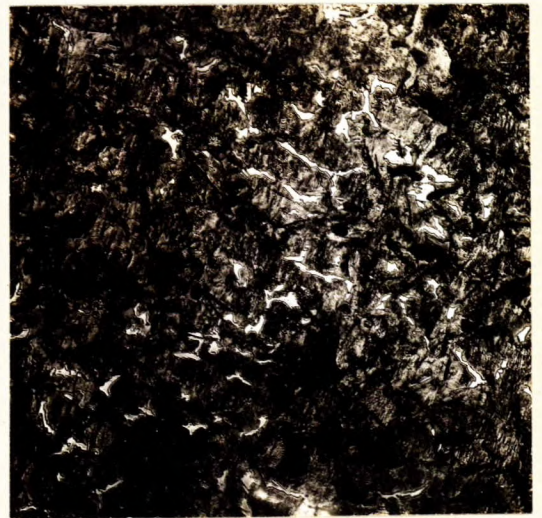
Figure 5.

X100, etched in  
2 per cent nital.

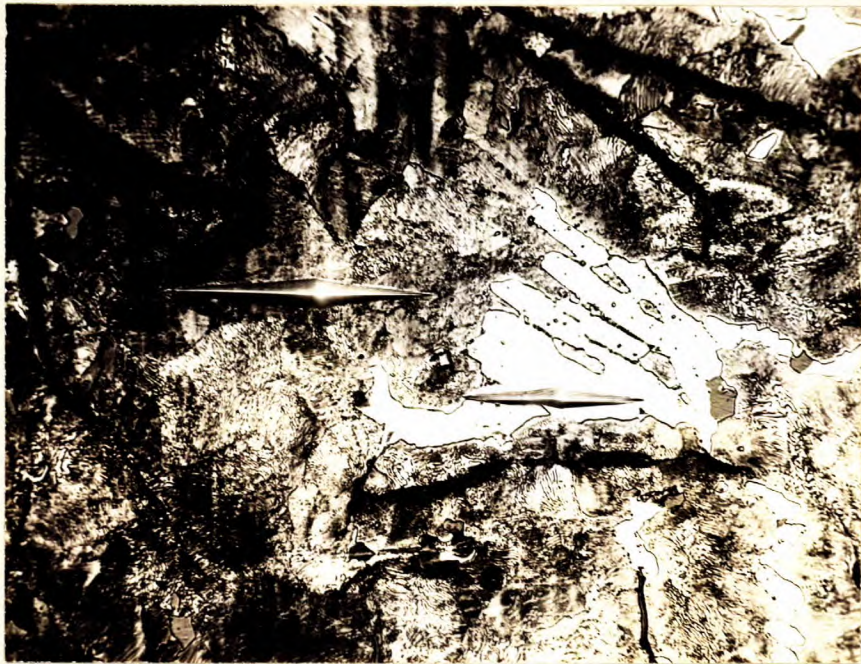
Figure 6.

X500, etched in  
2 per cent nital.

- A. Cementite; Tukon hardness number, 707.
- B. Pearlite; Tukon hardness number, 240.

Cast iron, on account of its relatively low impact strength as compared with steel, is seldom used where the part is subjected to heavy impact stresses. Therefore the presence of these carbides in the metal under normal operating conditions probably would not be a cause of failure. If, however, any change were made in the design or in the operating conditions which would increase these stresses on the camshaft, then one would expect the shaft to break sooner than if the metal were free from carbides. The evidence in the present case, however, would seem to indicate that failure was due to some external factor, such as the imposing of stresses

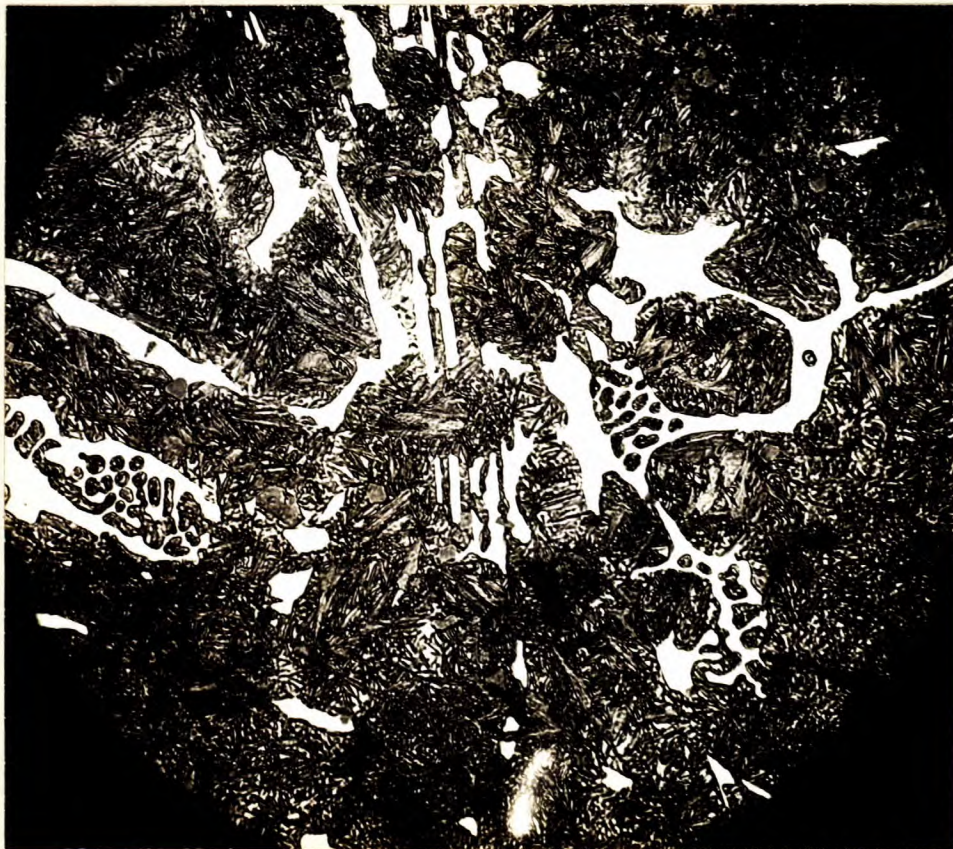
Figure 7.

X500, etched in  
2 per cent nital.

SHOWING THE STRUCTURE OF THE CHILLED PORTION  
OF THE CAMSHAFT.
